Tripping of 400 kV Meramundali - JSPL Ckt 1& 2

Report on the grid event in Eastern Region (पूर्वी क्षेत्र में ग्रिड घटना पर रिपोर्ट)

Multiple tripping of STPS-CHANDIL

**Outage of 220KV Bus-1 along with system disturbance occurred at
Budhipadar Grid S/s on dt. 08.04.2021.**

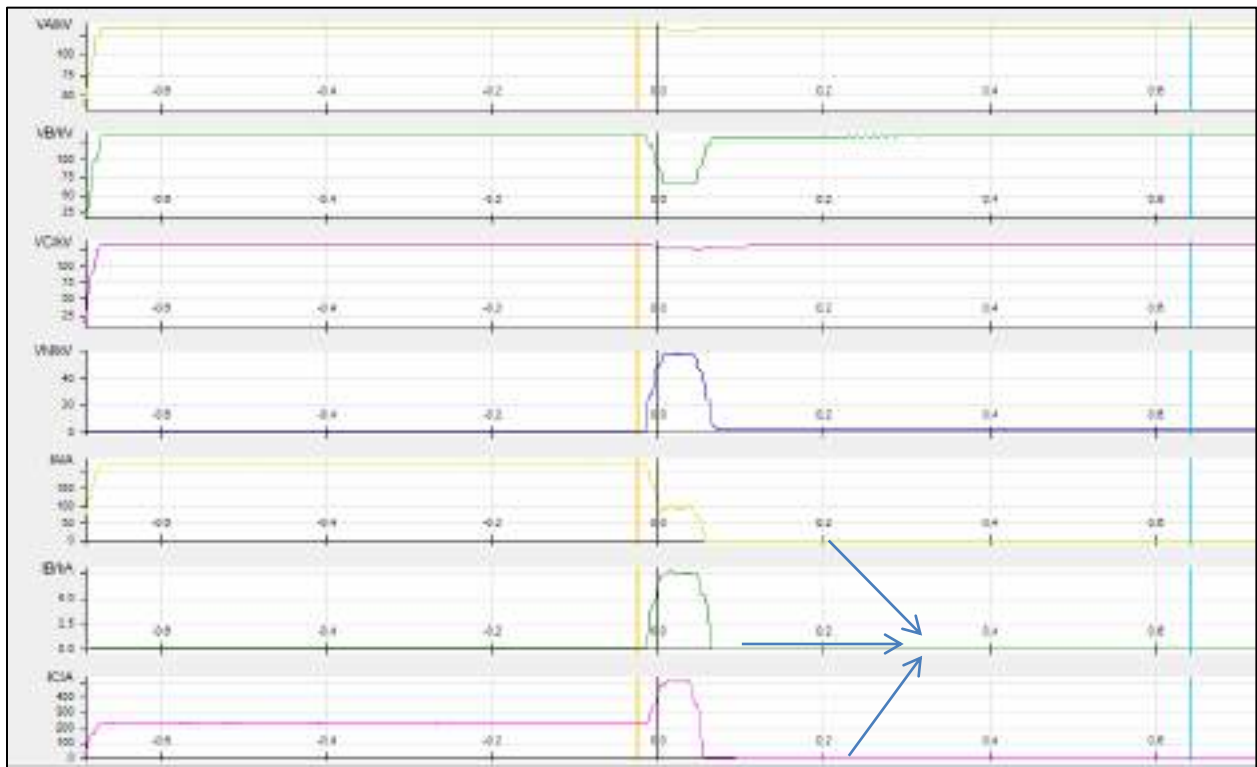
DR at STSPS END FOR 18/03/2021

It is observed that frequent single phase faults are occurring at the same location which is 98 km from chandil end and at 11 Km from STPS end .Row issue and proper line patrolling and maintenance may be ensured to avoid such frequent faults at same location.

In all cases of tripping it is observed that from Santaldih end, fault is in zone-1 and 3 phase tripping is occurring at the instant of single phase fault. So no auto reclose is observed in any event from Santaldih end ,if Auto reclose would have operated some tripping's of transient fault could have been avoided. Whether Auto reclose scheme is implemented and functional may please be communicated.

Carrier communication scheme failure : All faults were in zone-2 from Chandil end and delayed tripping observed after zone-2 time in each case, and all 3 phases from Chandil end tripped after z- 2time . Seems also carrier communication scheme not working as STPS end is sensing z-1 so it should send carrier signal to remote end to trip instantaneously faulty phase in case of zone-2 start at remote end and will further proceed for auto reclose after dead time .Delayed clearance also could have been avoided along with line tripping.

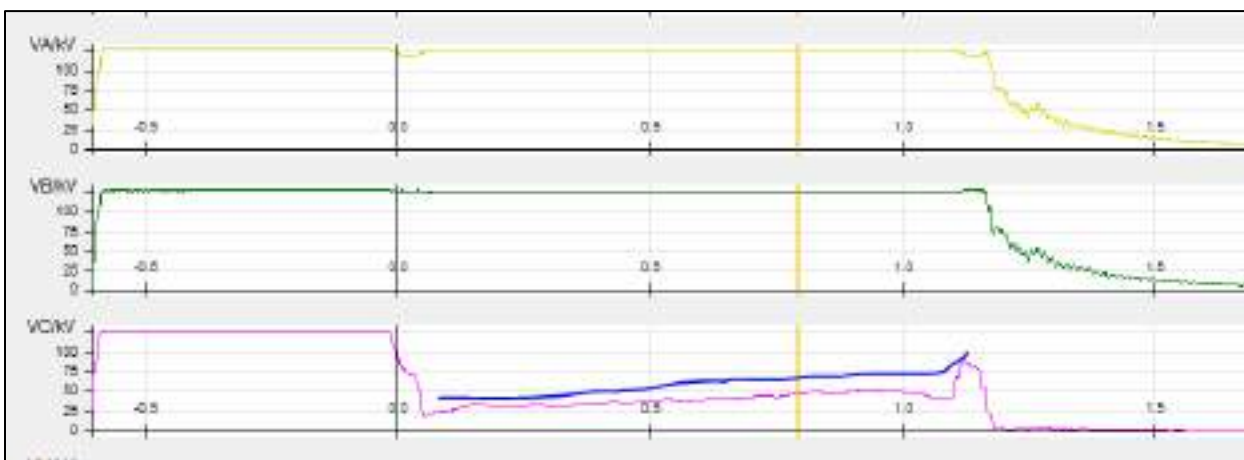
RMS VALUE:

AT CHARGING INSTANCE: Then at the charging instance after few milli line tripped due to Y-B fault and it appears from DR that prior to tripping B phase fault converted to Y-B fault and was existing in the line with small magnitude which increased in few milli seconds and got detected and tripping issued .

Similar phenomenon is also observed in the past this may be checked that what nature of fault is occurring where first B phase fault is being converted to Y-B phase fault with some small arcing kind of phenomenon leading to Phase to phase conversion. Whether any Row or clearance issue is there?

Initially B phase fault is getting converted to Y-B phase fault at the charging instance slowly where some arcing is been observed and at the charging instance before tripping it is observed line is already having Y-B fault whose magnitude is slowly increasing and getting detected by relay and tripped .

Whether any clearance issue is there needs to be checked .Initially also at the time of First time charging of this line this same sequence of tripping was observed several times.

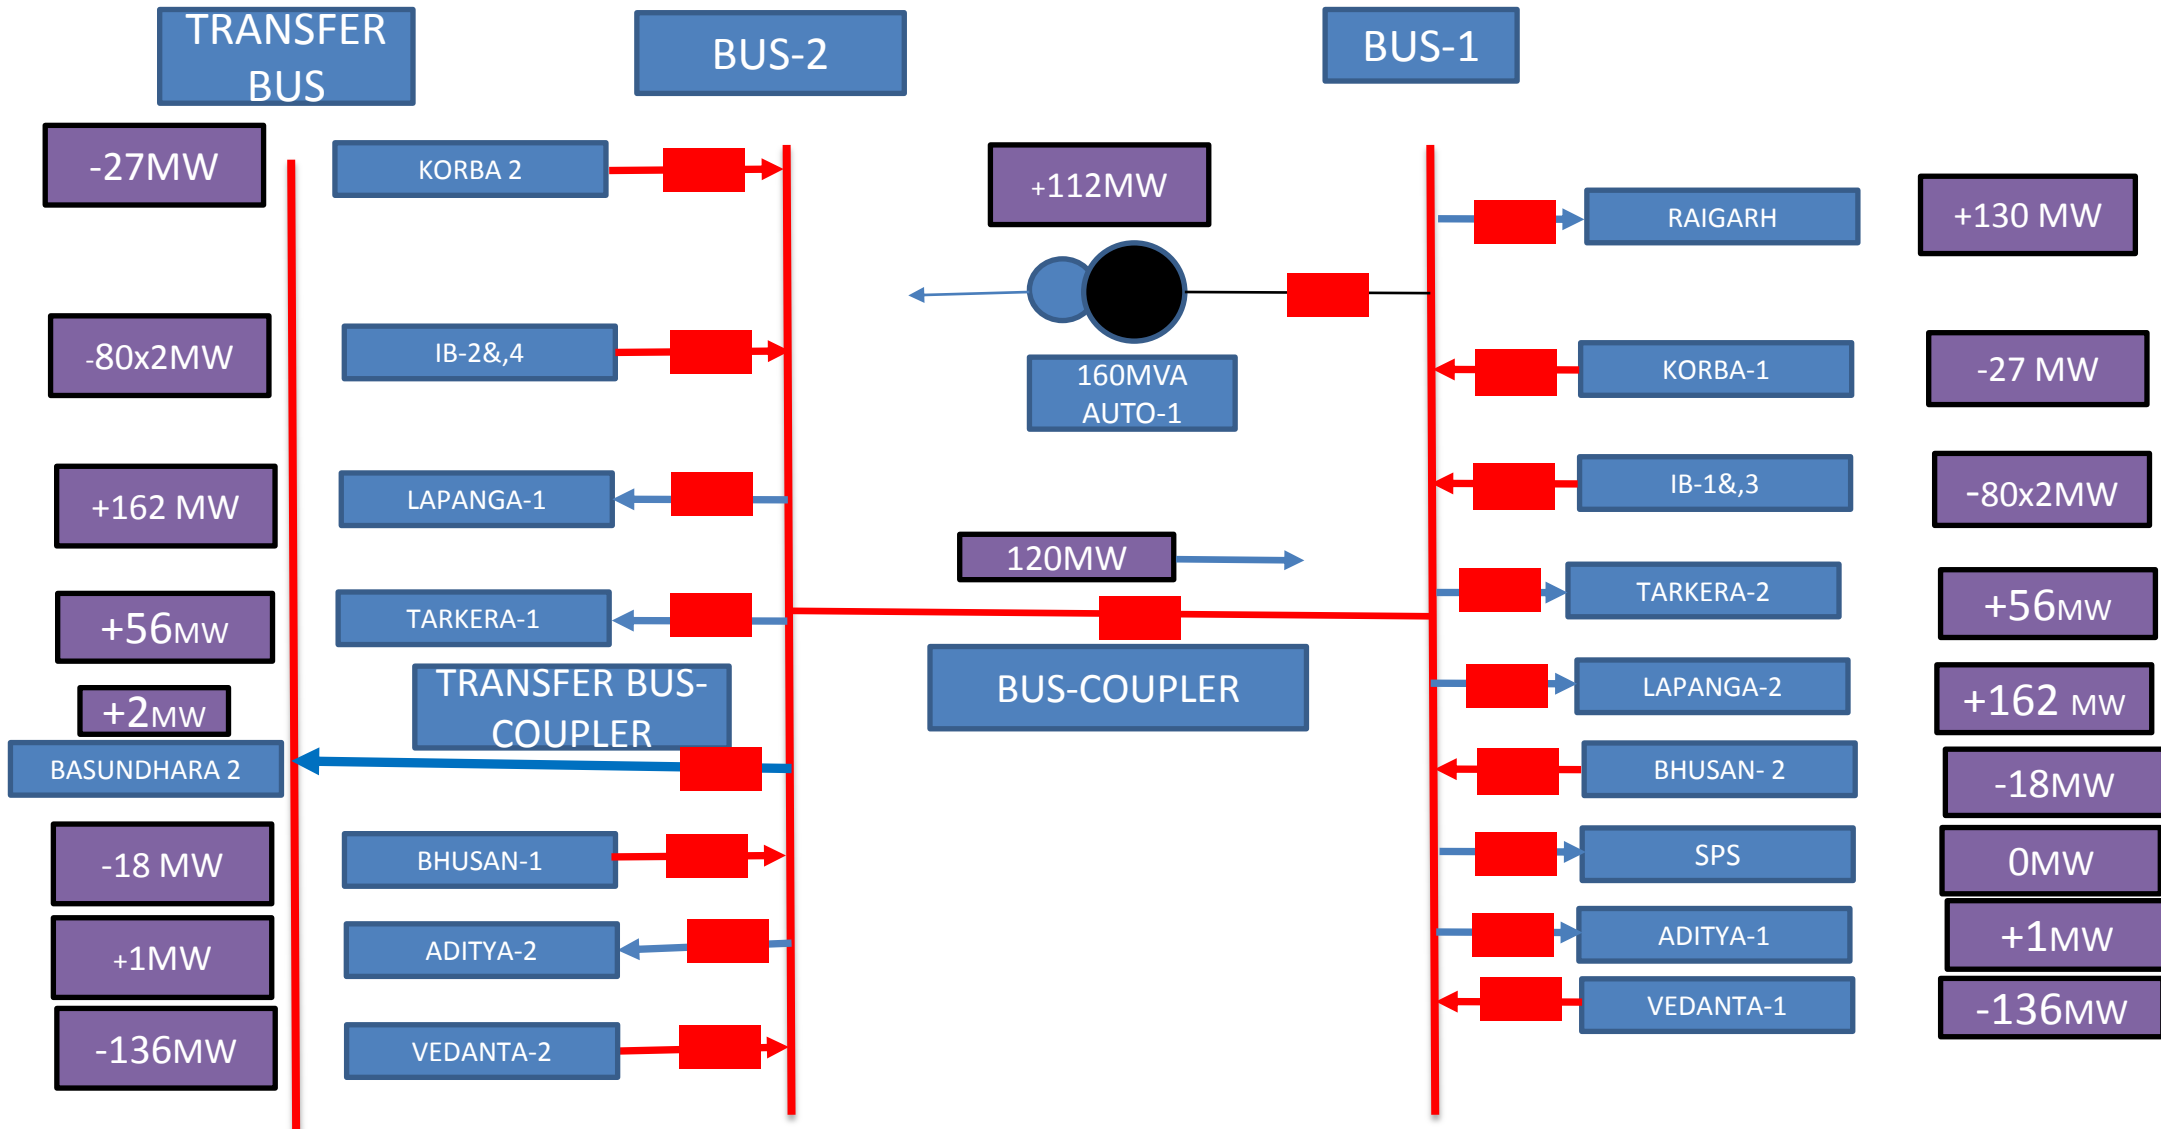
LOAD PATTERN OF DIFFERENT FEEDERS AT 13.00 HRS. DT.08.04.21

PRE-FAULT CONDITION

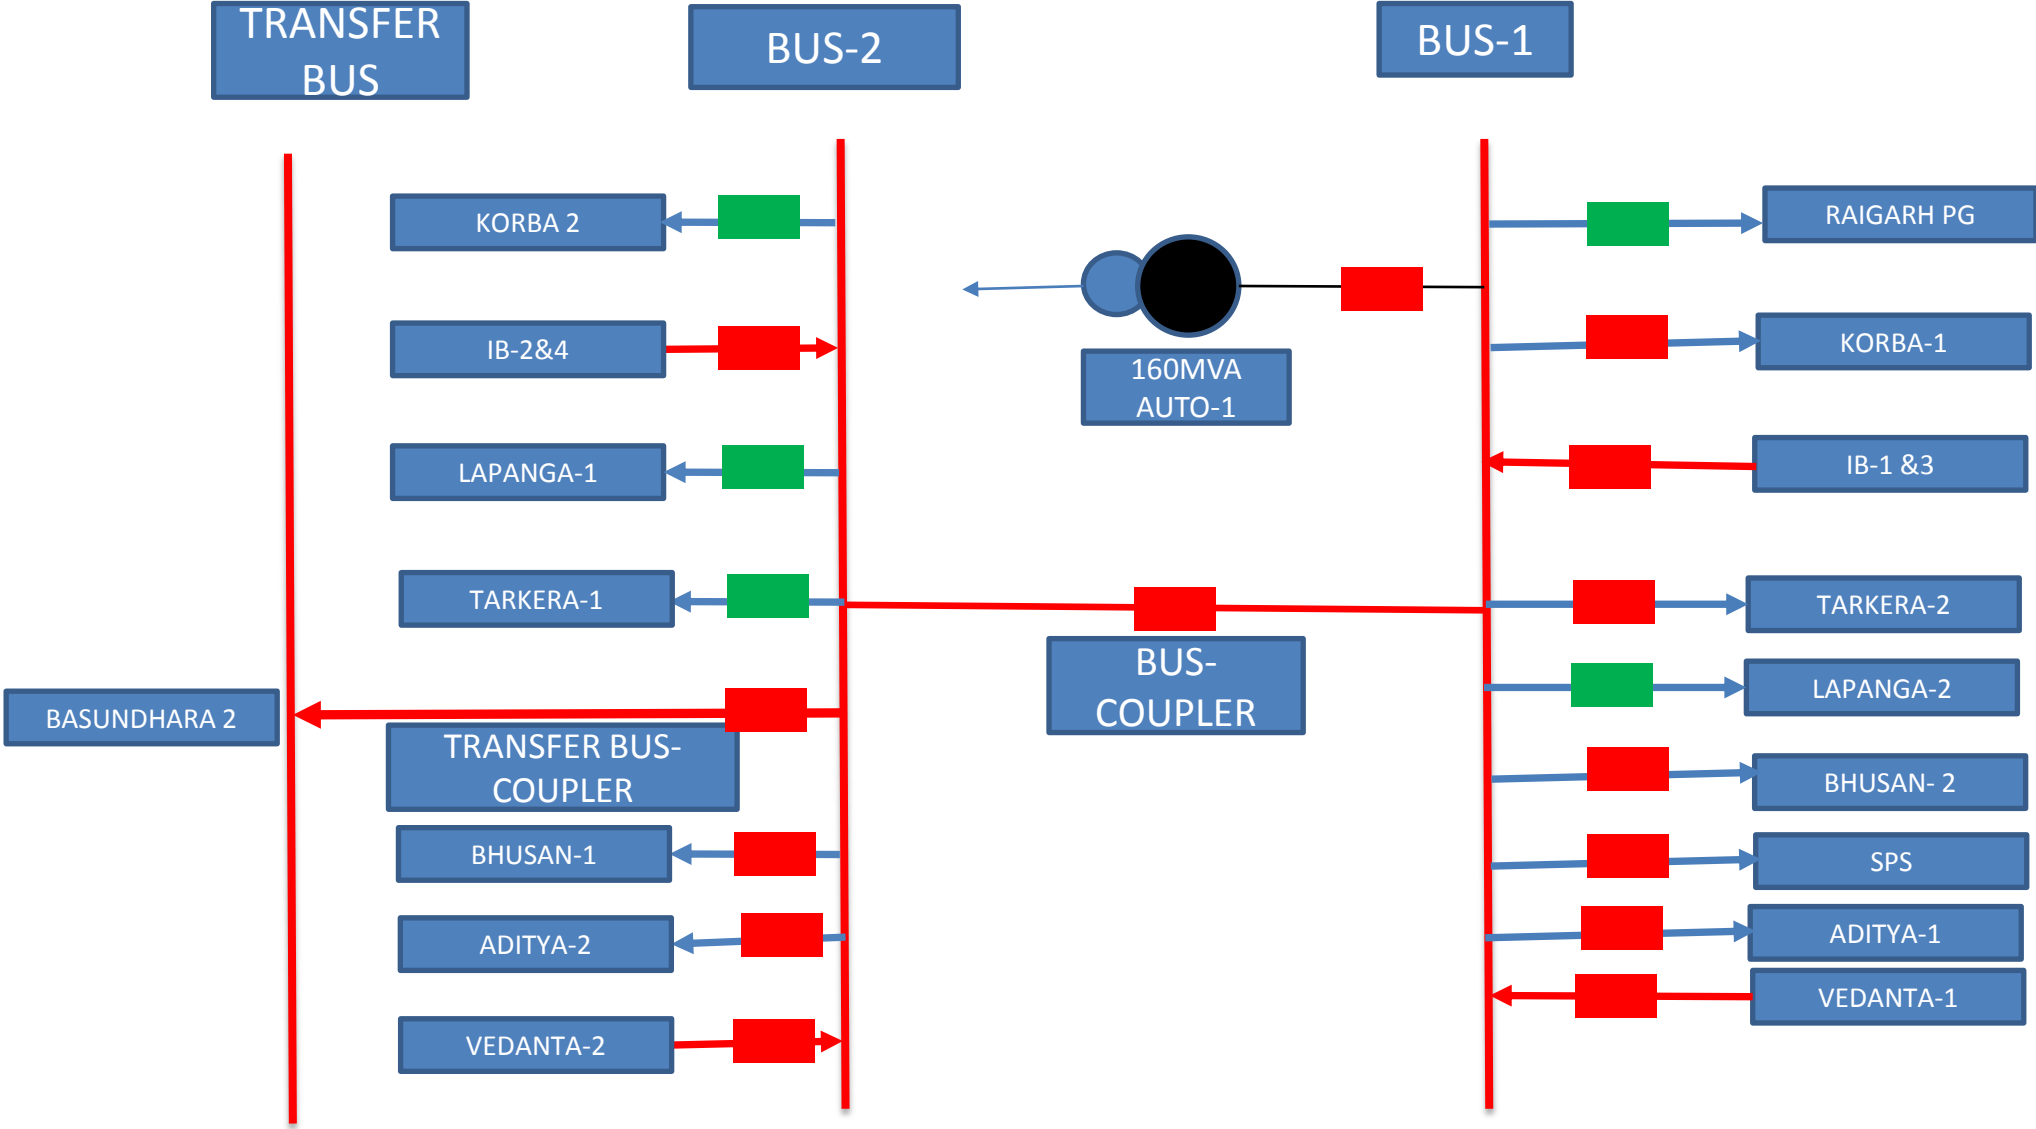
BEFORE BUS-1 FAULT CONDITION

(LAPANGA-1, LAPANGA-2, RAIGARH-PG, KORBA-3, TARKERA-1 WERE IN TRIPPED CONDITION)

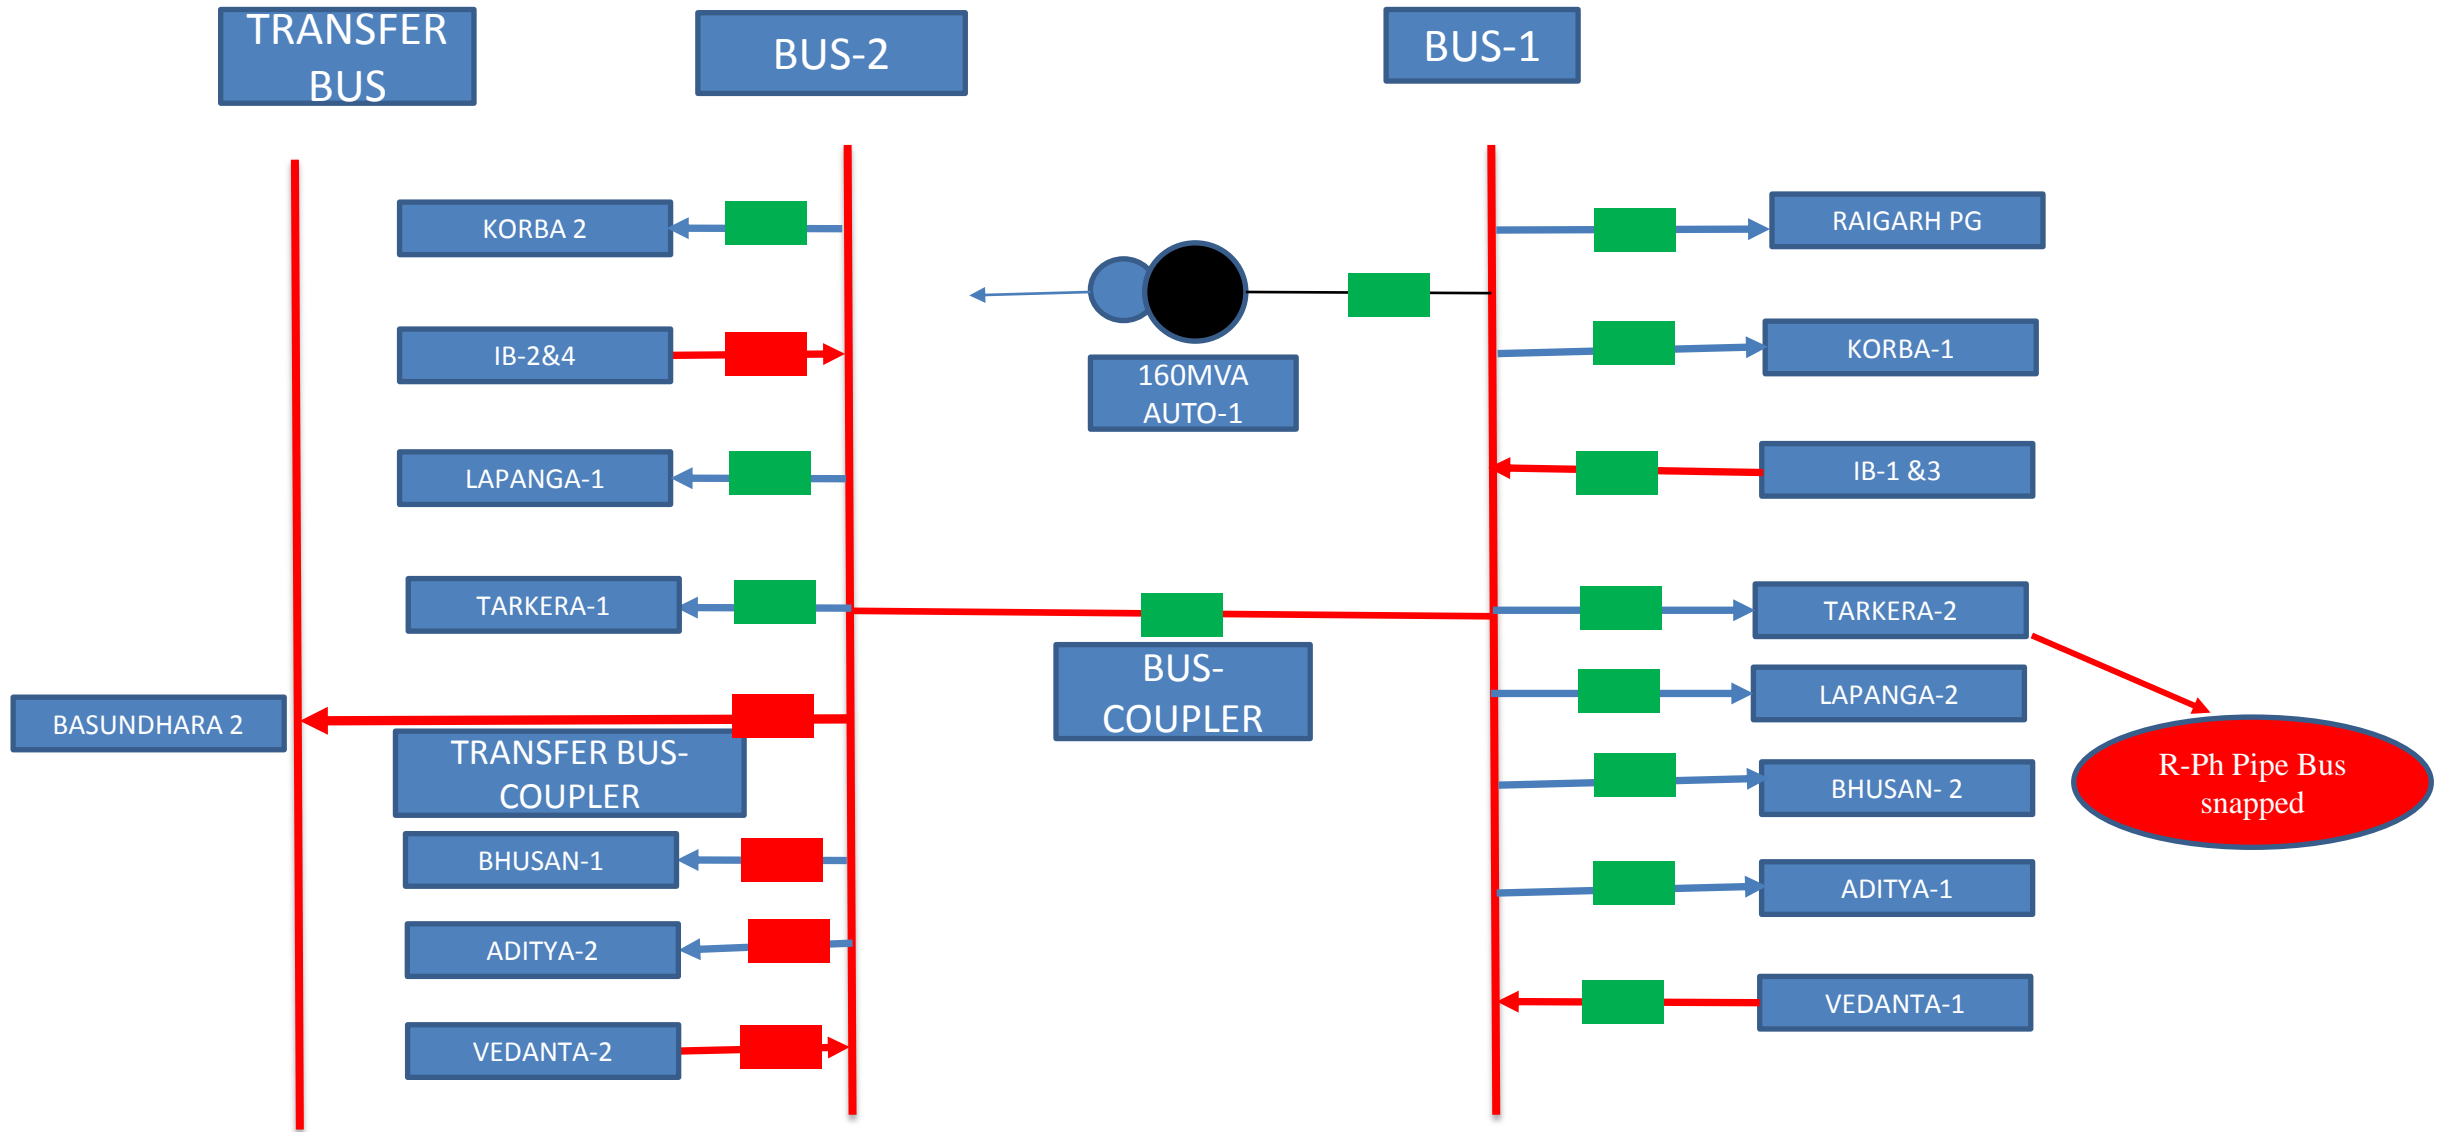
POST-FAULT CONDITION

(ALL FEEDERS IN BUS-1 TRIPPED ALONG WITH BUS- COUPLER)
