Minutes
of
104th PCC Meeting

EASTERN REGIONAL POWER COMMITTEE

MINUTES OF 104TH PROTECTION COORDINATION SUB-COMMITTEE MEETING HELD ON 13.07.2021 AT 10:30 HOURS

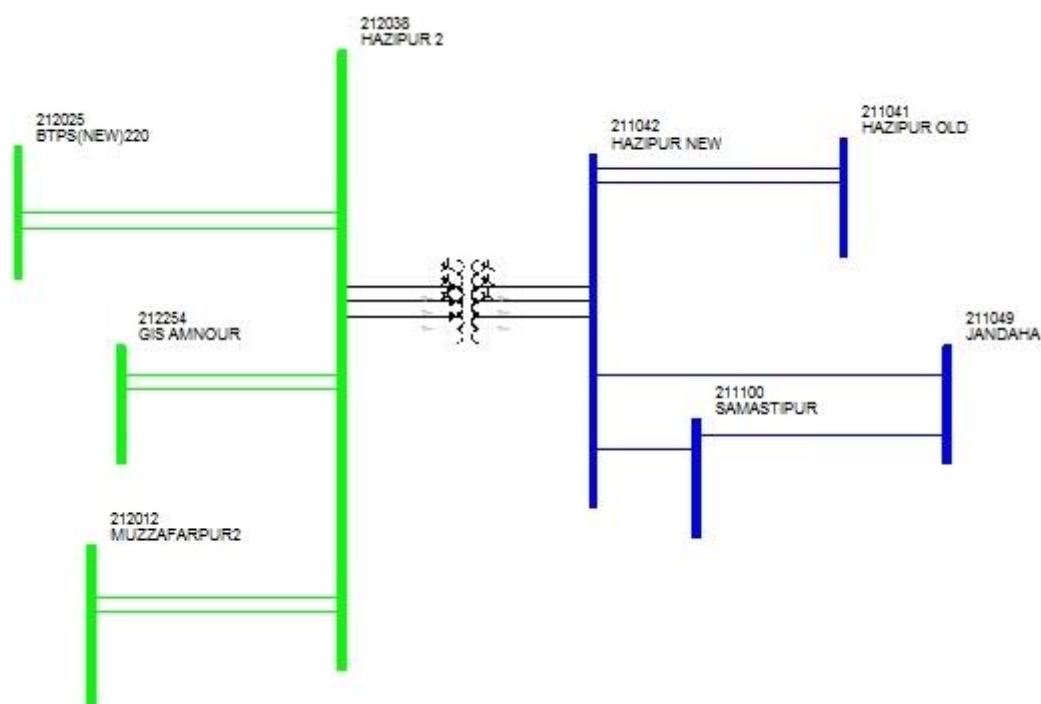
As per information received, Y-phase bus coupler CT at 220kV Hazipur S/S got blasted leading to operation of bus-bar protection. Both buses became dead along with tripping of all outgoing lines emanating from Hazipur S/s. Total load loss reported was 300 MW at Hazipur and nearby areas.

BSPTCL informed that the disturbance occurred due to bursting of Y phase CT of bus coupler bay at Hazipur S/S. This led to operation of bus bar protection for both 220 kV bus-1 & bus-2 and tripped all the elements connected to these buses. As a result, total power failure occurred at 220 kV Hazipur S/s.

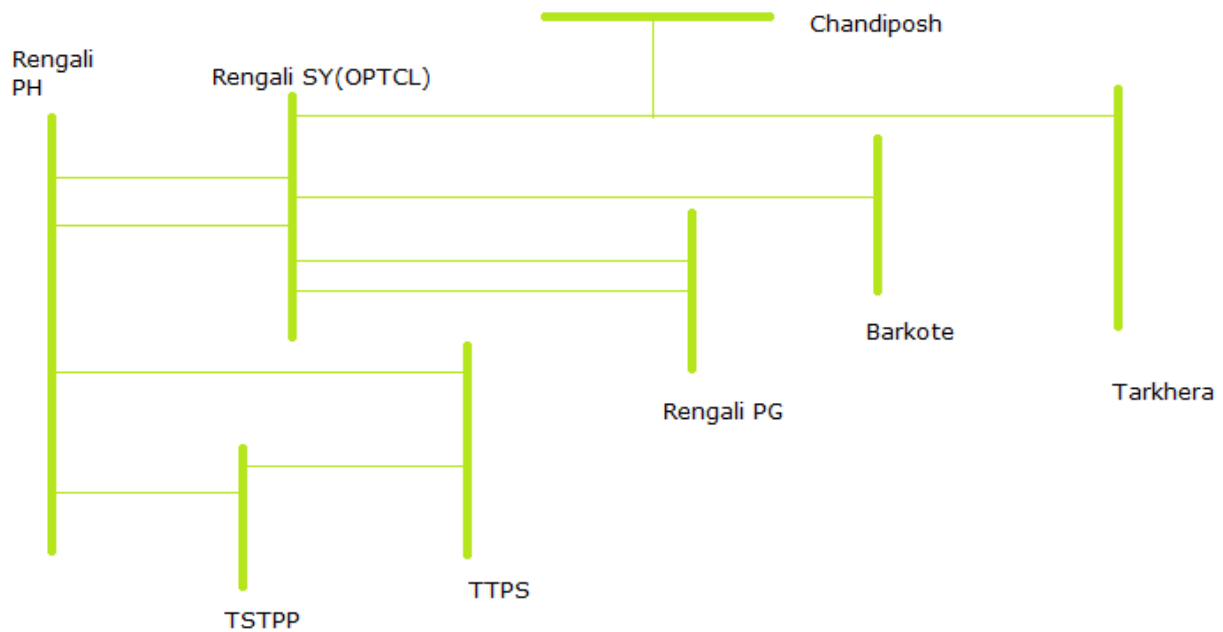
Due to CVT failure of 220 kV Rengali-TSTPP S/C at Rengali end, all 220 kV lines connected to 220 kV Rengali (OPTCL) S/S and 220 kV Rengali PH got tripped. Y phase jumper snapping of 220 kV Rengali-Rengali – 2 at 220 kV Rengali (OPTCL) Bus A was also reported at the same time.

In 103rd PCC , OPTCL explained that the fault occurred due to jumper snapping of Y-phase of 220 kV Rengali(OPTCL)- Rengali (PG)-2 line at Bus A of Rengali(OPTCL) switchyard resulting in a bus fault.

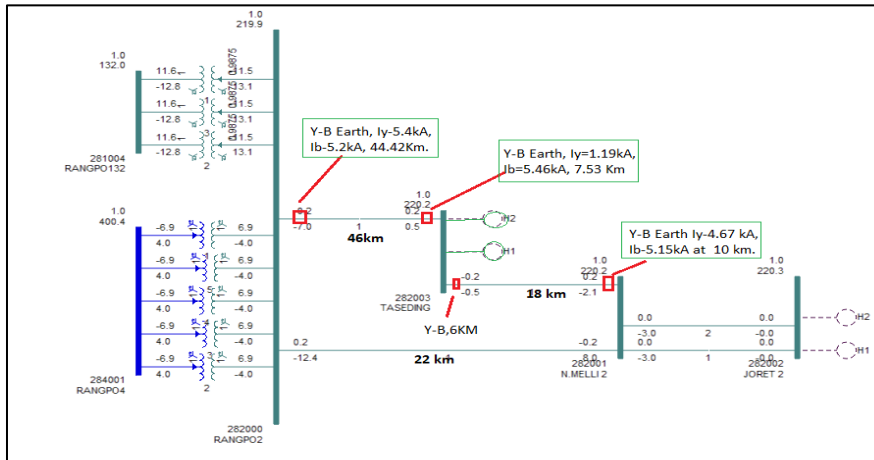
SLD of Affected Area:

- From DR plot it is clear that first fault was encountered by 220 Kv Tashiding-New Melli line. At New Melli end fault was sensed in zone -1 with Y-B nature at a distance of 10 km, and 3 phase tripping occurred .

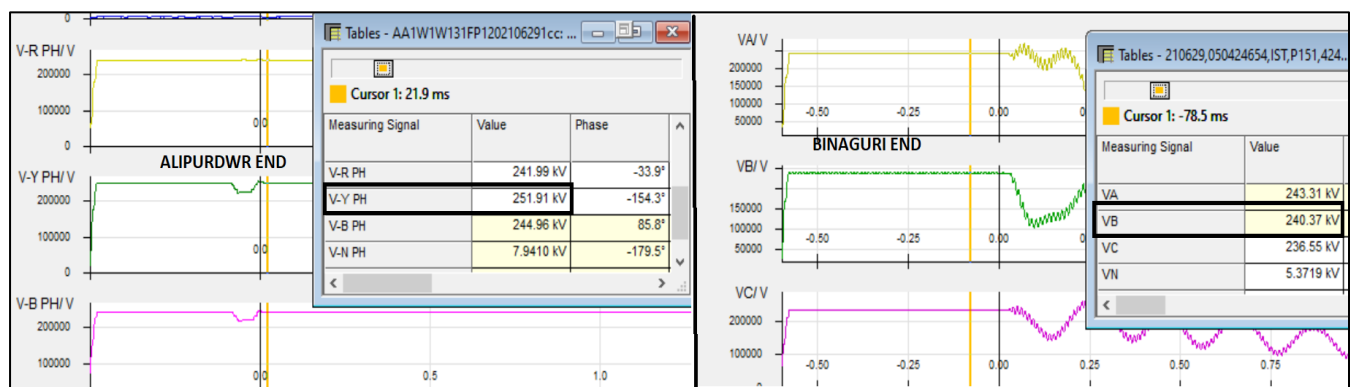
Alipurdwar & Binaguri end Line voltage comparison for 29 JUNE 2021:

For each tripping, it is observed that the Alipurduar end Y phase voltage is 17 kV higher than the rest two phases, while at the Binaguri end no such thing observed. This indicates that there is no such actual voltage rise existing in line due to mutual induction or transposition.

Powergrid informed that the overvoltage issue was due to damage in the CRP cable in switchyard. The cable has been changed and presently there is no overvoltage issue at Alipurduar end.

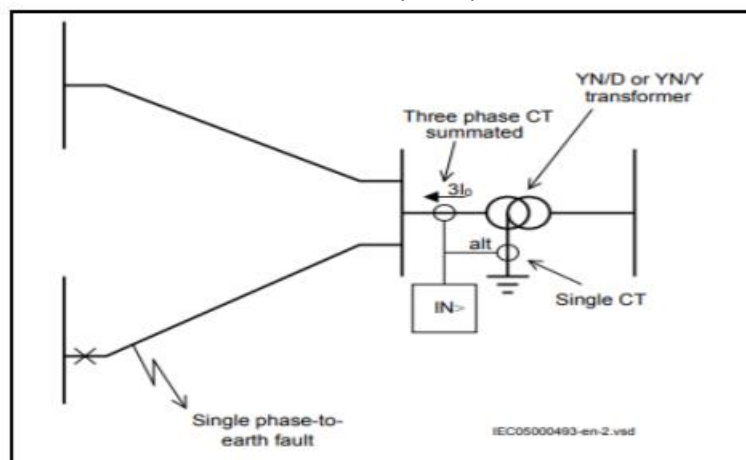
From the analysis of the all utilities practice it is seen that the setting are consistent with the upper limit as proposed in the OCC meeting. However in the lower limit side it is not directly ensured that for a remote end substation fault the same will not pick up as shown below.

Following the DVC's practice the line DEF and Transformer DEF can be coordinated. The overall recommendation is as follows for the satge-1 setting:
