# Agenda for 105<sup>th</sup> PCC Meeting

**Date:23.08.2021**  
**Eastern Regional Power Committee**  
**14, Golf Club Road, Tollygunge**  
**Kolkata: 700 033**

### AGENDA FOR 105<sup>TH</sup> PROTECTION COORDINATION SUB-COMMITTEE MEETING TO BE HELD ON 23.08.2021 AT 10:30 HOURS

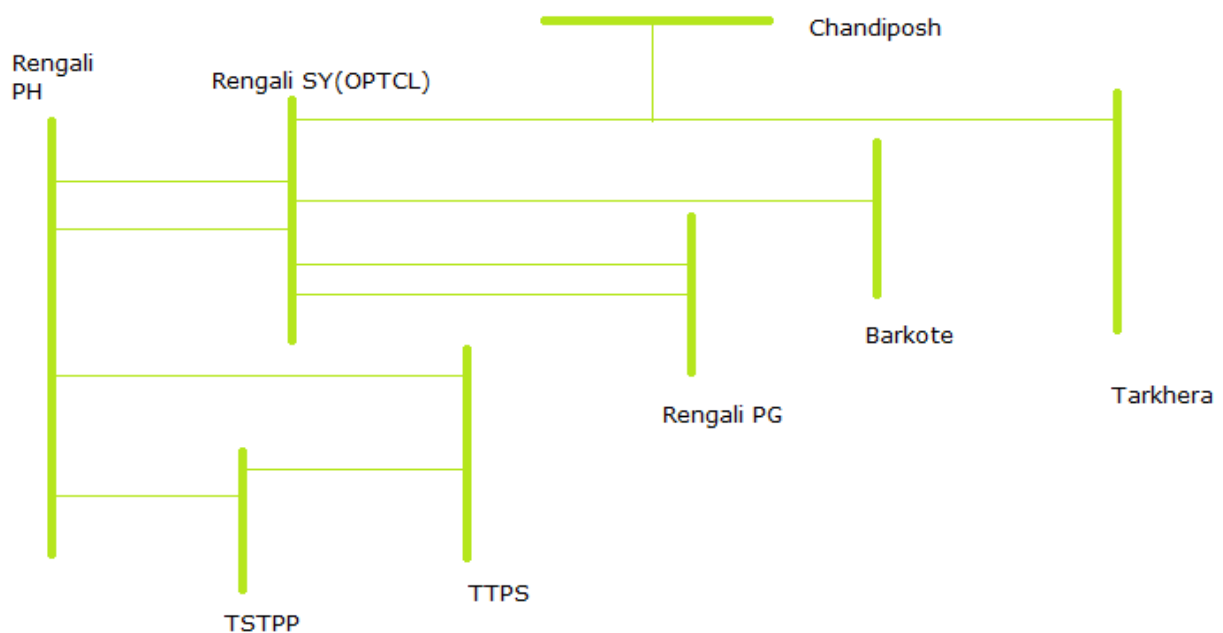
Time	Name	End 1	End 2	PMU Observation
08:57 Hrs	220kV Rengali PH-TSTPP S/C	B-Earth fault and overcurrent in the downstream of 33 kV	Yet to receive	PMU captured at Rengali shows B-Earth fault and slight dip in voltage
	220kV Rengali PH-TTTPS S/C	Yet to receive	Yet to receive	
	220kV Rengali PH-Rengali (OPTCL) -1	Yet to receive	Yet to receive	
	220kV Rengali PH-Rengali (OPTCL) -2	Yet to receive	Yet to receive

Following issues are observed related to this grid disturbance –

- Fault of 33 kV System got cleared from 220 kV system. All the protection system of downstream (33 kV and above) failed to clear the fault which led to tripping of all 220 kV lines.
- All four 220 kV lines tripped on O/V from Rengali PH only. Line didn't trip from remote ends.
- All generating units (U#1, U#2, U#4, U#5) tripped on Reverse Power Flow protection. Reason for reverse power flow and settings may be shared.
- There was loss of evacuation path due to tripping of all emanating lines. Whether any Over-frequency relay picked up in any unit need to be answered by concerned utility Over-frequency settings may be shared.
- Root cause analysis need to be done to identify faulty system

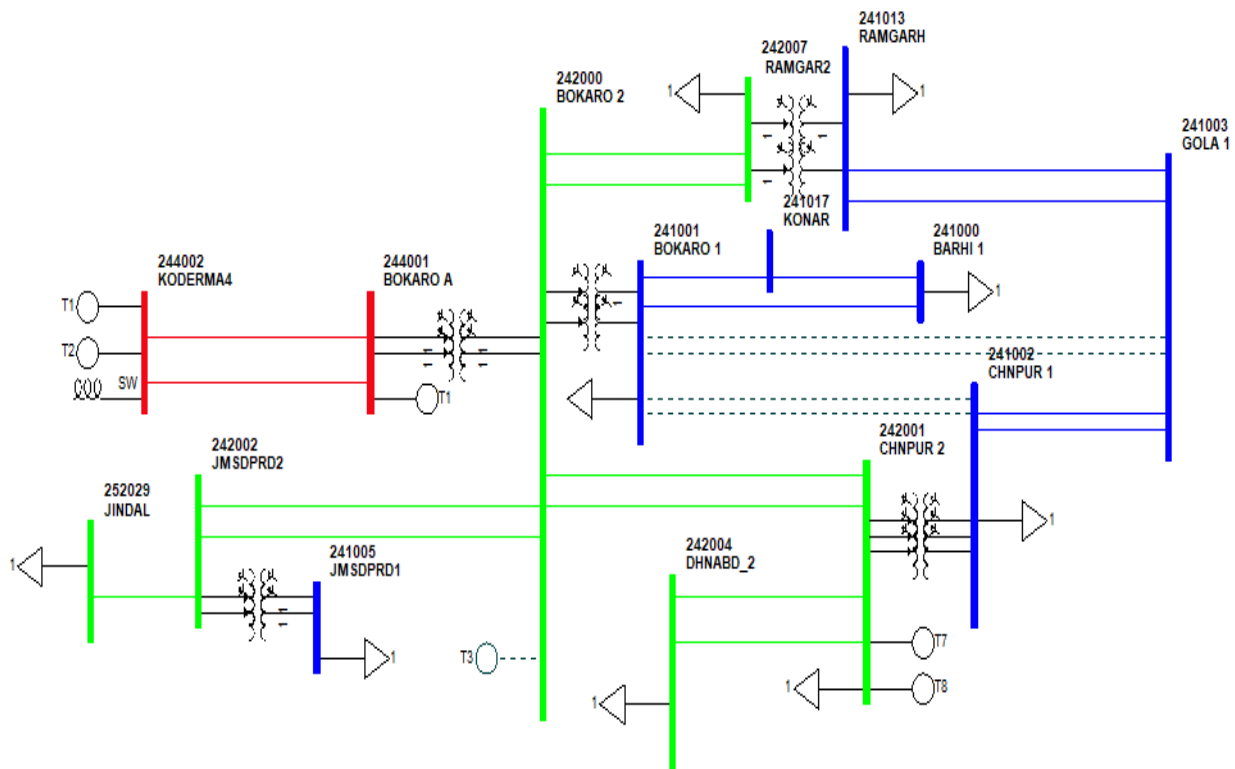
At 19:37 hrs, Bus differential protection of 220 kV Bus 1&2 at Bokaro TPS- B operated. As a result all the feeders connected to 220 kV Bus I & Bus II got tripped leading to total power failure at 220/132 kV Bokaro S/S, 220/132 kV Ramgarh, 132 kV Patratu, 132 kV North Karnpura.

Time	Name	End 1	End 2	PMU Observation
19:37 Hrs	220 kV Bus I & Bus II at Bokaro	Bus differential relay operated due to bus fault at BTPS-B	NA	PMU captured at Bokaro shows fault was cleared in around 1.5 seconds after first dip.
	2*315 MVA 400/220 kV ICTs at Bokaro			
	150 MVA 220/132 kV ICT I at Bokaro			
	220 kV Bokaro – Chandrapura D/C		Yet to be received	
	220 kV Bokaro – Jamshedpur D/C			
	220 kV Bokaro – Ramgarh D/C			
	132 kV Gola-Ramgarh-I		R/I of L-55 at Gola end- D.P. - B, O/C, E/F, VAJ 86, Zone 2.	
132 kV Gola-Ramgarh-I	R/I of L-56 at Gola end- D.P - B, C, B/U, O/C, E/F, and Zone 3.	R/I of L-56 at Ramgarh end- 21M1, R & B ph. , 21M2 B-Ph.

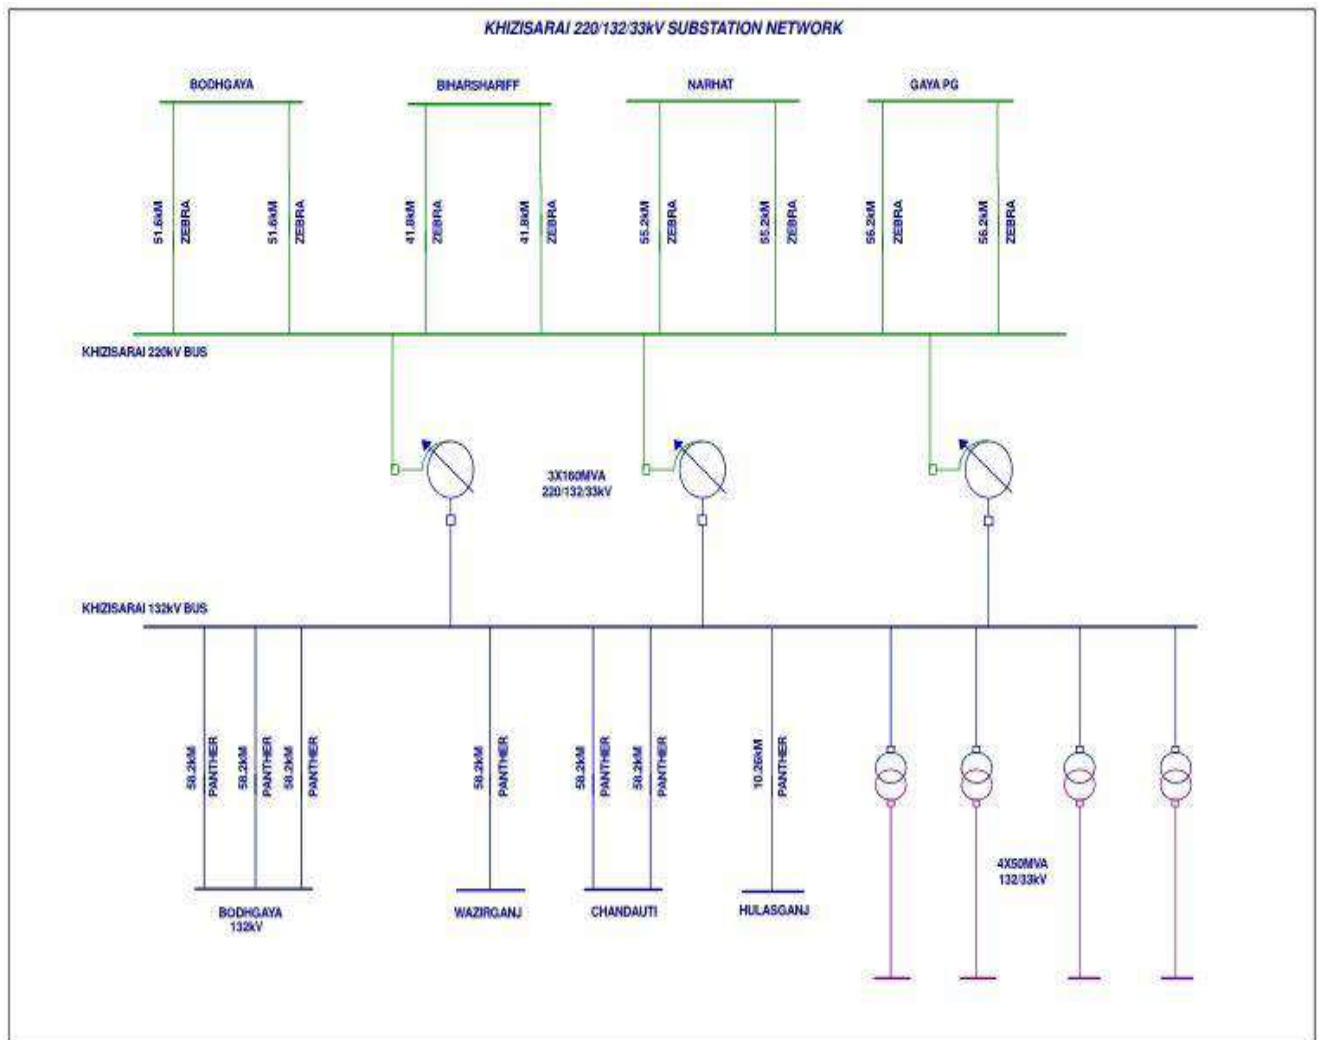
Time	Name	End 1	End 2	PMU Observation
19:04 Hrs	220 kV Gaya- Khizisarai-1	Y-Earth , 2.04kA, 56.2kM (100 %), A/R successful	Yet to receive	PMU captured at Chandauti and Biharshariff shows existence of R-Y fault with 3kV and 20 kV dip in both the phases respectively and fault clearing time was within 160 msec.
	220kV Khizisarai- Biharshariff -1		R-Y-Earth, Z2, 71.04 kM, Ir= 3.9kA, Iy:=2.5kA, Ib=646.8 A, Fr=7.9ohm	
	220kV Khizisarai- Biharshariff -2		R-Y-Earth, Z3, 74 kM, Ir- 3.kA, Iy=2.7kA, Ib=656.1 A, 129.4kV, Fr=9.1ohm

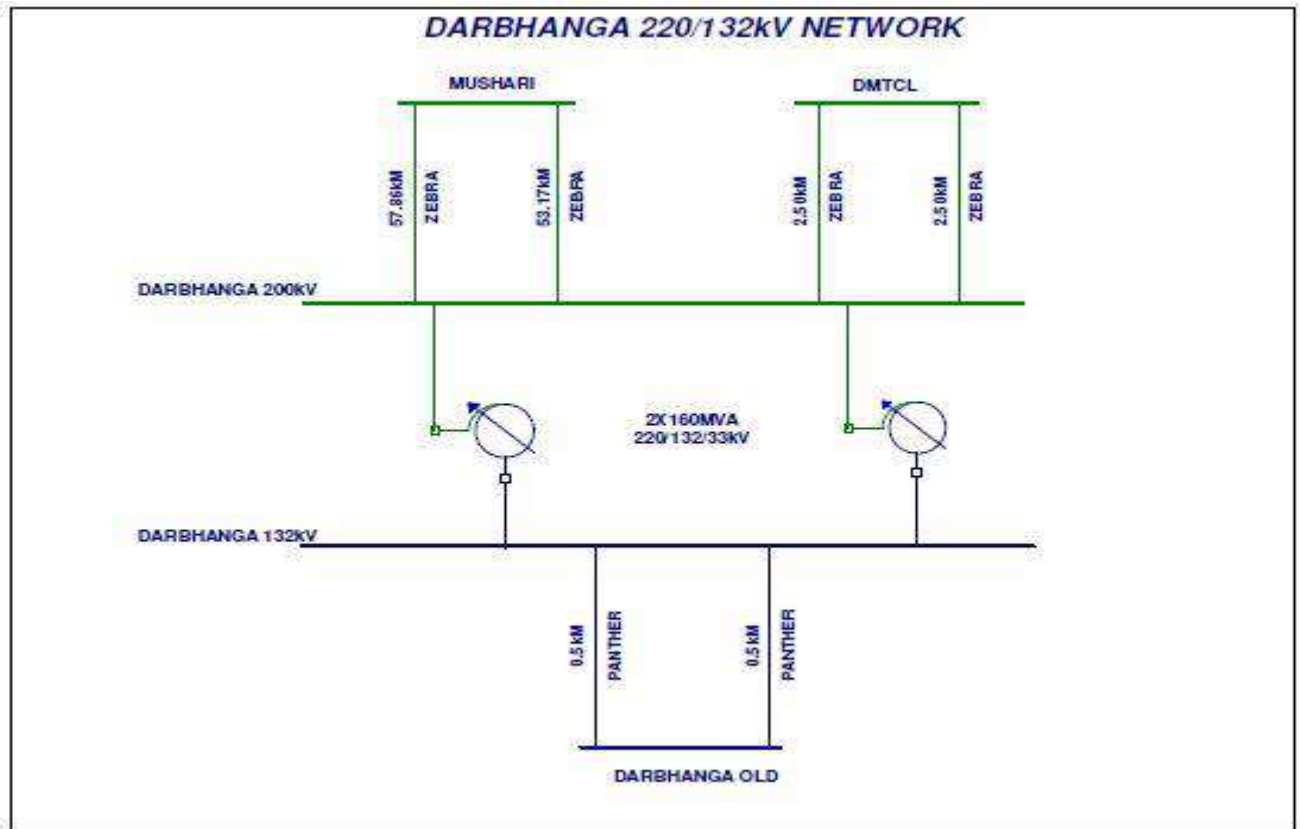
Subsequently, 220/132 KV 200 MVA ATR-1 tripped on O/C. This led to total power failure on 132 KV side of Darbhanga (BSPTCL). 220 KV Darbhanga (BSPTCL)-Musahari-2 sensed the same fault and tripped from Musahari end only. Later, all 220 KV lines at Darbhanga (BSPTCL) were manually hand-tripped due to fire in the substation initiated due to blasting of Bushing.

- 220/132 KV 200 MVA ATR-1 should not trip on O/C immediately as total load after tripping of ATR-2 was less than 100% of its rating. O/C settings of both 220/132 KV ATRs need to be reviewed and revised as margin available.
- 220 KV Darbhanga (BSPTCL)-Musahari tripped from Musahari end only in Zone 1.

Time	Name	End 1	End 2	PMU Observation
07:33 Hrs	220/132 KV 160 MVA ATR-2 at Darbhanga (BSPTCL)	Differential relay operated		PMU at Muzaffarpur captured R_N fault which was captured within 100 msec
	220/132 KV 200 MVA ATR-1 at Darbhanga (BSPTCL)	Tripped on O/C		
	220 KV Darbhanga (BSPTCL)-Musahari-2	Darbhangha: Didn't trip (hand-tripped at 07:36 Hrs)	Musahari: R_N, Z I	
07:36 Hrs	220 KV Darbhanga (BSPTCL)-Musahari-1	hand-tripped (Line was idle charged from Darbhanga)		
07:36 Hrs	220 KV Darbhanga (BSPTCL)-Darbhanga (DMTCL)-1	Manually hand-tripped from BSPTCL end	Didn't trip	
07:36 Hrs	220 KV Darbhanga (BSPTCL)-Darbhanga (DMTCL)-2

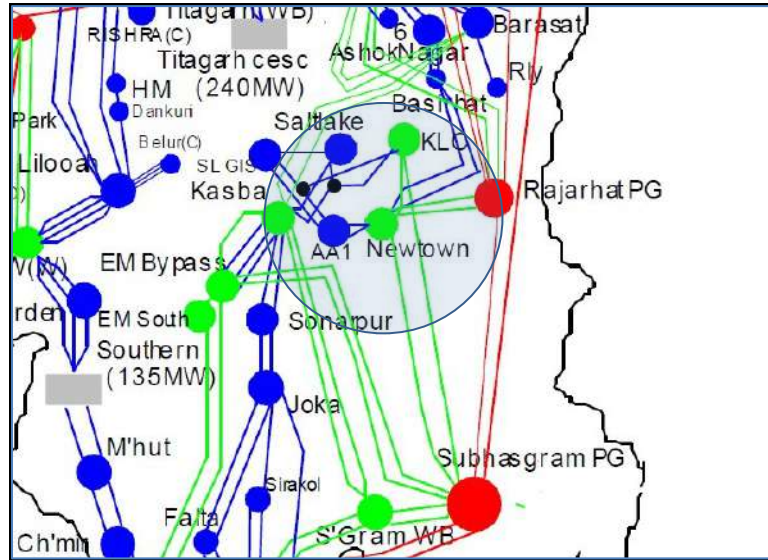
Figure 1: Network across the affected area

- 220 kV Bus 1 & Bus 2 at Newtown AA III
- 220 kV New Town AA III-Rajarhat D/C
- 220 kV New Town AA III-Subhashgram S/C
- 220 kV New Town AA III-KLC Bantala
- 2\*160 MVA 220/132 kV ICTs at New Town AA III
- 3\*50 MVA 220/33 kV ICTs at New Town AA III

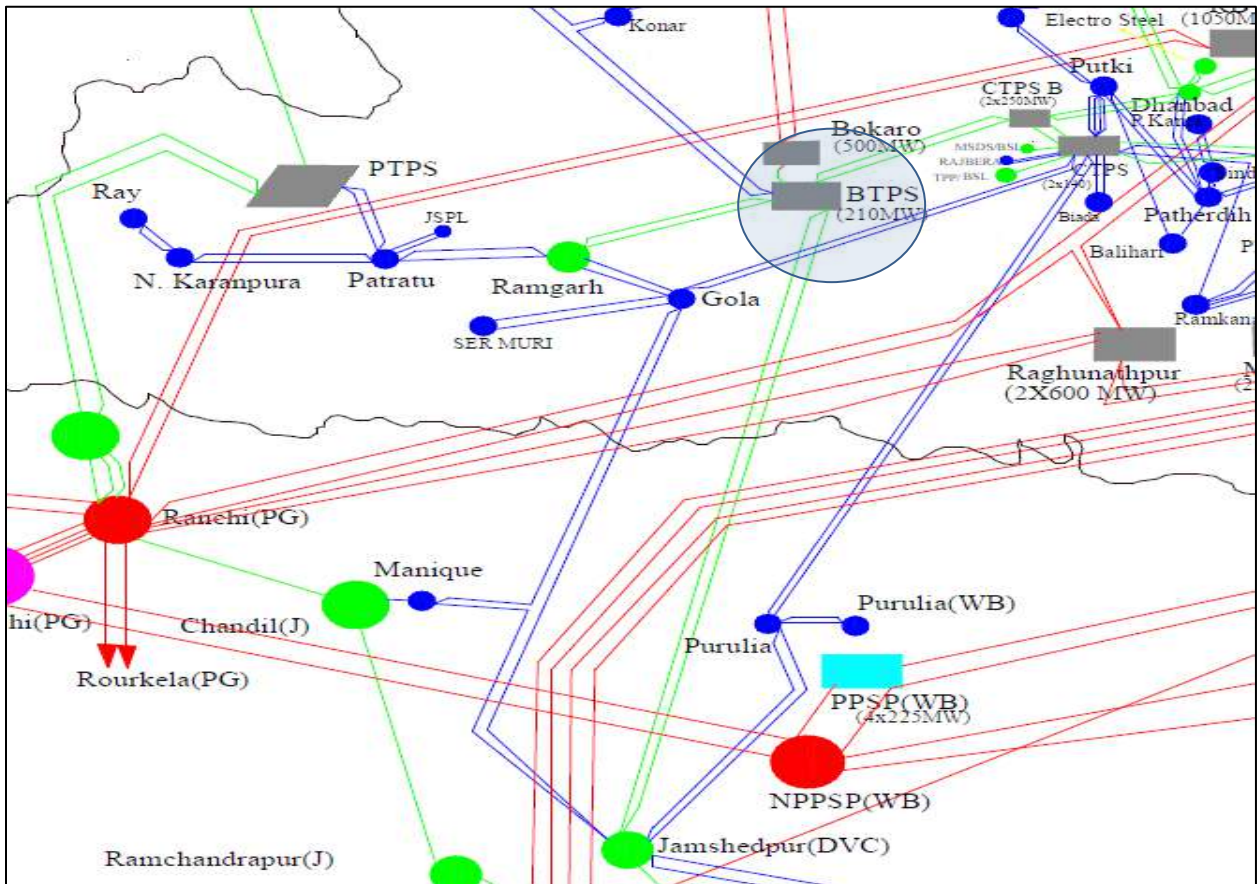
Figure 1: Network across the affected area

- 220 kV Bus I & Bus II at Bokaro
- 220 kV Bus coupler at Bokaro
- 220 kV Bokaro – Chandrapura D/C
- 220 kV Bokaro – Ramgarh D/C
- 220 kV Bokaro – Jamshedpur D/C
- 2\*315 MVA 400/220 kV ICTs at Bokaro
- 150 MVA 220/132 kV ICT I at Bokaro
- 132 kV Gola-Ramgarh D/C
