**107 वीं पीसीसी बैठक
का
कार्यवृत्त
Minutes
of
107th PCC Meeting**

Eastern Regional Power Committee

MINUTES OF 107th PROTECTION COORDINATION SUB-COMMITTEE MEETING HELD ON 22.10.2021 AT 10:30 HOURS

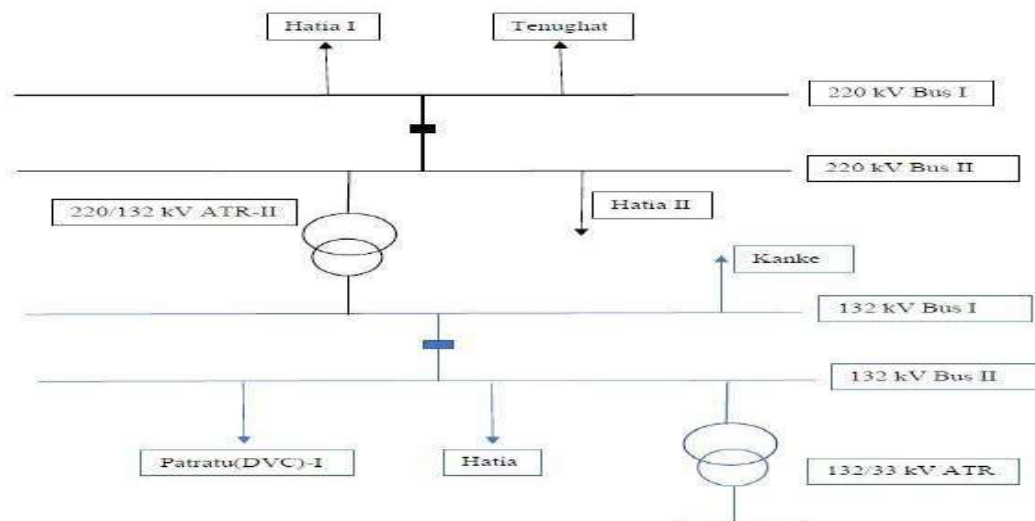
SLD of 220/132 kV Patratu S/s

At 16:01 hrs, all 132 kV lines at 220/132 kV Patratu S/s tripped to clear fault in 132 kV Patratu-Patratu(DVC) line. At 16:32 Hrs, 132/33 kV ATR tripped leading to 15 MW load loss at Patratu.

During restoration, while charging 132 kV Patratu-Patratu (DVC) line at 18:43 Hrs, total power failure occurred and 220 kV side also became dead at Patratu.

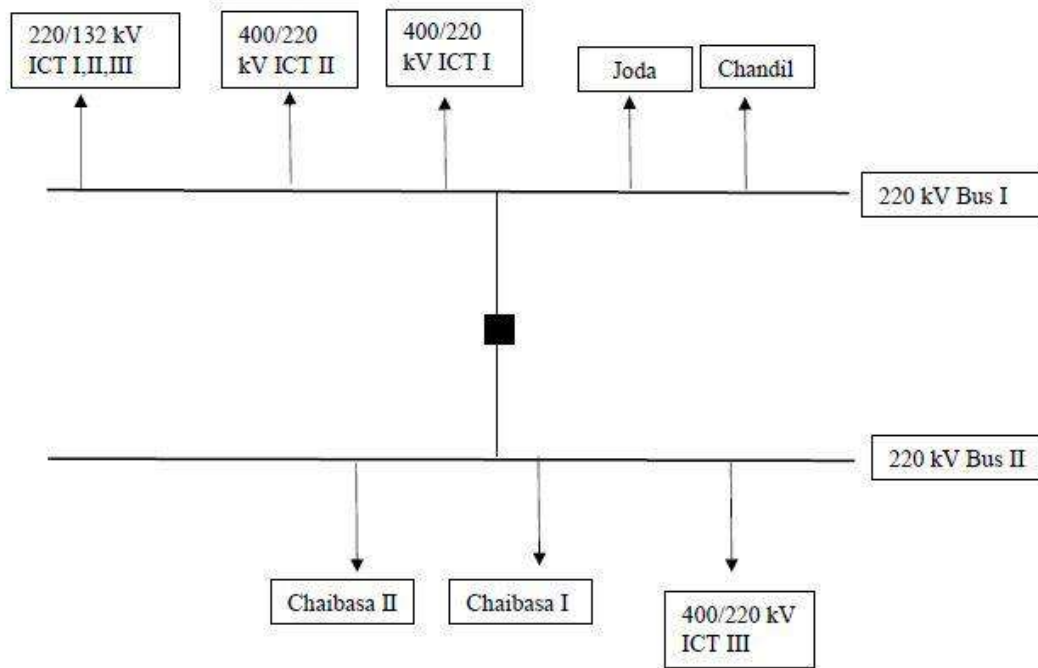
220/132 kV Ramchandrapur Schematic Bus diagram

At 21:52 hrs, Bus PT of 220 kV Bus-2 at Ramchandrapur got burst leading to tripping of both 220 kV buses. This resulted in total power failure at Ramchandrapur S/s.

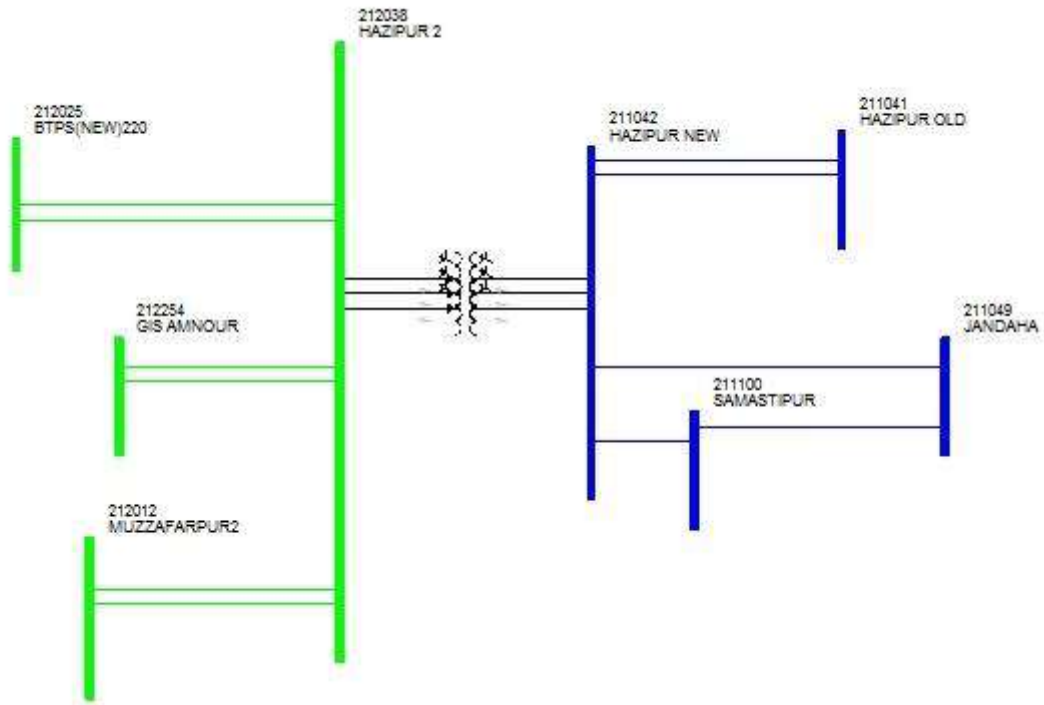
Both 220 kV Buses at Hazipur tripped due to operation of LBB of 220 kV Hazipur-Amnour-II line which lead to total power failure at Hazipur and Amnour.

Time	Name	End 1	End 2	PMU Observation
17:18 Hrs	220 kV Bus-I, Bus II at Hazipur	Z-1 in Amnour-2 circuit but breaker did not open. Subsequently LBB operated which caused tripping of all ckt's from Hazipur end.		23 kV dip in R phase with fault clearance time of 250ms.
	220 kV Hazipur-Muzaffarpur-I		Didn't trip	
	220 kV Hazipur-Muzaffarpur-II			
	220 kV Hazipur-Amnour I			
	220 kV Hazipur-Amnour II			
	220 kV Hazipur-Barauni (BTPS)-II		Didn't trip	
	2*100 MVA 220/132 kV ICTs at Hazipur

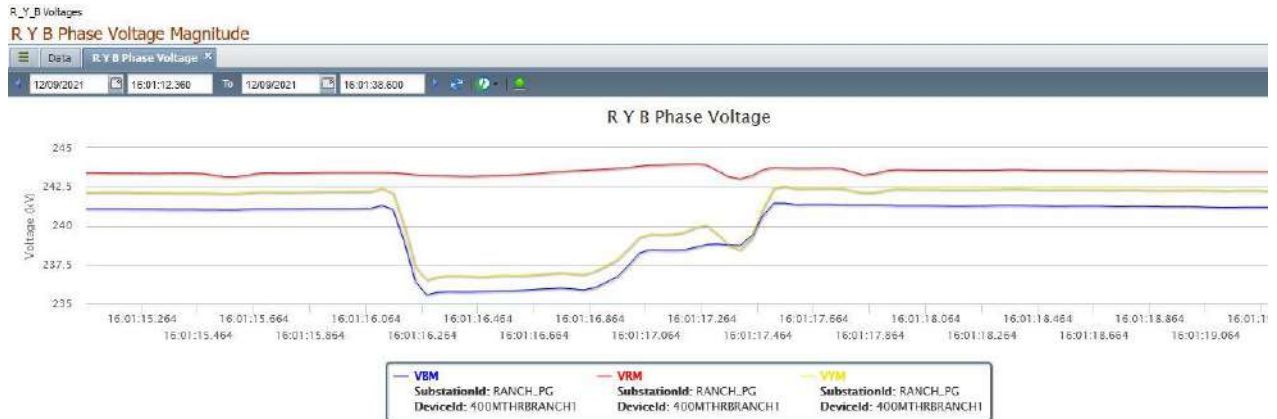
Figure 3: PMU snapshot of 400/220 kV Ranchi S/s (16:01 Hrs)

समय	नाम	उप केंद्र 1 रिले संकेत	उप केंद्र 2 रिले संकेत	पीएमयू पर्यवेक्षण
16:01	220 kV Patratu-Hatia-2	Y_B fault	-	6 kV dip in Y-ph and B-ph at Rancho. Fault clearance time: 1.3 seconds
	132 kV Patratu-Kanke	Y_B, Z I, Iy:1.337 kA, Ib: 1.388 kA	-	
	132 kV Patratu-Hatia	Y_B, Iy:2.11 kA, Ib: 2.16 kA	-	
	132 kV Patratu-Patratu (DVC)-1 (Idle charged)	Only B_ph tripped	-	
18:43	220 kV Bus-1 & 2 at Patratu	-	-	7 kV Dip in Y-ph at Rancho. Fault clearance time: 1.3 seconds
	220 kV Patratu-Hatia D/c	Didn't trip	Ckt II tripped on O/c	
	220 kV Patratu-Tenughat	Didn't trip	E/F O/C, Iy: 1.003 kA	
	150 MVA 220/132 kV ICT-2 at Patratu	O/C		
	132 kV Patratu-Hatia	B_N, Z I		
	132 kV Patratu-Kanke	B_N, Z I	-	
	132 kV Patratu-Patratu (DVC)-1 (Idle charged)	-	-

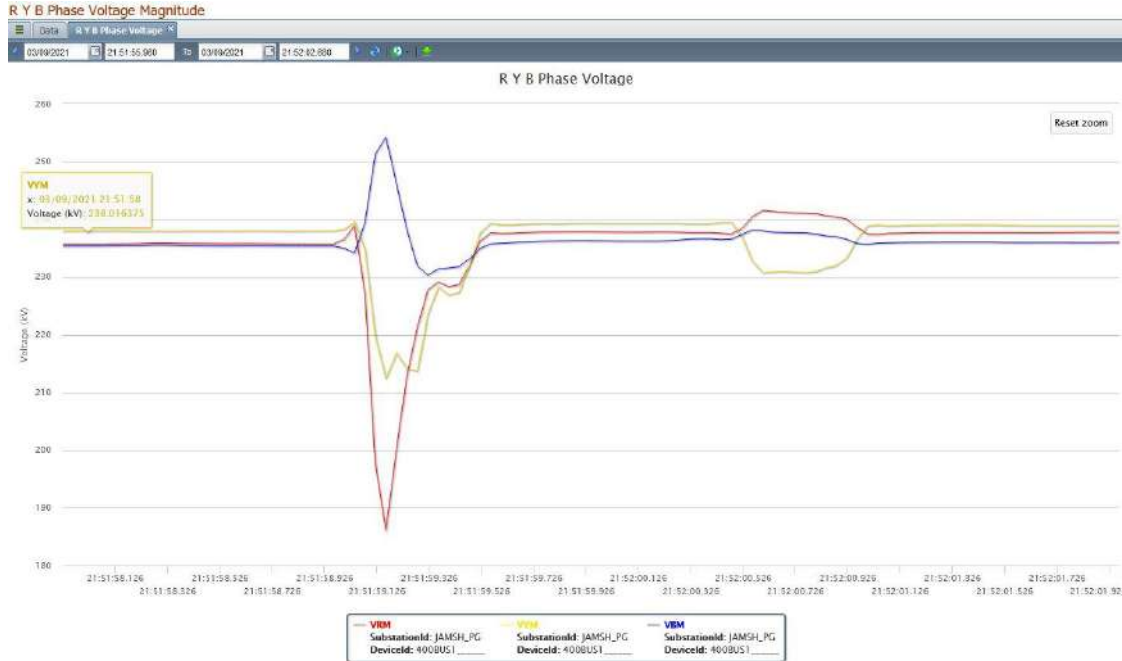
Figure 3: PMU snapshot of 400/220 kV Jamshedpur S/s

समय	नाम	उप केंद्र 1 रिले संकेत	उप केंद्र 2 रिले संकेत	पीएमयू पर्यवेक्षण
21:52	220 kV Bus-I, Bus II at Ramchandrapur	R_ph Bus PT of 220 kV Bus I burst	-	Around 50 kV dip in R_ph, 28 kV dip in Y_ph at Jamshedpur
	220 kV Ramchandrapur-Jamshedpur I, II, III		Didn't trip from 400kV side	
	220 kV Ramchandrapur-Chaibasa D/c		-	
	220 kV Ramchandrapur-Chandil		-	
	220 kV Ramchandrapur-Joda		-	
	3*150 MVA 220/132 kV ICTs at Ramchandrapur		-

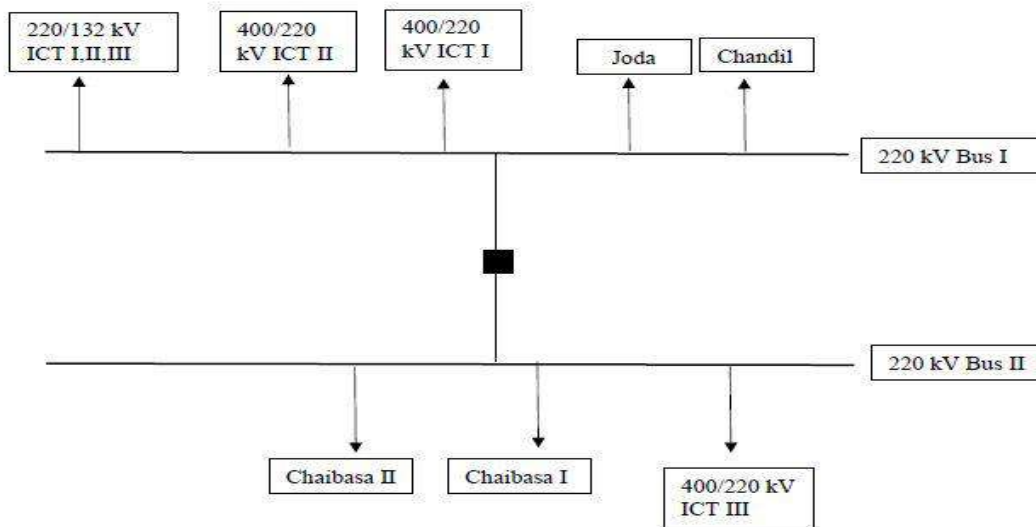
220/132 kV Ramchandrapur Schematic Bus diagram

- R_ph Bus PT of 220 kV Bus II burst. As there was no busbar protection, the fault should be cleared either by Zone-4 of local end or Z-2 of remote end.

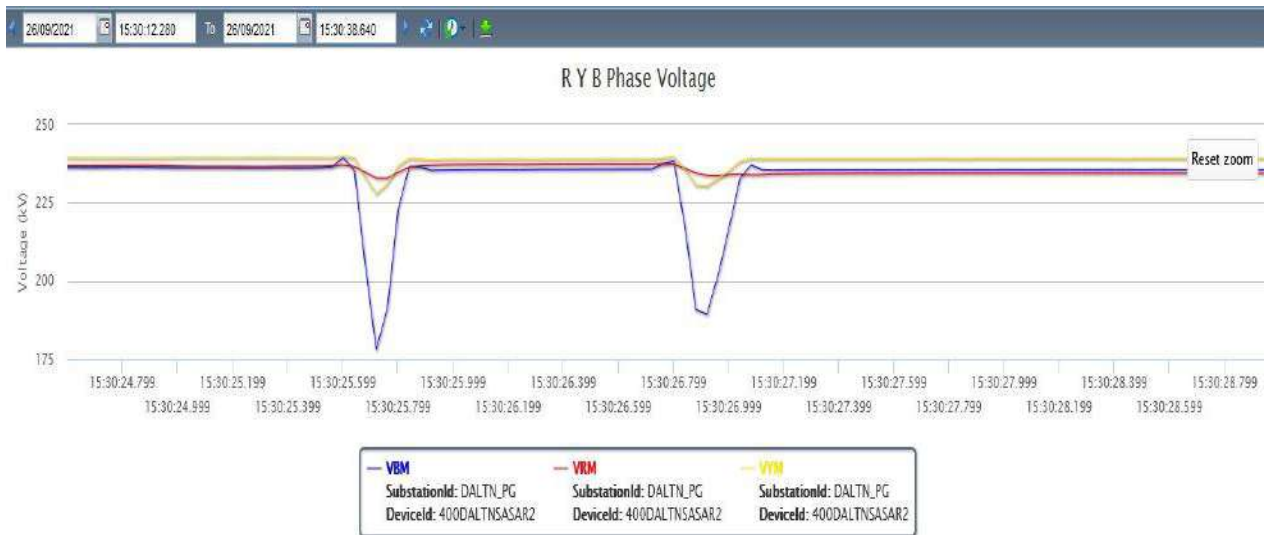
Figure 3: PMU snapshot of 400/220 kV Daltonagnj S/s

समय	नाम	उप केंद्र 1 रिले संकेत	उप केंद्र 2 रिले संकेत	पीएमयू पर्यवेक्षण
15:31	220 kV Bus-1, Bus 2 at Garhwa (New)	-	-	Around 52 kV dip in B_ph at Daltonagnj. A/r failed
	220 kV Daltonagnj-Garhwa(New)-1	B_N, FC-1.7 kA, FD- 56 km	B-N, FC-1.4kA, FD- 59 km	
	220 kV Daltonagnj-Garhwa(New)-2	Didn't trip	B-N, FC-1.4Ka, FD- 65 km

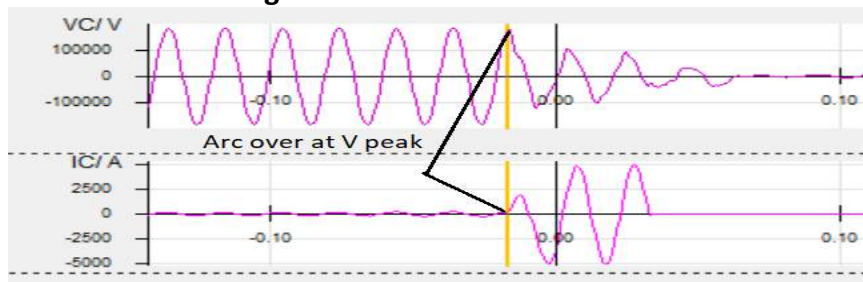
Non-Operation of Auto Reclose:

In 3 instances, it was observed that for B-Earth single phase fault Single(B) phase opening is occurring at Garhwa end but, after dead time A/R is not occurring and B phase kept opened until Pole discrepancy operated and caused tripping of line .For all these instances A/R was successful from Daltonganj end proper A/R operation at Garhwa end could have avoided tripping .

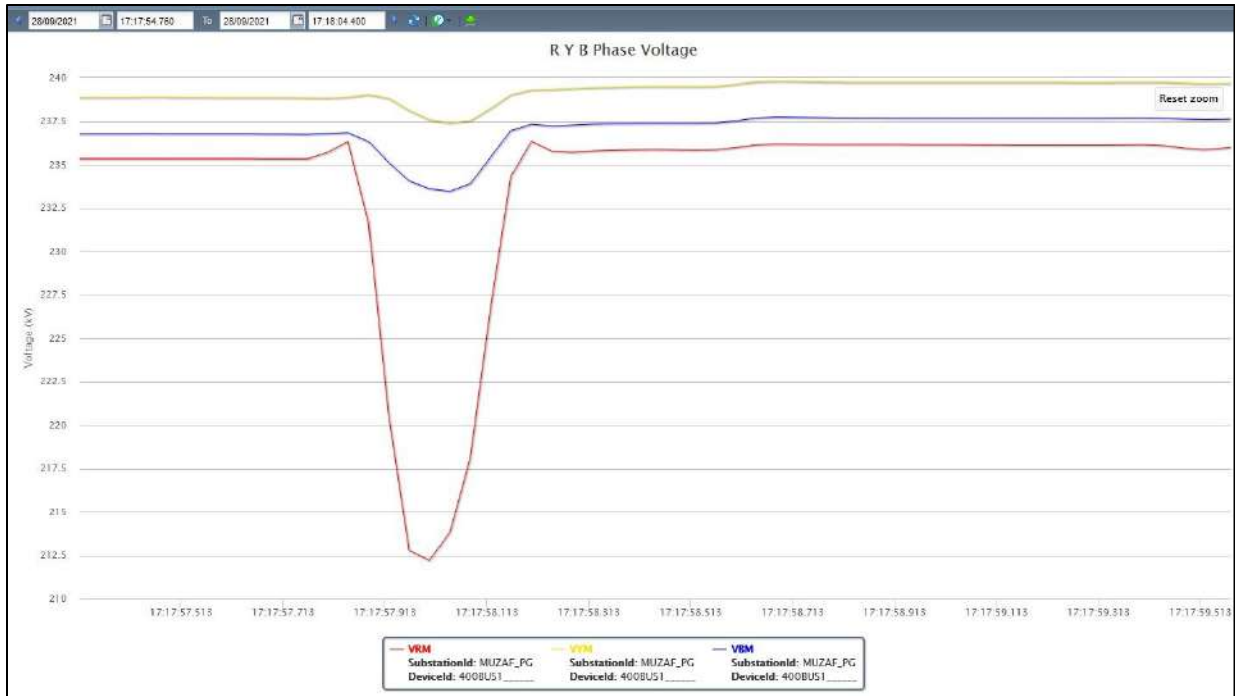
Figure 3: PMU snapshot of 400/220 kV Muzaffarpur S/s

समय	नाम	उप केंद्र 1 रिले संकेत	उप केंद्र 2 रिले संकेत	पीएमयू पर्यवेक्षण
17:18	220 kV Bus-I, Bus II at Hazipur	Z-1 in Amnour-2 but breaker did not opened initiated LBB which caused tripping of all ckt's from Hazipur end.	Didn't trip	23 kV dip in R phase with fault clearance time of 250ms.
	220 kV Hazipur-Muzaffarpur-I			
	220 kV Hazipur-Muzaffarpur-II			
	220 kV Hazipur-Amnour I			
	220 kV Hazipur-Amnour II

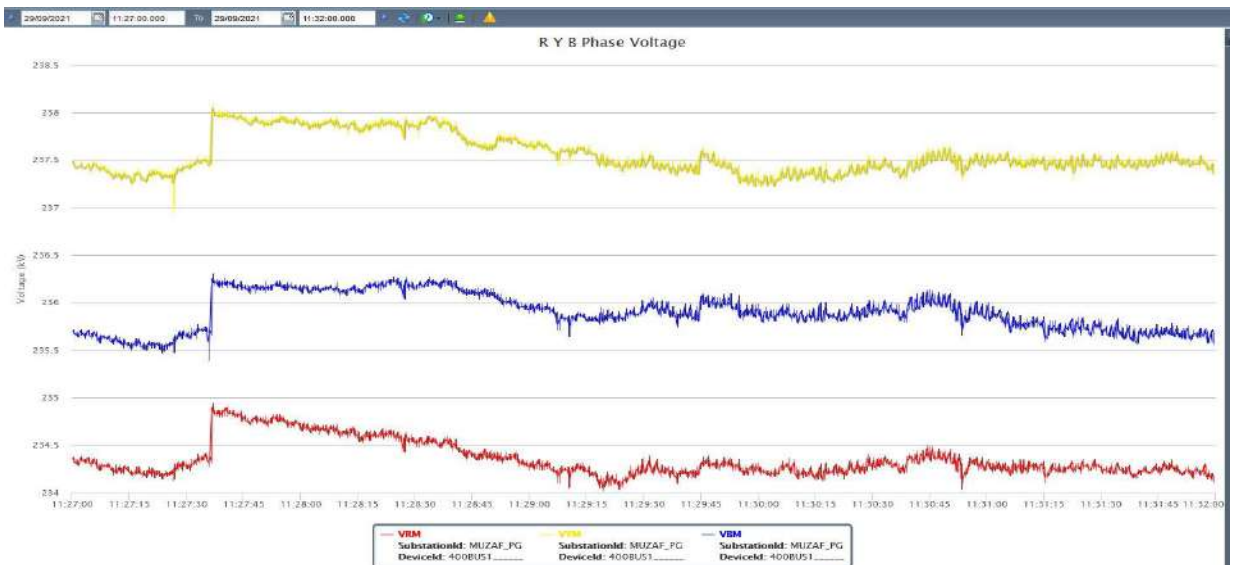
Figure 3: PMU snapshot of 400/220 kV Muzaffarpur S/s

समय	नाम	उप केंद्र 1 रिले संकेत	उप केंद्र 2 रिले संकेत	पीएमयू पर्यवेक्षण
11:28	220 kV Bus-I at Hazipur	Bus bar protection operated at Hazipur	Didn't trip	No fault observed in PMU
	220 kV Hazipur-Muzaffarpur-I			
	220 kV Hazipur-Barauni (BTPS)-II			
	220 kV Hazipur-Amnour I			
	220 kV Bus-I,II at Amnour	Loss of power supply

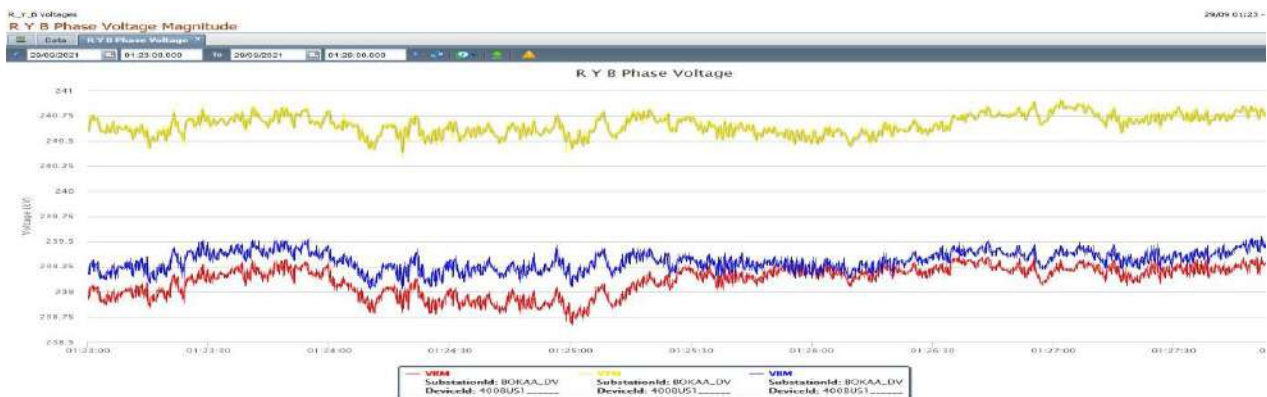
Figure 3: PMU snapshot of 400/220 kV Bokaro S/s

समय	नाम	उप केंद्र 1 रिले संकेत	उप केंद्र 2 रिले संकेत	पीएमयू पर्यवेक्षण
01:24	220 kV Bus-I, Bus II at Ramgarh	-	-	No fault observed in PMU at Ranchi
	220 kV Ramgarh-Ranchi-I	Z IV	Didn't trip	
	220 kV Ramgarh-BTPS B D/c	Z IV	-	
	2*100 MVA 220/132 kV ICTs at Ramgarh	-	-

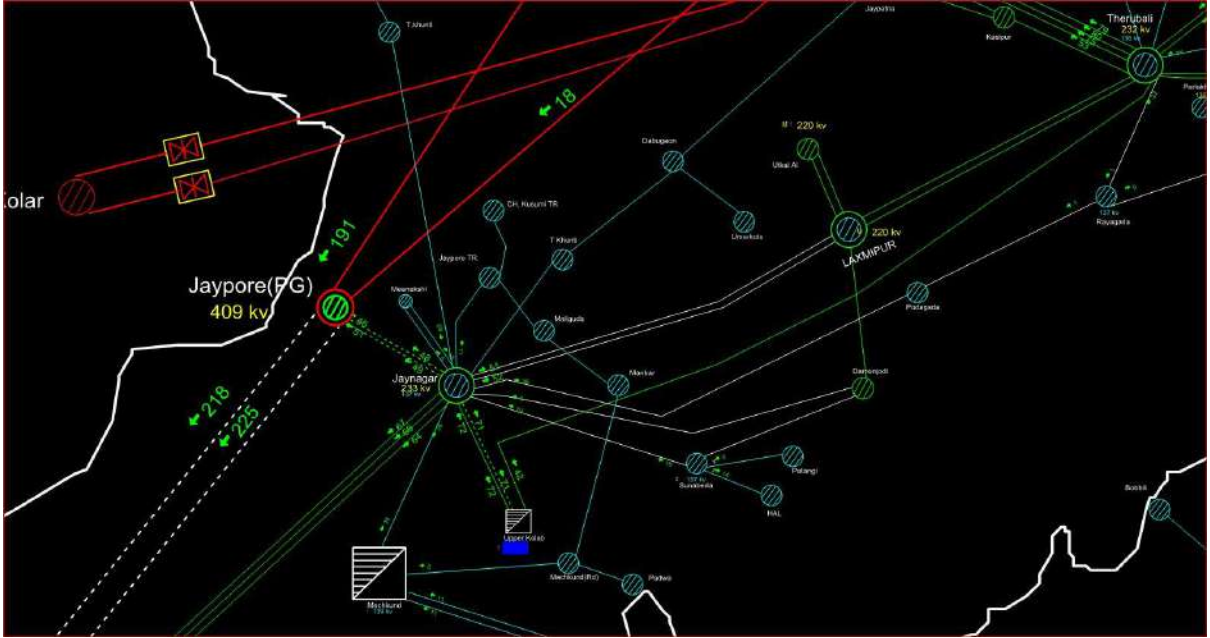
Figure 2: SCADA snapshot of the system

- 220 kV Main Bus I & II at UpperKolab
- 220 kV UpperKolab-Jaynagar-1
- 220 kV UpperKolab-Jaynagar-2
- 220 kV UpperKolab-Therubali-1
- 80 MW U#1 at UpperKolab

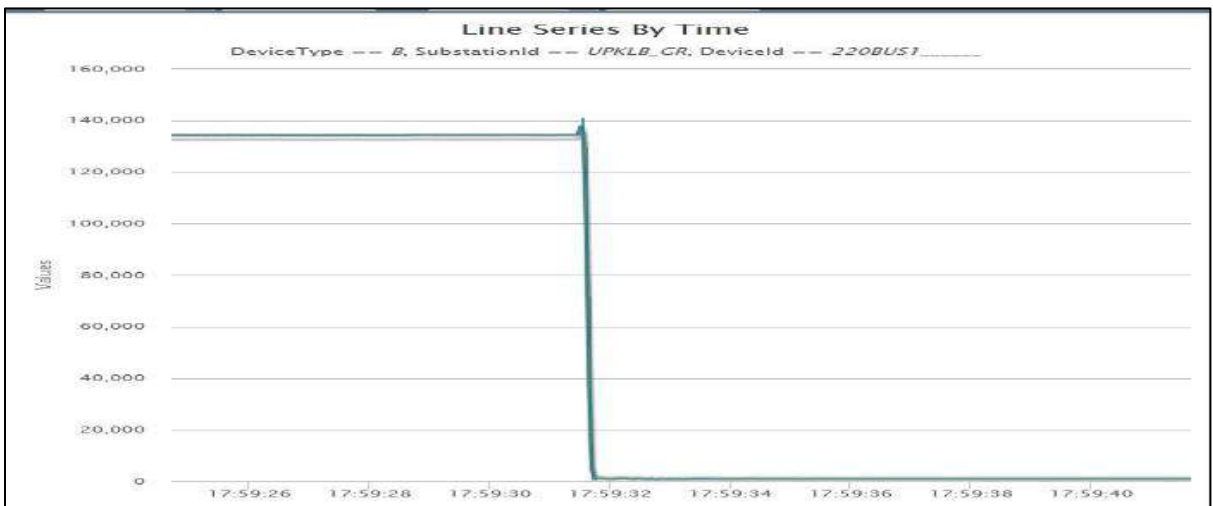
Figure 3: PMU snapshot of 220 kV UpperKolab S/s

समय	नाम	उप केंद्र 1 रिले संकेत	उप केंद्र 2 रिले संकेत	पीएमयू पर्यवेक्षण
21:52	220 kV Bus-I, Bus II at UpperKolab	U#2 LBB operated	-	No fault observed in PMU
	220 kV UpperKolab-Jaynagar-1		-	
	220 kV UpperKolab-Jaynagar-2		-	
	220 kV UpperKolab-Therubali		-	
	80 MW U#1 at UpperKolab		-

- As per PMU plot at UpperKolab, no fault was observed. The reason of operation of LBB of U#2 may be analysed.

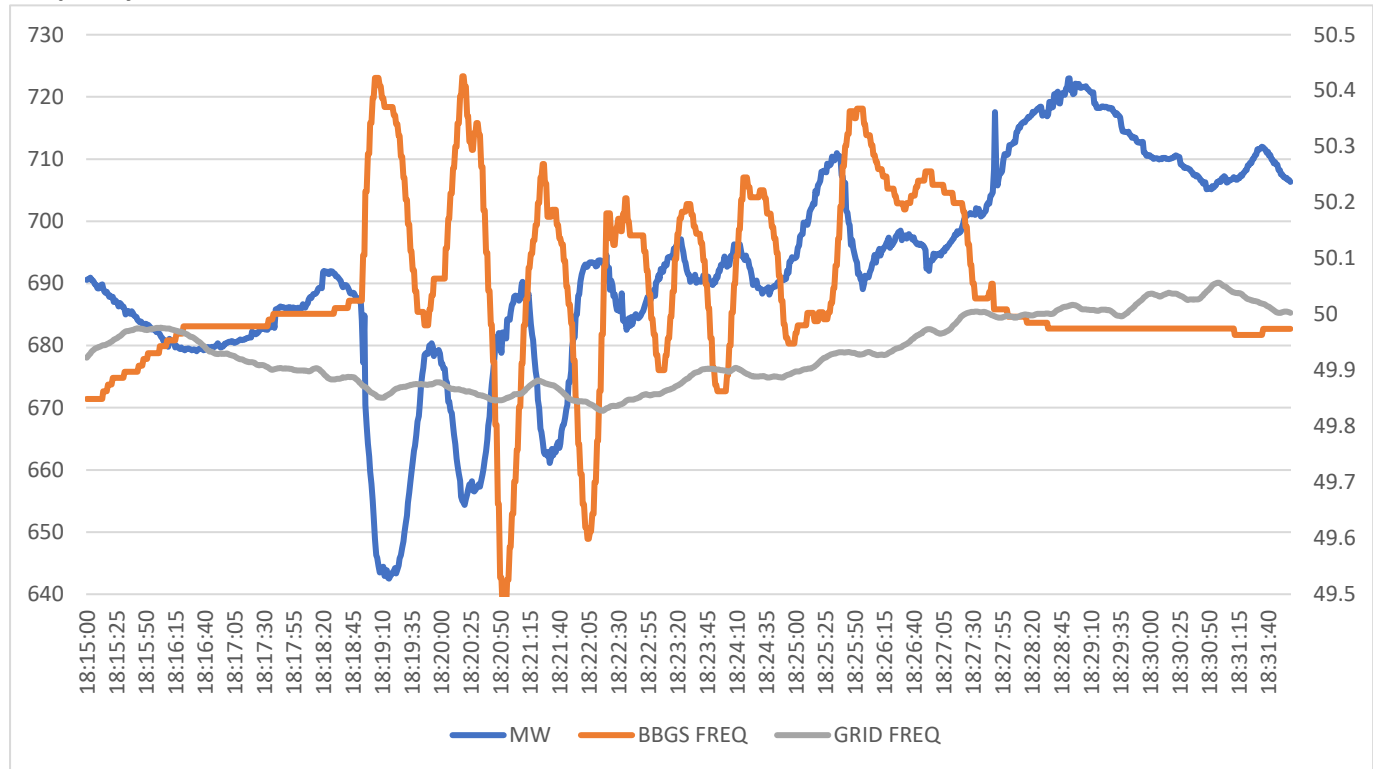
SCADA plot for EVENT 1: 01st August 18:18Hrs, Budge-Budge generation Vs CESC frequency vs Grid Frequency

- Oscillating Variation of frequency after island formation in Budge-budge frequency is observed upto (0.5-1Hz) and was varying continuously till it got synchronised with grid at Howrah point, this may also be checked.

- **Reason for such continuous high oscillating variation in frequency may be analysed and possible consequences may also be looked.**
- **Frequency of oscillation was very slow 1 cycle in a minute so approx. 0.014Hz. So mechanical parameters associated with Machines may be checked for root cause analysis .**

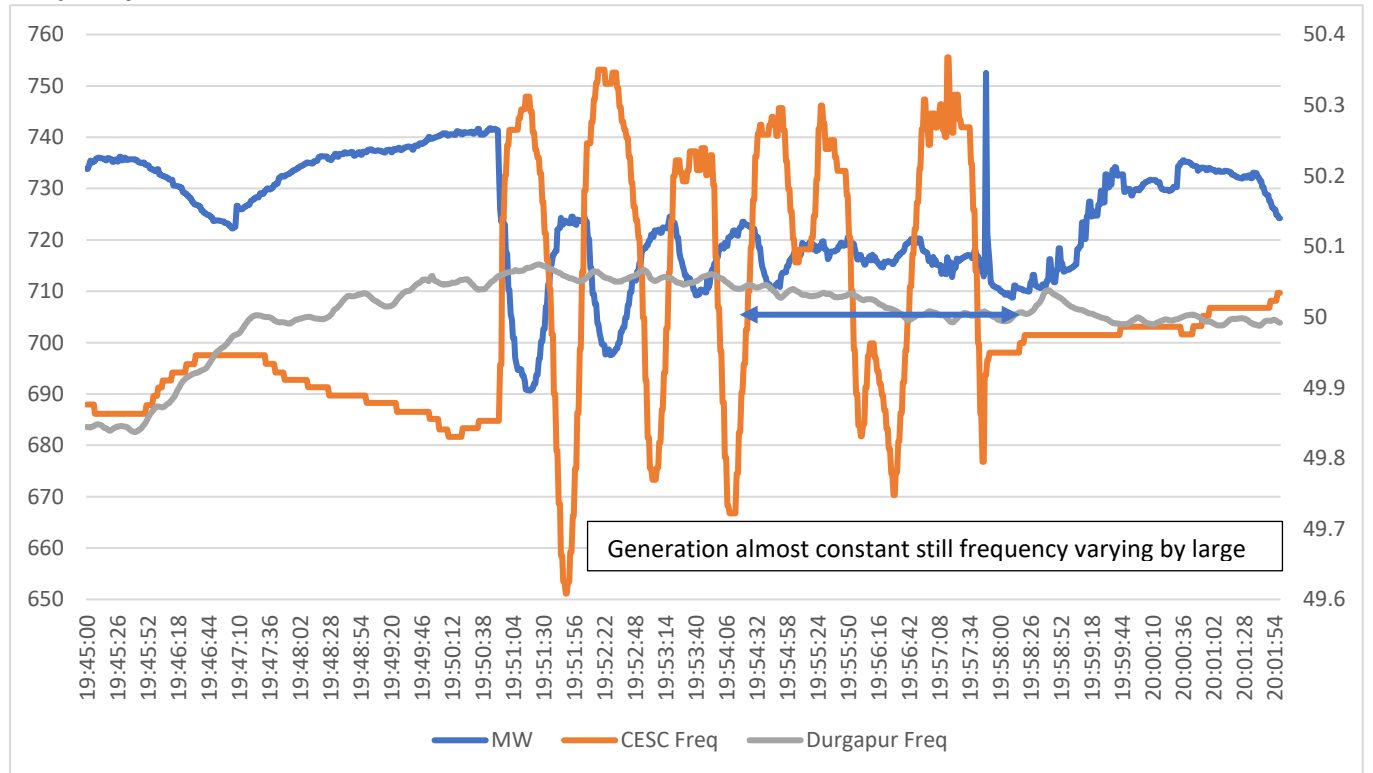
SCADA plot for EVENT 2: 01st August 19:50 Hrs ,BugBug generation Vs CESC frequency vs Grid Frequency

- **As observed in below cases for 2 events, Frequency dipped upto 49.5 & 49.6Hz due to these variations. Chakmir -47Mw is under UFR shedding at 49.4Hz, tripping of which may further cause stability problem within island. (Setting attached)**

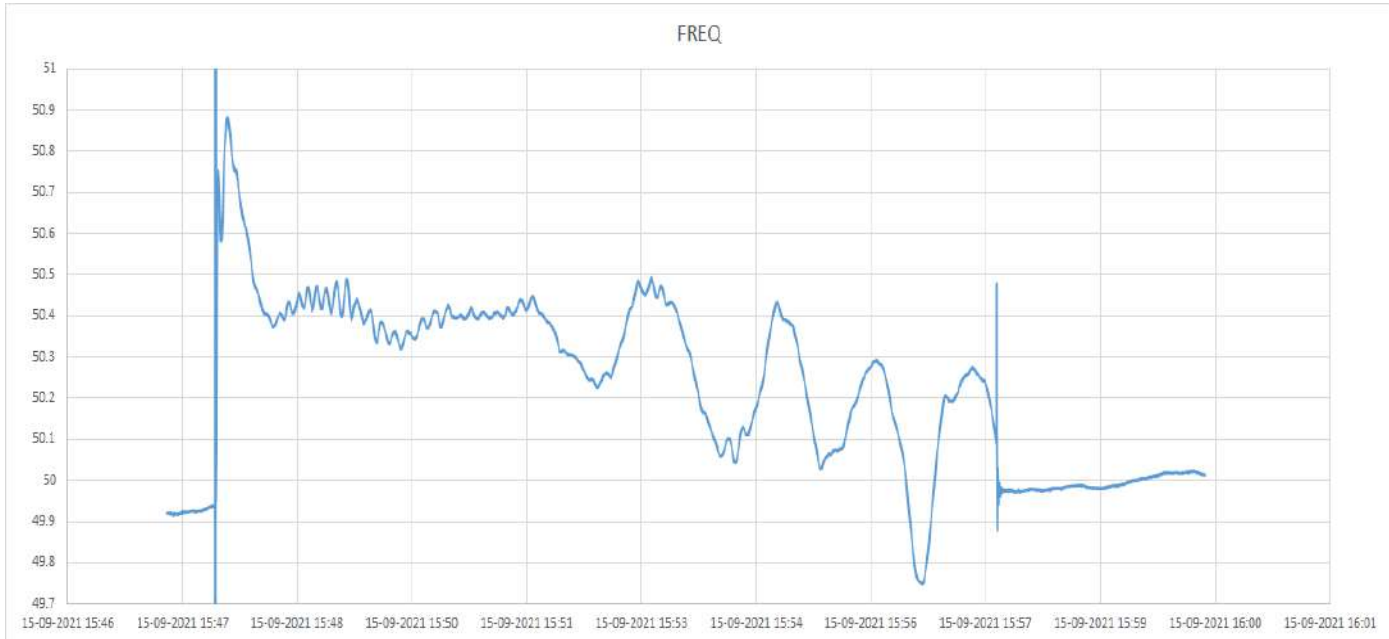
EVENT 3: PMU PLOT 15 September 2021

Same pattern of Frequency variation observed. Governor performance during Islanding needs to be checked. In 15th September event also Budge-budge generation is oscillatory this needs to be checked and also any cyclic load variation for the same to be looked.

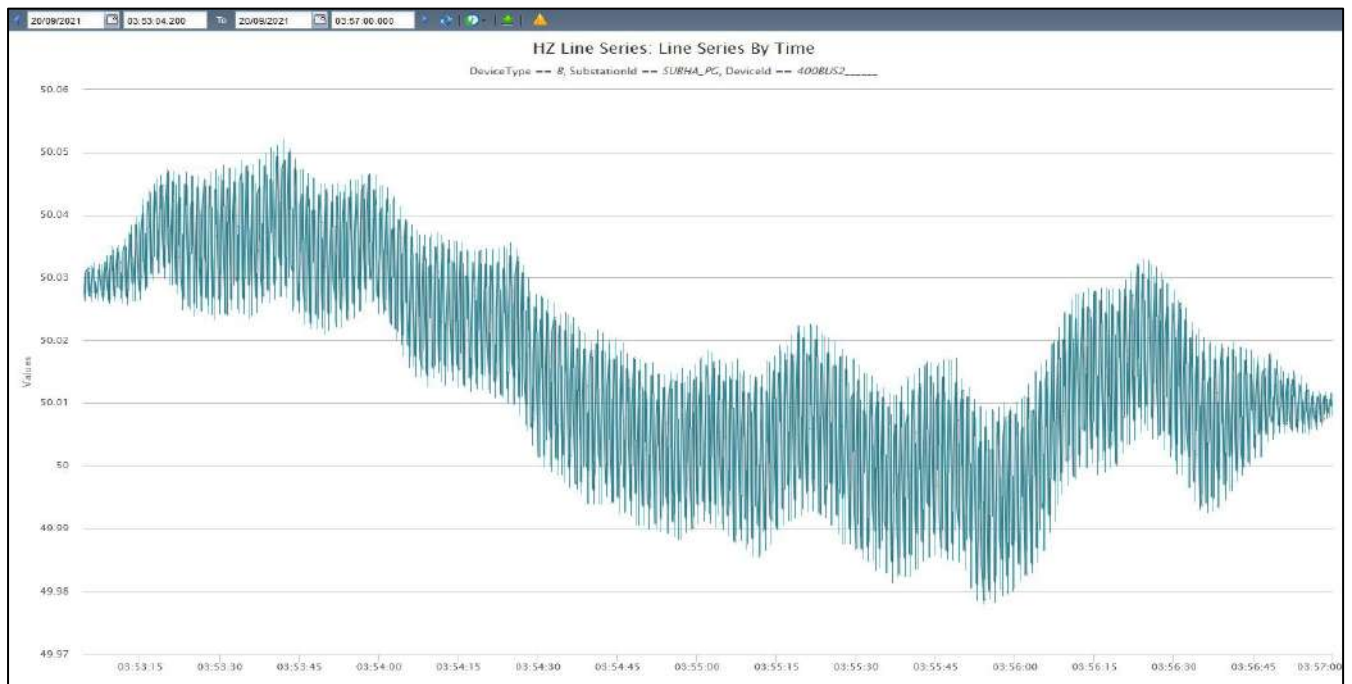
Subhas gram Frequency

LFO of **0.8-0.9 Hz** was observed between 03:53 Hrs to 03:57 Hrs near Subhasgram area, magnitude of which was observed most near Subhas gram and magnitude started reducing as moving away from Subhasgram.

LFO was of Local mode which indicates that the oscillation initiated with hunting of any nearby unit.

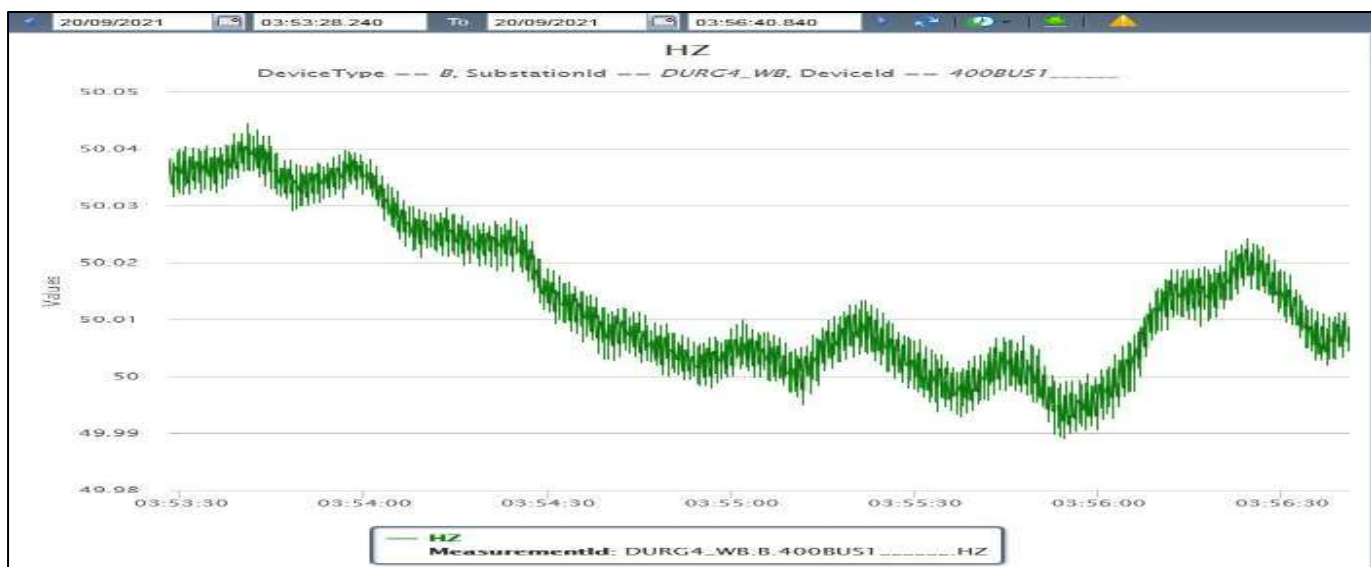
Durgapur Frequency: Frequency variation in Durgapur was comparatively less as moving away from Subhasgram

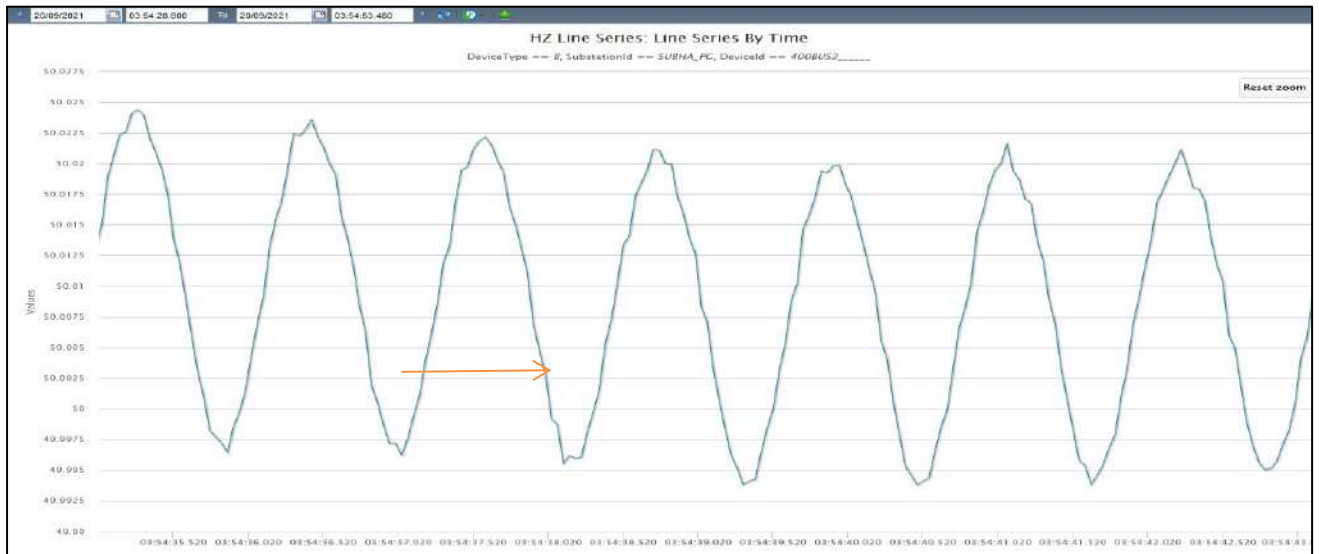
Mode : 0.8 to 0.9 hz (Local mode) ,This also indicates towards oscillation of any plant against the whole grid of Hunting of any unit due to any problem.

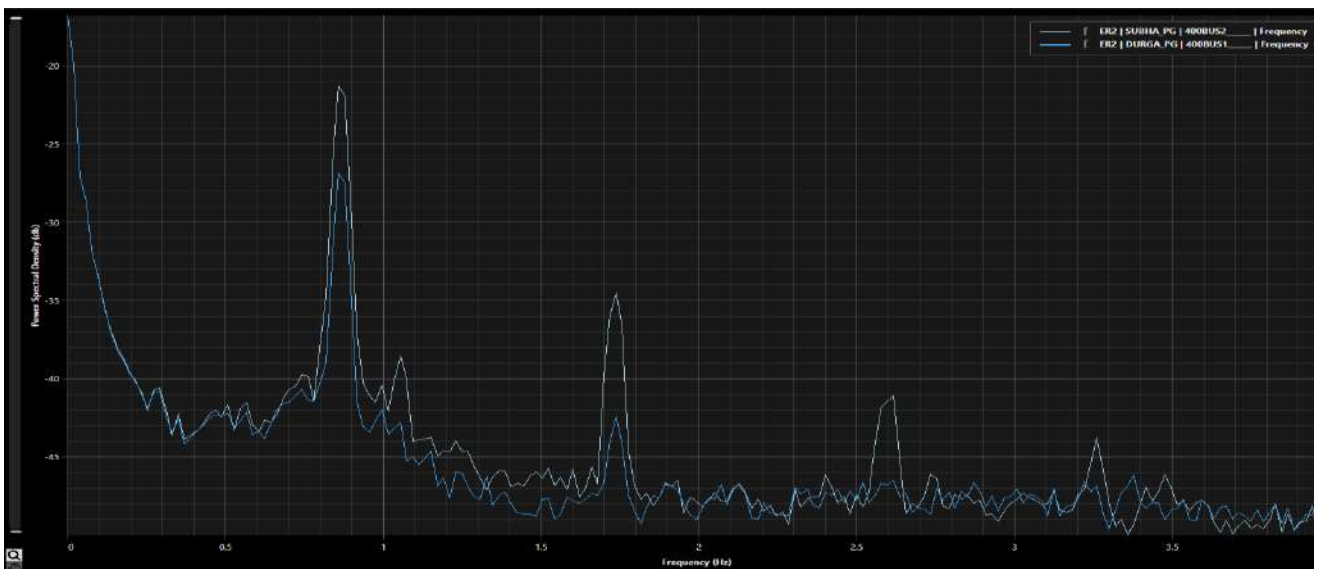
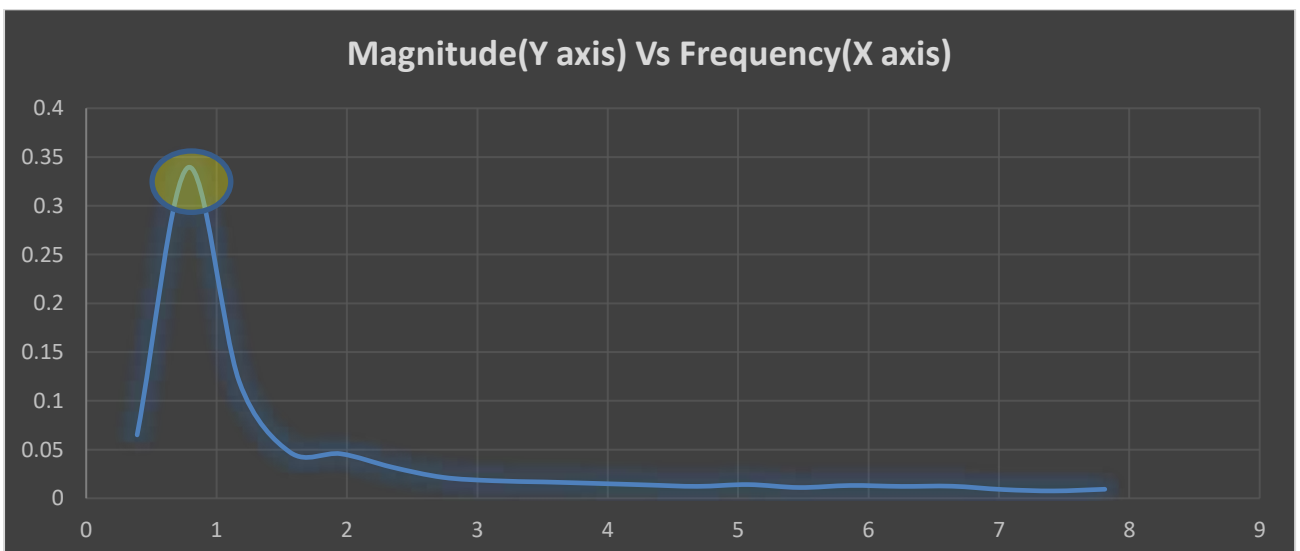
Power Spectral Density as shown below also shows that the highest energy is of 0.8-0.9Hz .

Above signal conditioning PSD and FFT of plot also shows Prominent mode of oscillating frequency 0.8-0.9 Hz (Local mode).

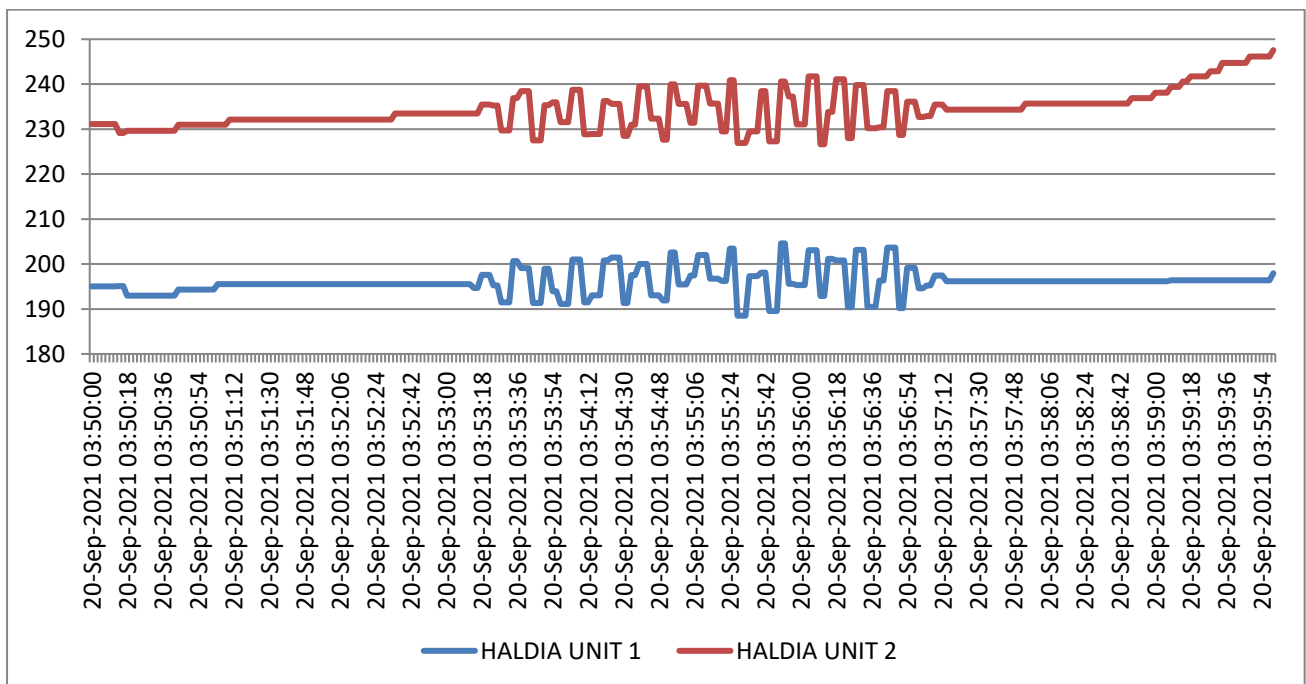
HALDIA GENERATION VARRIATION: 10 TO 20 Mw in each unit of Haldia observed .

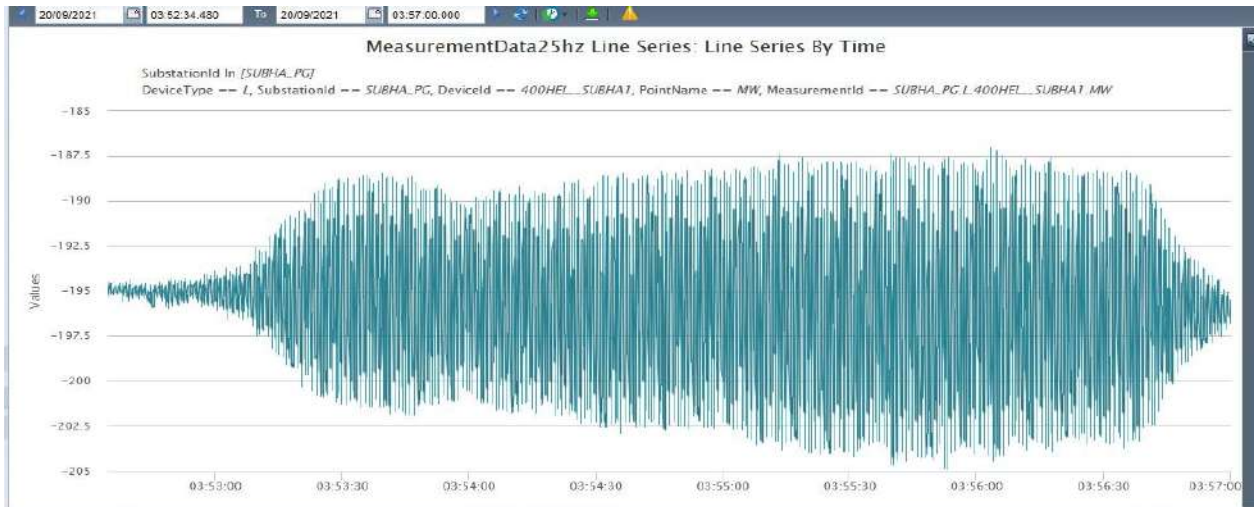
Same was also observed in Haldia Subhasgram power flow variation: 10 Mw variation in each circuit observed as Haldia generation varied.

It was most prominent in Budge-budge units: 140 to 160 Mw variation observed in each unit ,which is maximum and hunting of these units seems to be the source of oscillation .CESC also observed the hunting in these units.

Detailed root cause analysis from CESC and reasons are required for the hunting of BUDGE-BUDGE units .

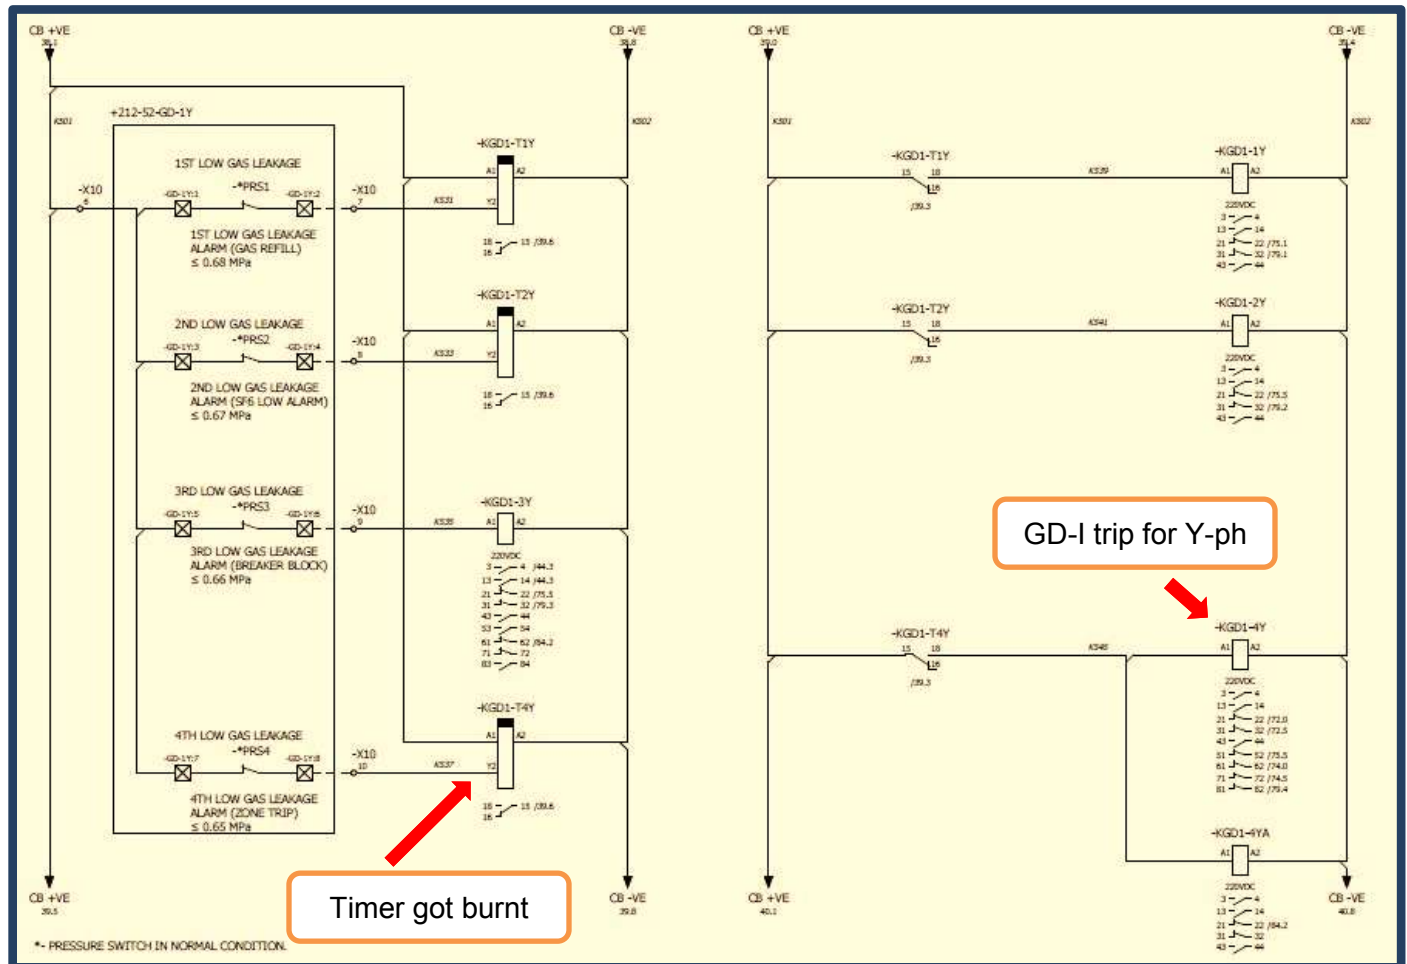
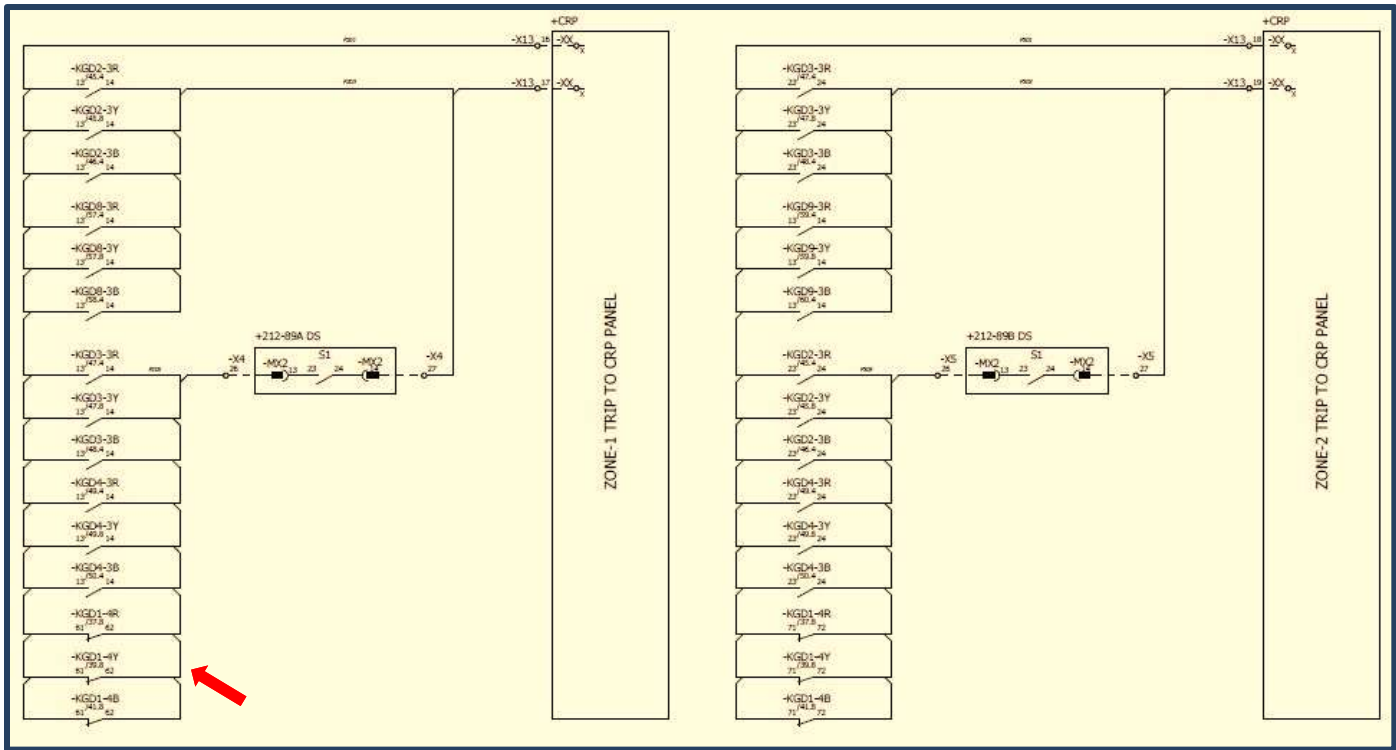
Scheme drawing of 220KV Rangpo-Rongdichu Ckt.-I

Timer relay (KGD1-T4Y) of 220KV Rongdichu Ckt.-I (bay-212) found burnt. This causes extension of +ve to GD trip relay (KGD1-4Y).

Due to burning of timer relay (KGD1-T4Y) the trip contacts got shorted and '+ve' was extended to GD trip relay (KGD1-4Y) as shown below.

- 1) Faulty timer replaced with new spare. 220KV Bus-I and other connected feeders restored.

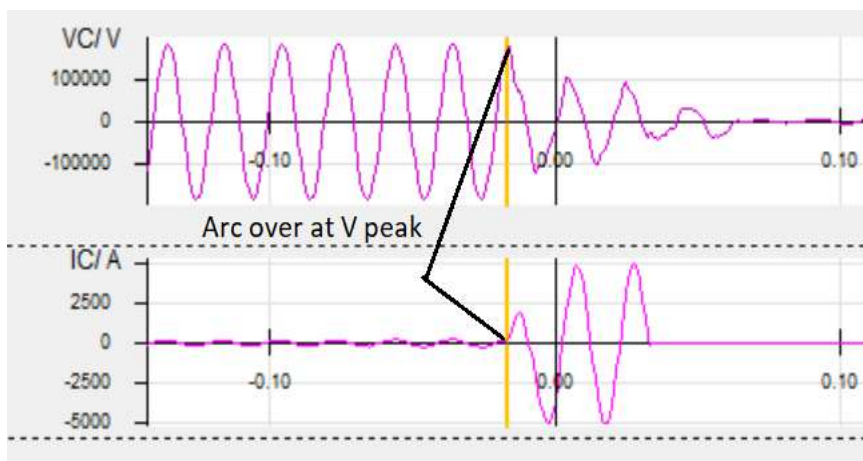
ARC OVER AT Volatge Peak:

It can be observed from below plots that B phase current started rising slowly and then got converted to perfect phase to phase fault (as phase currents of Y and B are 180 degree apart) due to arc over at voltage peak instance. B phase was involved in each fault.

Same phenomenon as mentioned above is observed in almost all cases, which indicates that the fault is **occurring due to sag and clearance issues, hence** proper line patrolling and healthiness of line should be maintained, same kind of fault nature was also observed in this line few months ago which was resolved by, jumper tightening and tree pruning at some locations. This needs to be looked into again and taken care.
