**107 वीं पीसीसी बैठक
का
कार्यवृत्त
Minutes
of
107th PCC Meeting**

Eastern Regional Power Committee

MINUTES OF 107th PROTECTION COORDINATION SUB-COMMITTEE MEETING HELD ON 22.10.2021 AT 10:30 HOURS

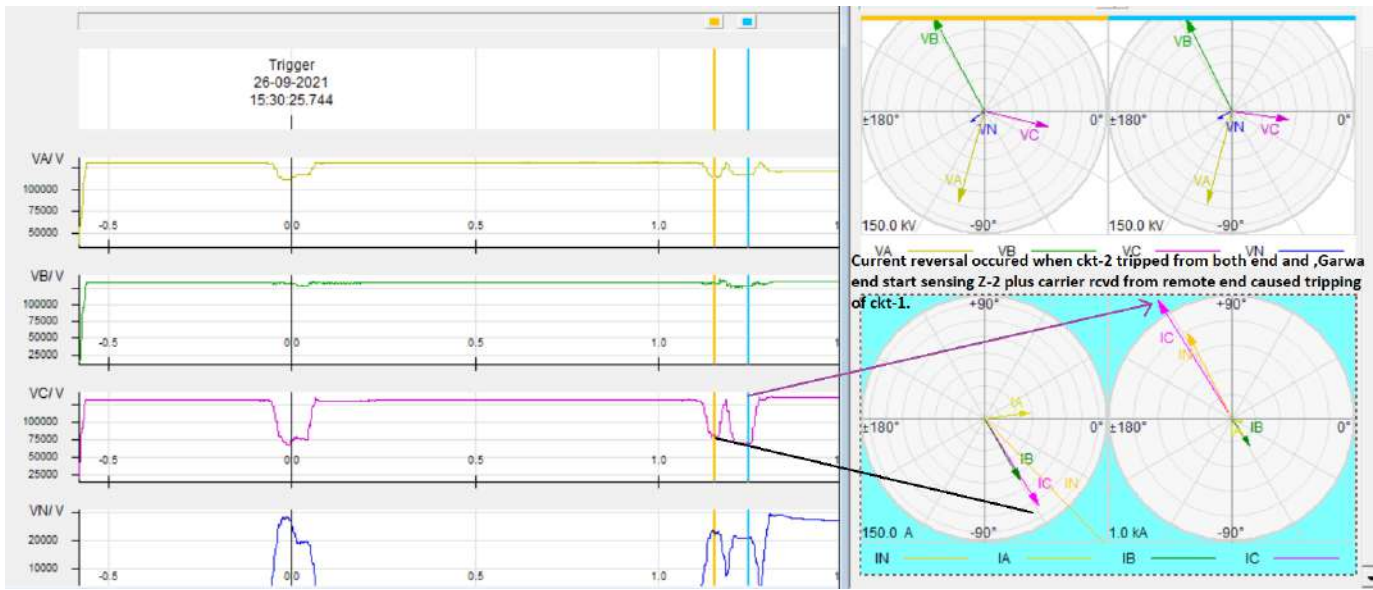
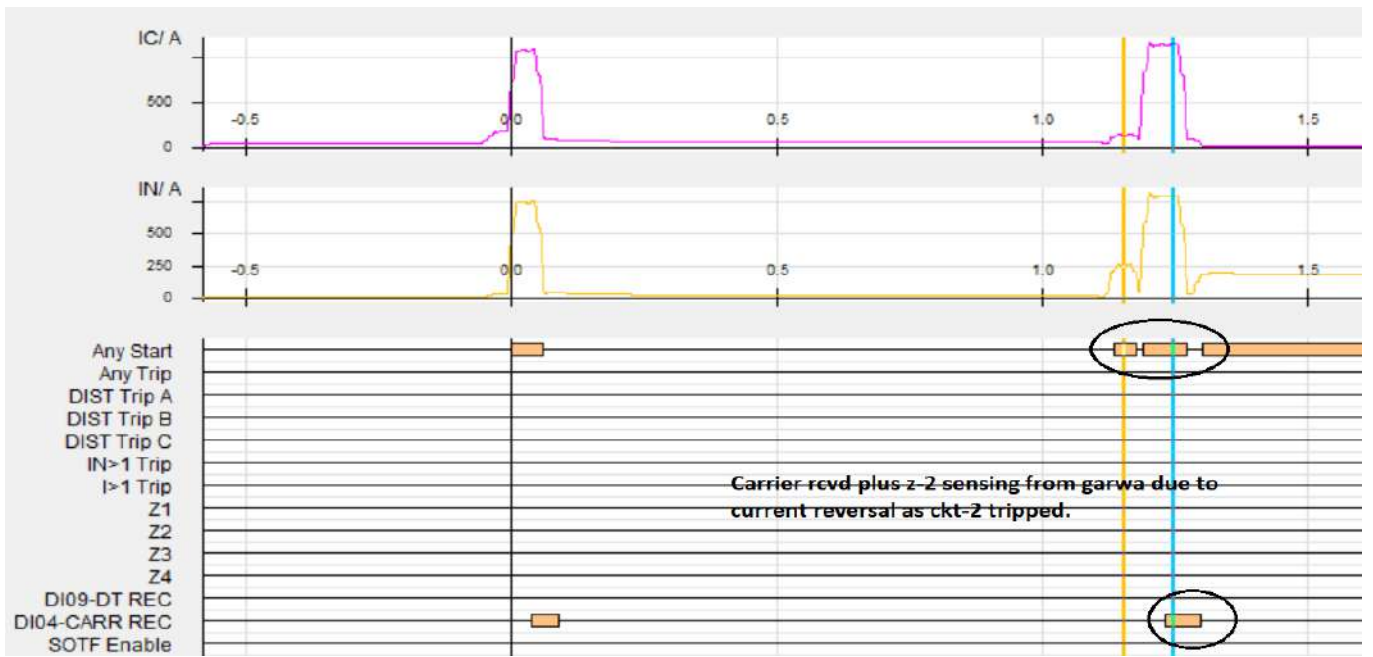
As the line is radial in nature POTT scheme is implemented, it was observed that on 26th for the fault in Ckt-2 both lines tripped .

- At the A/R instance of ckt-2 ,Daltonganj end of ckt-1 was sensing the fault of ckt-2 in Zone-2 and was sending carrier to Garwa end .
- Then as the A/R of Ckt-2 got failed and ckt-2 opened from garwa end ,suddenly current reversal took place and Garwa end of ckt-1 started sensing the same fault in zone -2 ,and it was receiving the carrier also so tripping condition for ckt-1 at Garwa end got satisfied and caused the ckt-1 tripping from Garwa end only(can be observed from below plot) .This also caused the load loss at Garwa.
- Proper implementation of Current reversal guard needs to be ensured to avoid such tripping
