Minutes
of
108th PCC Meeting

EASTERN REGIONAL POWER COMMITTEE

MINUTES OF 108th PROTECTION COORDINATION SUB-COMMITTEE MEETING HELD ON 16.11.2021 AT 10:30 HOURS

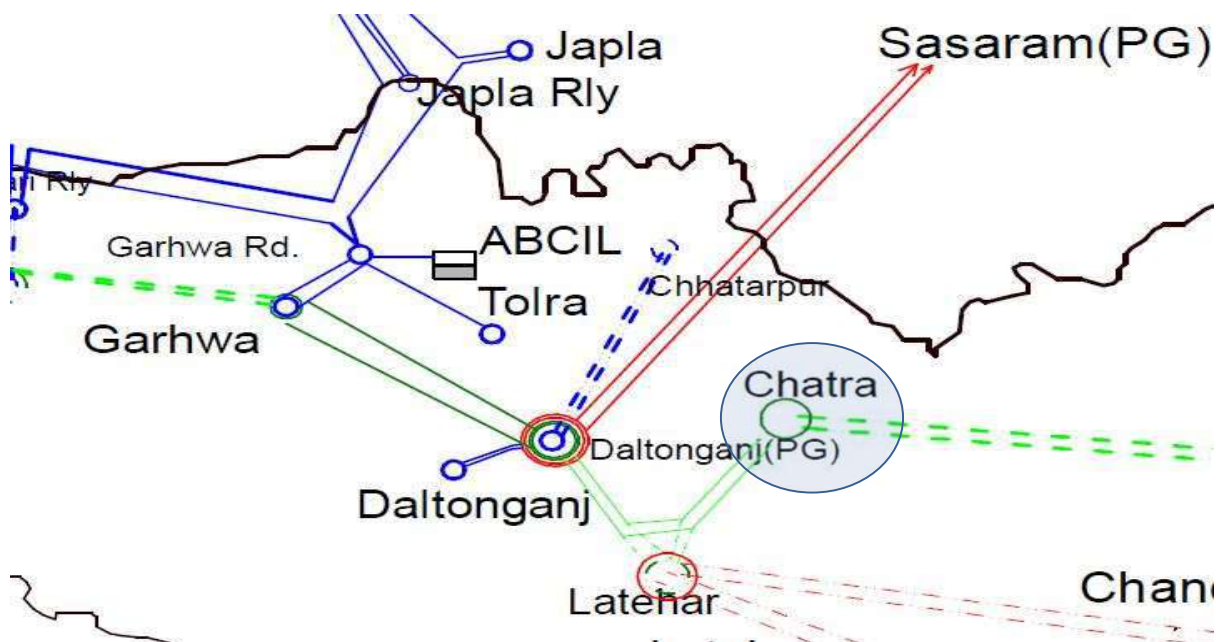
Figure 1: Network across the affected area

At 12:44 Hrs, 220 kV Daltonganj-Chatra D/c tripped on B-phase to earth fault, leading to total power failure at 220/132 kV Chatra S/s. There was total load loss of 15 MW during the event.

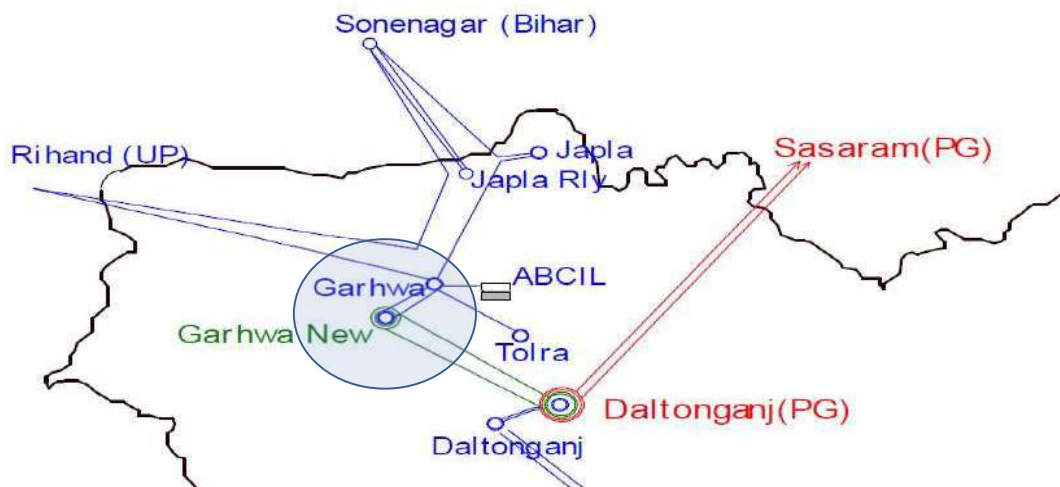
Figure 1: Network across the affected area

220 kV Daltonganj-Garhwa(New) D/C tripped on B-phase to earth fault, leading to total power failure at 220/132 kV Garhwa(New) S/s.

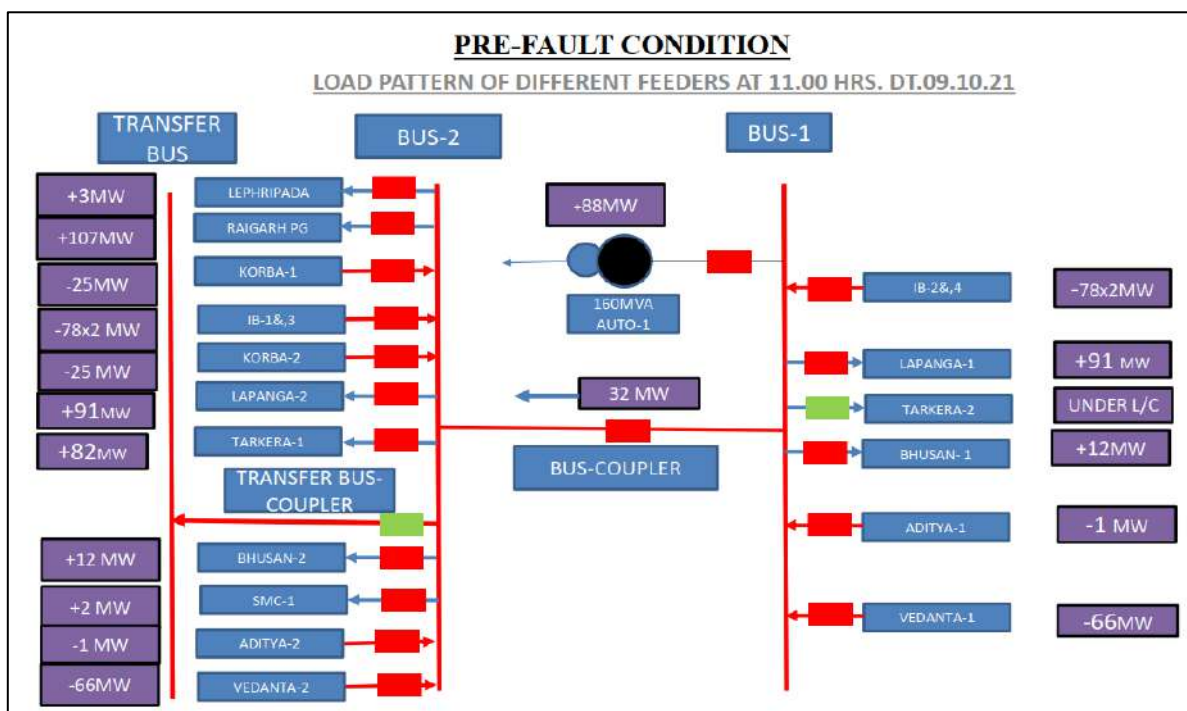
Fig: Power flow pattern at 220 kV Budhipadar substation before event (Source : OPTCL)

- IBTPS: 300 MW generation loss
- Budhipadar load loss: 115 MW loss in local loads of Budhipadar.
- Vedanta CPP: 1120 MW generation loss + 880 MW captive load loss= 240 MW net injection loss to Orissa grid
- Bhushan Steel CPP: 300 MW generation loss (130 X 2 MW + 40 MW) and 300 MW captive load loss for Load generation balance as per CILMS scheme. There was no injection/drawal loss.

Overall Loss for Indian grid : 240 Injection (Vedanta)+300 MW (IBTPS Gen) -115 MW load loss =425 MW Generation loss

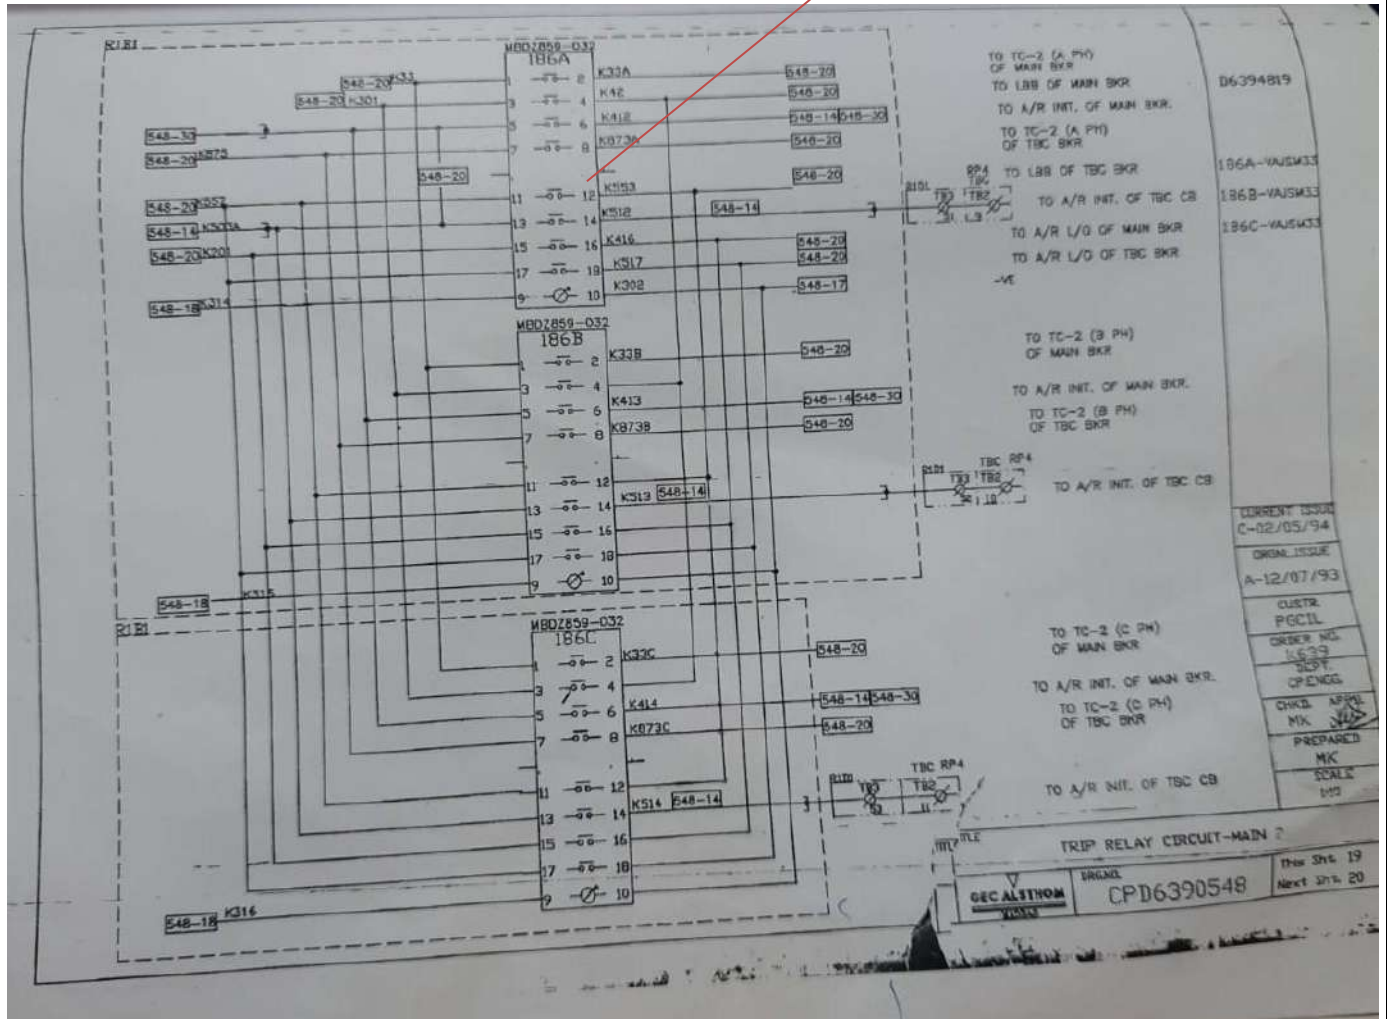
Scheme drawing:

Regarding tripping of 400 kV Main Bus-1 at Malda S/S on 23-10-2021, Powergrid ER-II representative informed that the tripping occurred due to faulty 186A relay in 400 kV Malda-New Purnea Circuit-1. The same had been replaced with healthy spare and busbar protection was taken into service. The report received from Powergrid is enclosed at **Annexure B7.2**.

Contact became high resistive

1. 186A relay replaced with healthy spare.
2. All feeders are normalized accordingly.

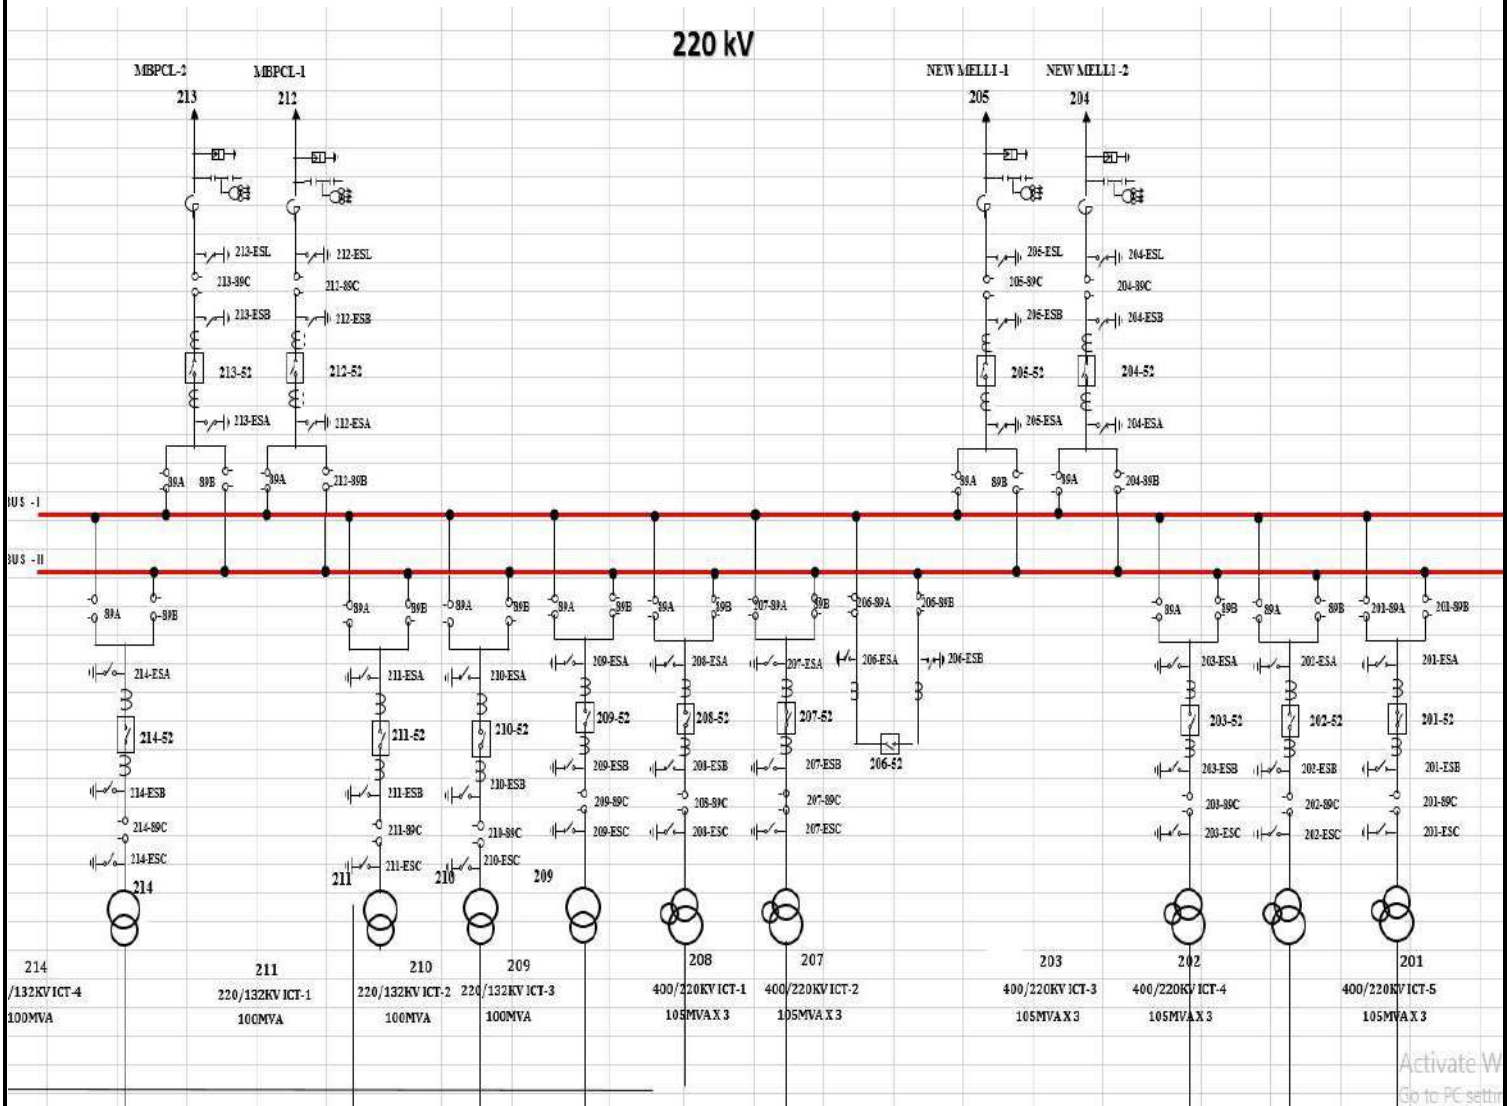
4.0 SLD of 220KV at GIS Rangpo substation:

Regarding the event on 08.11.2021, Powergrid representative informed that 220 kV Bus-2 got tripped on operation of 4th stage low gas level in GD-1 of CB compartment of 220 kV Rangpo-Rongnichu circuit-2. During investigation it was found that there was loose connection at terminal of timer dedicated for 4th stage low gas level of R phase CB (GD-1).

They added that as a remedial measure, the timer was replaced and loosened wire at terminal of timer was tightened. Further they informed that to avoid the mal operation of busbar protection the following measures were taken:

- 4) Also DC segregation for 1st stage & 2nd stage (through MCB-12) and 3rd stage & 4th stage (through MCB-10) of GD-1 of CB compartment done so that falling of a single MCB would not extend Bus bar gas zone tripping signal.

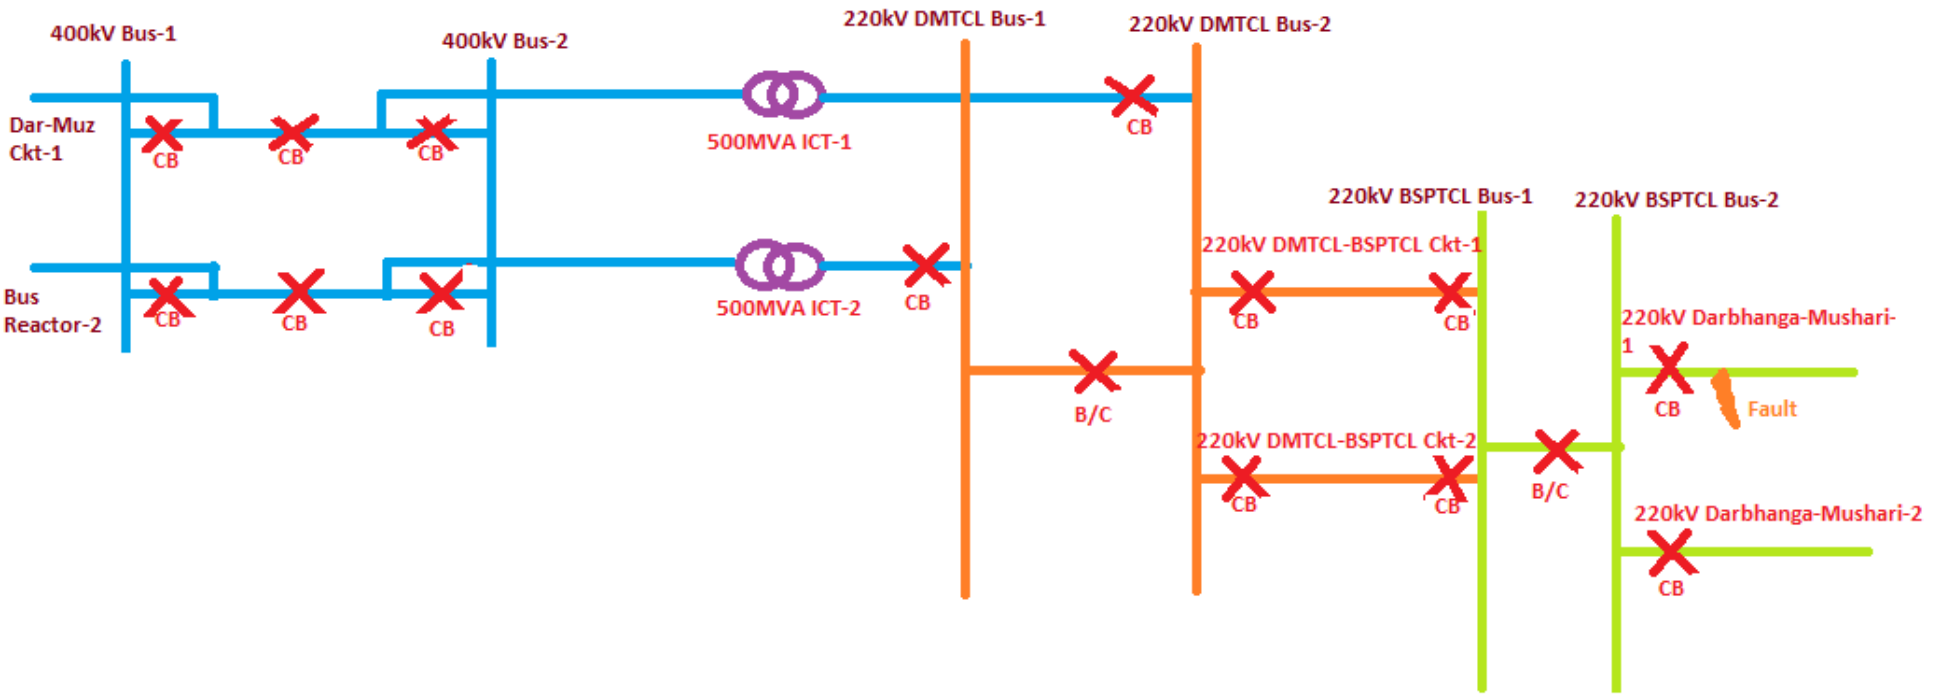
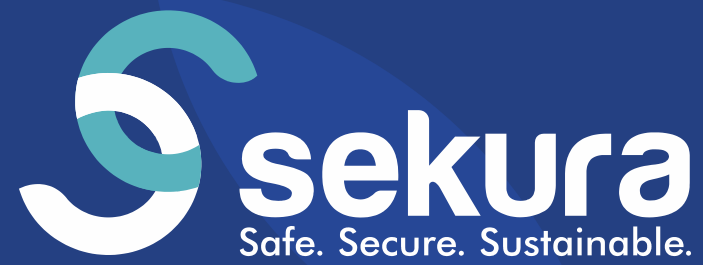
Reference SLD:

On 25.09.2021, both 500MVA ICT- 1&2 at Darbhanga(DMTCL) S/s tripped due to HV directional earth fault protection. During analysis it was found that the disturbance occurred due to failure of R-phase LA in 220 kV Darbhanga(BSPTCL)-Mushari circuit-1 at Darbhanga end. The ICTs at Darbhanga got tripped within 100 msec on DEF protection. There was no tripping observed in any of the 220 kV lines.
