Sub: Minutes of the 112th PCC meeting held on 11.03.2022.

Minutes
of
112th PCC Meeting

EASTERN REGIONAL POWER COMMITTEE

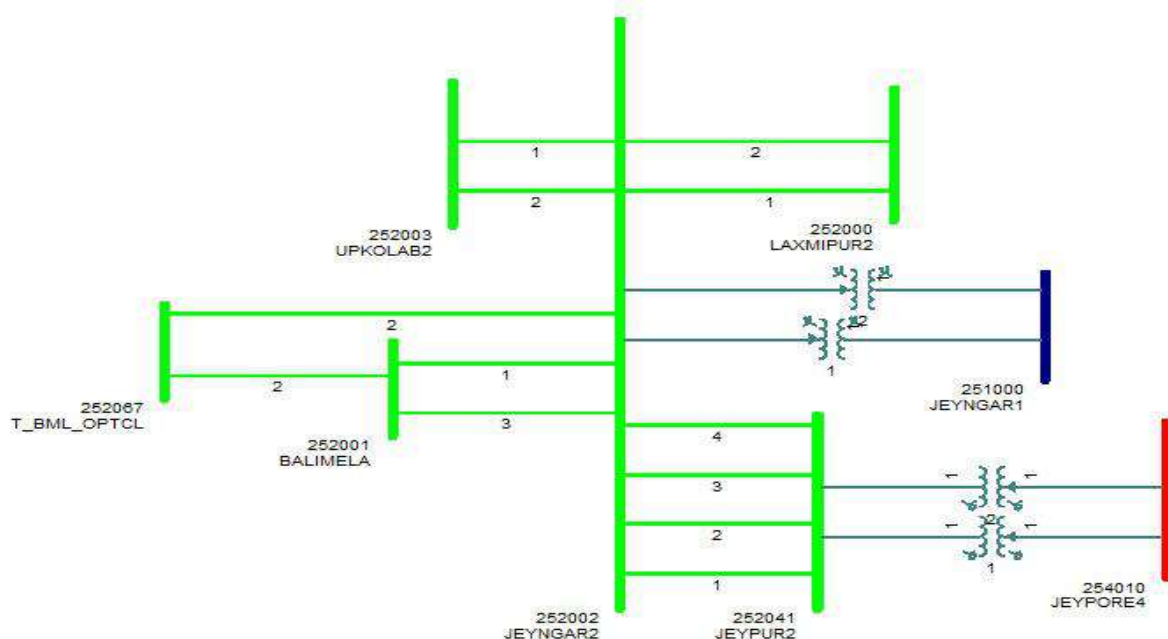
There was a fault in 220 kV Jaynagar-Laxmipur circuit-1 and the Jaynagar end failed to clear the fault. Subsequently total power failure occurred at 220/132 kV Jaynagar, 220 kV Balimela & 220 kV Upper Kolab S/s.

220 kV Bus-1 at Jeypore (PG) along with 400/220 kV ICT-1 & 3 also tripped during the incident.

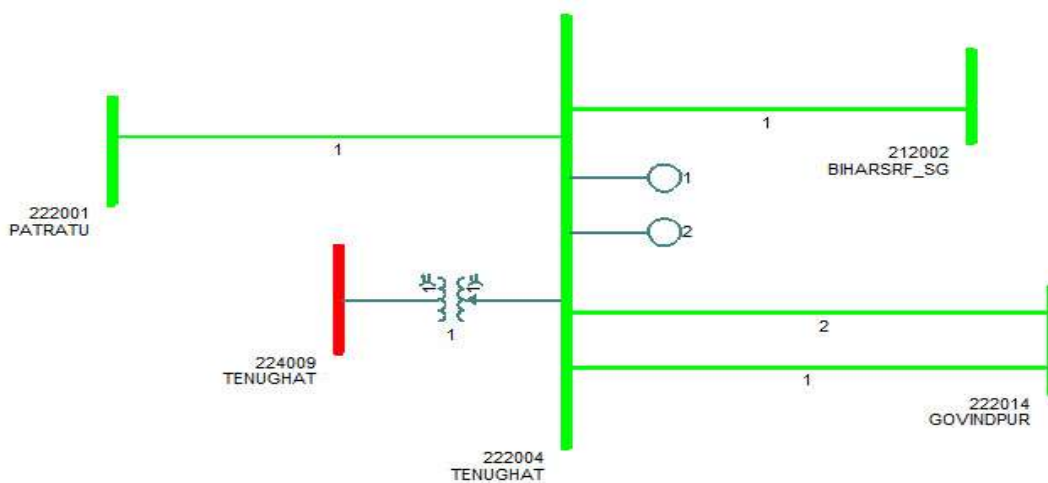
On 04th February 2022 at 05:53 Hrs, all emanating lines from 220 kV Tenughat (TVNL) along with two running units tripped at Tenughat.

Time	Name	End 1	End 2	PMU Observation
05:53	220 kV Tenughat-Patratu	Didn't trip	PTPS: Y_N, Zone 1, 51.26 km, 3.097 kA	6 kV dip in Y_ph; 1.5 kV dip in R_ph and B_ph at Biharsharif. Fault Clearance time: 350 msec
	220 kV Tenughat-Biharsharif	Didn't trip	Biharsharif: Y_N, Zone-2, 1.8 kA	
	220 kV Tenughat-Govindpur-2	Tenughat: Y_N, 1.73 km, 3.56 kA	Govindpur: Y_N, Zone-2 carrier received	
	Tenughat U#1 & U#2	-	-

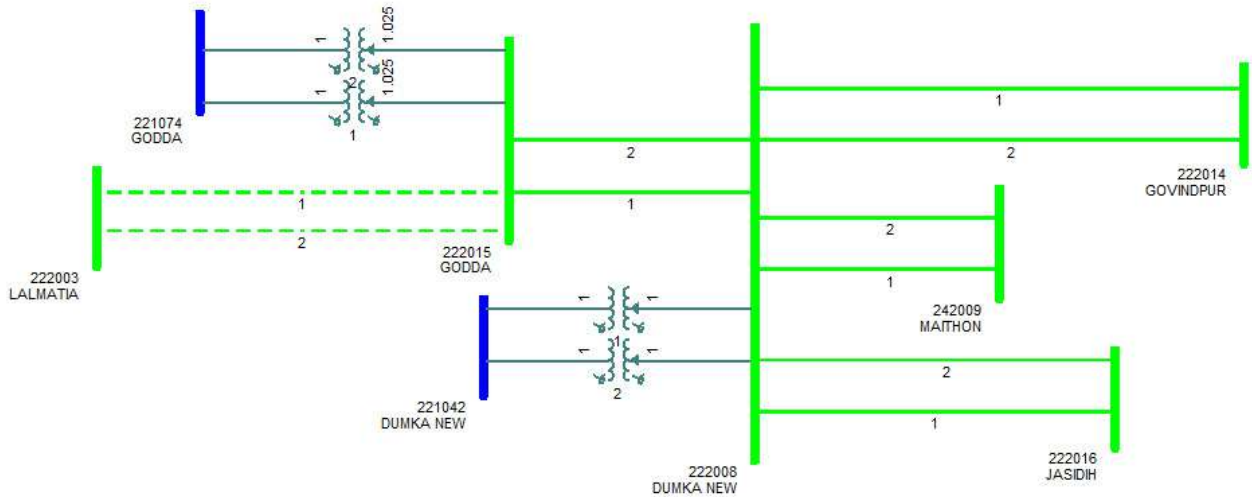
On 3rd February 2022 at 07:37 Hrs, 220 kV Dumka-Godda D/c and 220 kV Dumka-Jasidih D/c tripped on overvoltage protection leading to total power failure at Godda & Jasidih. Inclement weather was reported during the event.

ERLDC representative informed that tripping had occurred due to improper overvoltage settings at Dumka end. He further added that revised settings with proper time and voltage grading had been shared with JUSNL on 10th March 2022.

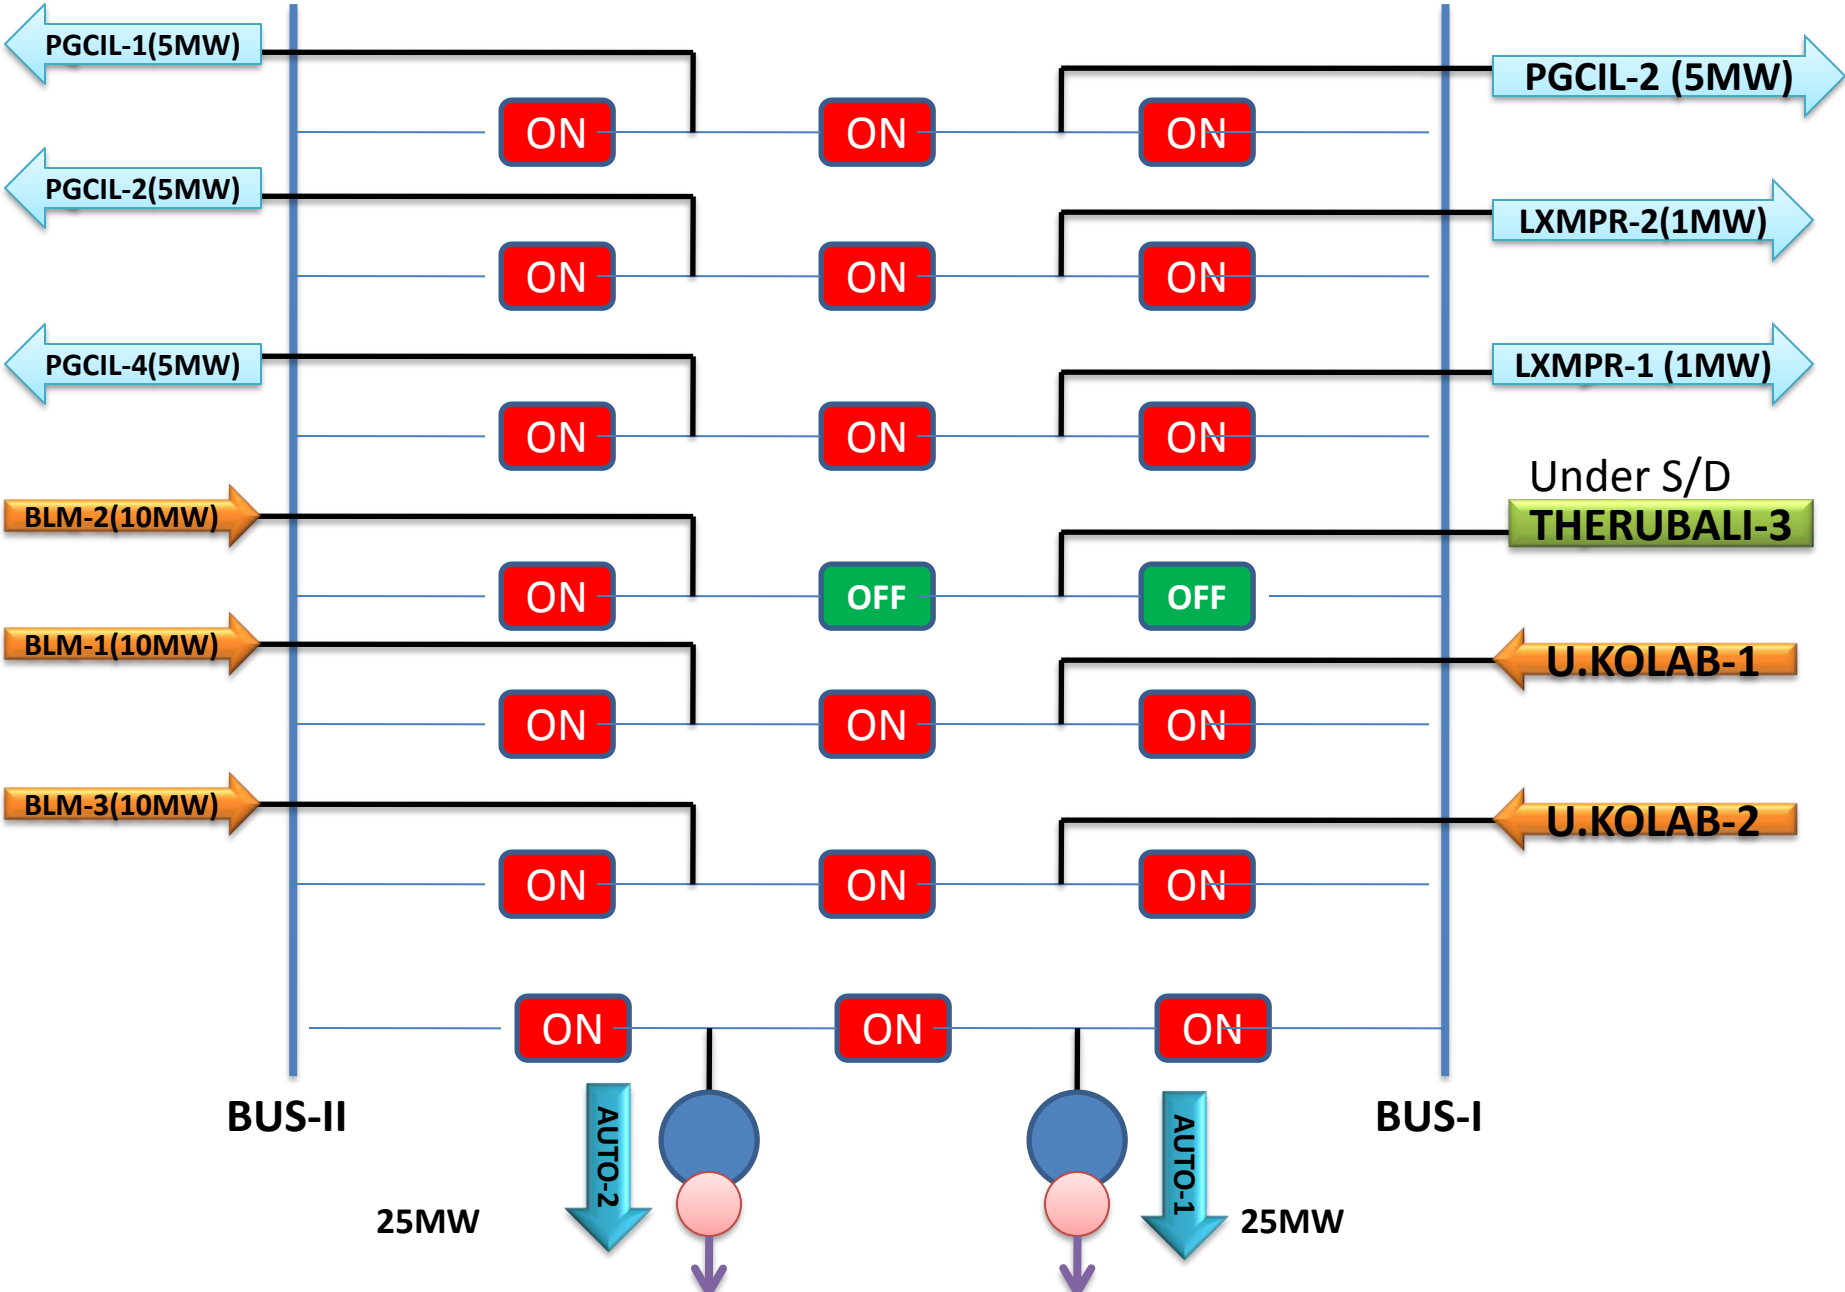
PRE FAULT LOAD PATTERN OF DIFFERENT 220KV FEEDERS

Sl.No	Bus-1 Feeder/Bay Name	MW	Load Flow		Sl.No	Bus-II Feeder/Bay Name	MW	Load Flow
1	PGCIL-3	5MW	Export		8	PGCIL-1	5MW	Export
2	LAXMIPUR-2	2MW	Export		9	PGCIL-2	5MW	Export
3	LAXMIPUR-1	2MW	Export		10	PGCIL-4	5MW	Export
4	THERUBALI-3	0			11	BALIMELA-2	10MW	Import
5	UPPER KOLAB-1	23MW	Import		12	BALIMELA-1	10MW	Import
6	UPPER KOLAB-2	23MW	Import		13	BALIMELA-3	10MW	Import
7	160MVA AUTO-1	25MW	Export		14	160MVA AUTO-2	25MW	Export

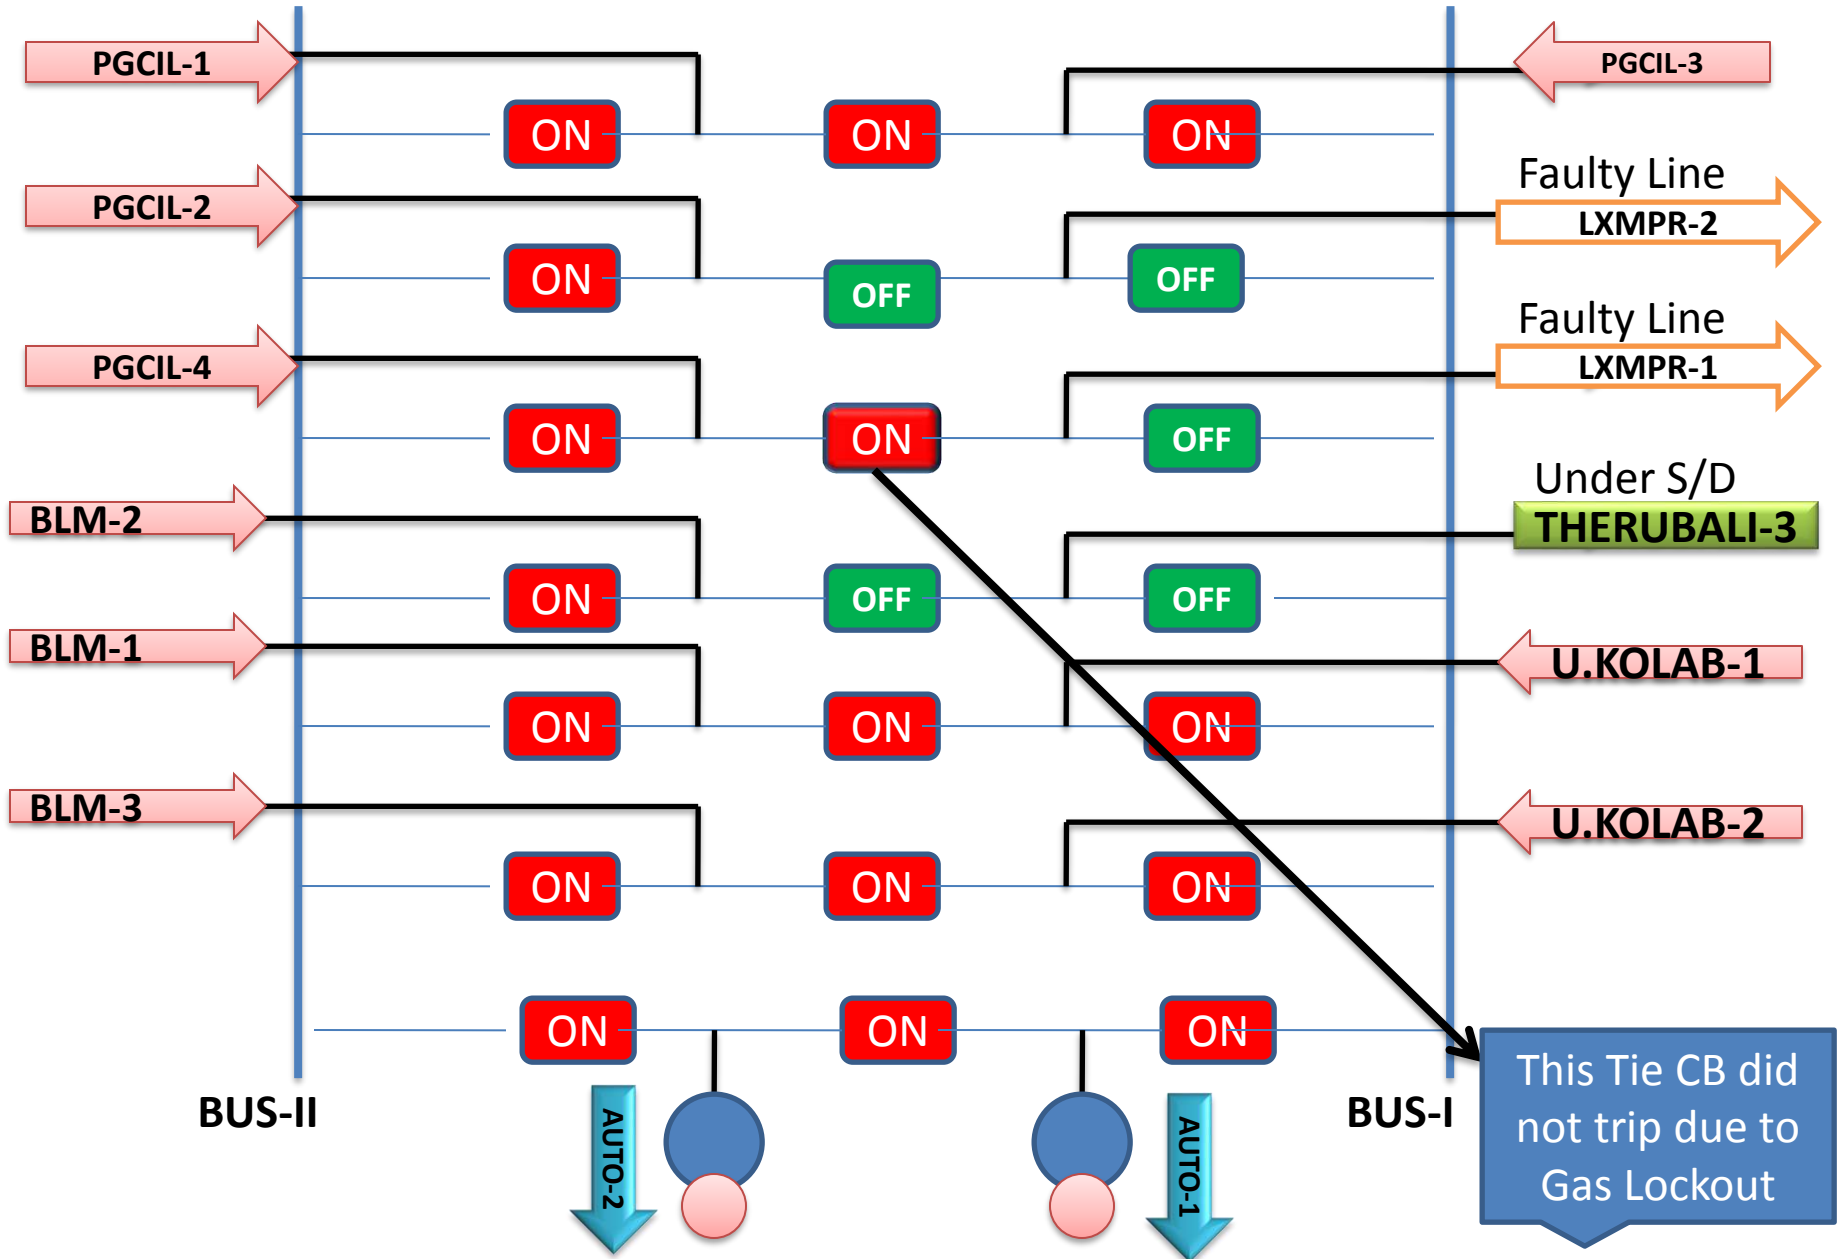
POST FAULT CONDITION

- PGCIL end: DP relay operated and all four feeders tripped in Z-3 with fault current 0.8 to 0.9KAmps.
- Laxmipur End: Circuit-1 tripped in Z-1 with 3.4KM (IR= 4KAmps) and Circuit-2 tripped in E/F> with IN current 1.01KA.
- Balimela P/H end: Tripping details of three 220KV feeders not provided. But as per the information feeders not tripped at Baliemla end.
- Upper Kolab P/H end: Proper tripping details not provided. But as per the DR data it has been observed that fault persisted up to 42 sec at their end in both circuits.
- Auto Trf. downstream 132KV Source end:
 - 132KV Dabugaon end source tripped in Zone-3 with Ia=624A,Ib=360A & Ic=203A
 - 132KV Meenakshi P/H end tripped in O/C within the time.

1. Line fault of 220KV Jayanagar-Laxmipur Circuit-1 not cleared due to non-tripping of its TIE-CB after command initiated by relays . Also the CB did not tripped by TNC switch . Observed that the CB is in gas lockout mode and the gas pressure of Y-phase limb was near to lockout border line. Due to this all remote end feeders affected and fault continued up to long time. At 12:45 Hrs due to rise in atmospheric temperature the lockout mode gone and tie CB tripped through TNC switch.
2. As per the information of Grid operation team, the defective annunciation module misled to get the status of Gas lockout.
3. Due to long fault clearing time, wave trap of R-Phase (at Jayanagar End) burnt.
4. Fault continued up to 43sec due to delay in fault clearance from Upper Koaab/Balimela P/H ends.

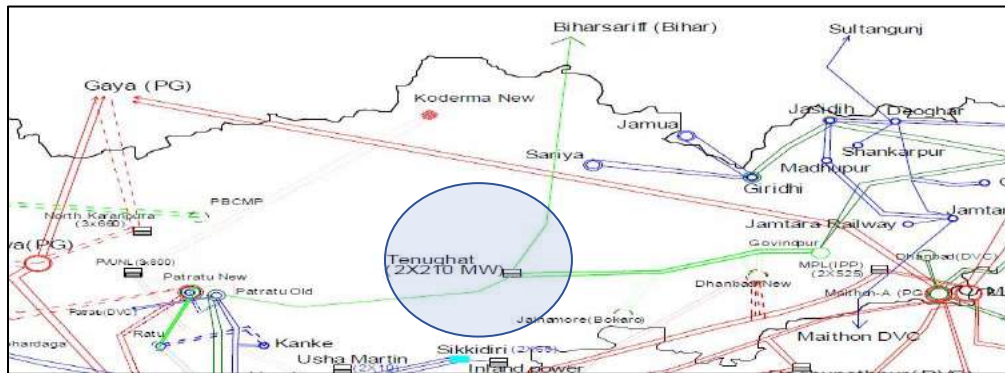
Figure 1: Network across the affected area

- 220 kV Tenughat-Patratu
- 220 kV Tenughat-Biharsharif
- 220 kV Tenughat-Govindpur-2

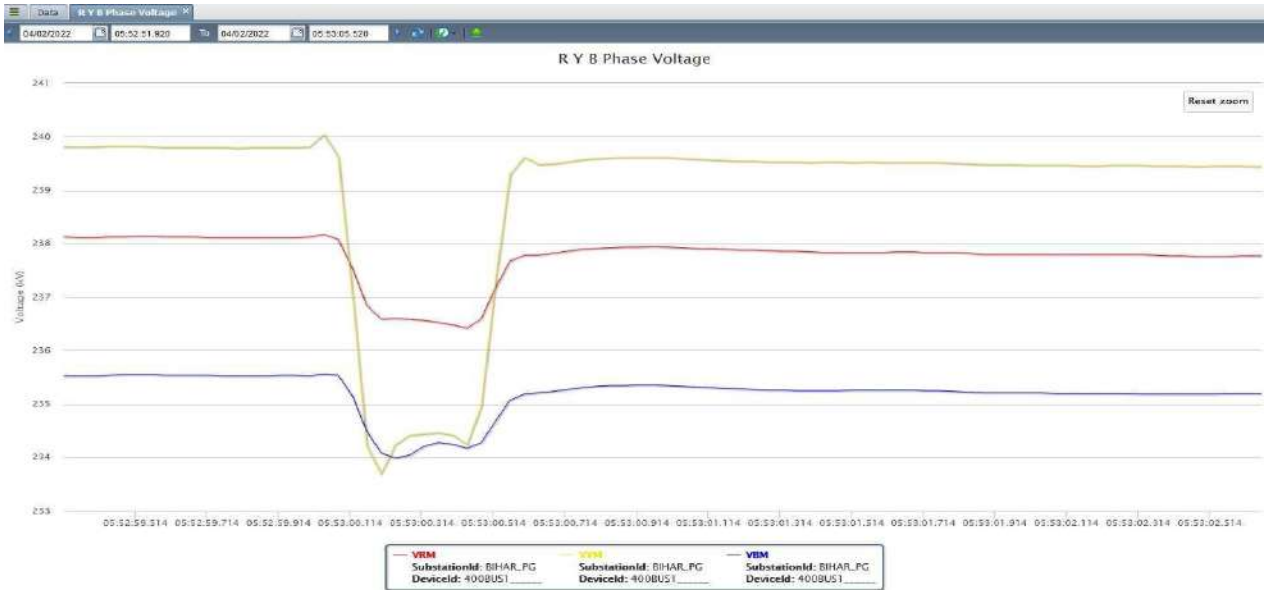
Figure 3: PMU voltage snapshot of 400/220 kV Bihar sharif S/s

समय	नाम	उप केंद्र 1 रिले संकेत	उप केंद्र 2 रिले संकेत	पीएमयू पर्यवेक्षण
05:53	220 kV Tenughat-Patratu	Didn't trip	PTPS: Y_N, Zone 1, 51.26 km, 3.097 kA	6 kV dip in Y_ph; 1.5 kV dip in R_ph and B_ph at Bihar Sharif. Fault Clearance time: 350 msec
	220 kV Tenughat-Bihar sharif	Didn't trip	Bihar Sharif: Y_N, Zone-2, 1.8 kA	
	220 kV Tenughat-Govindpur-2	Tenughat: Y_N, 1.73 km, 3.56 kA	Govindpur: Y_N, Zone-2 carrier received	
	Tenughat U#1 & U#2	-	-

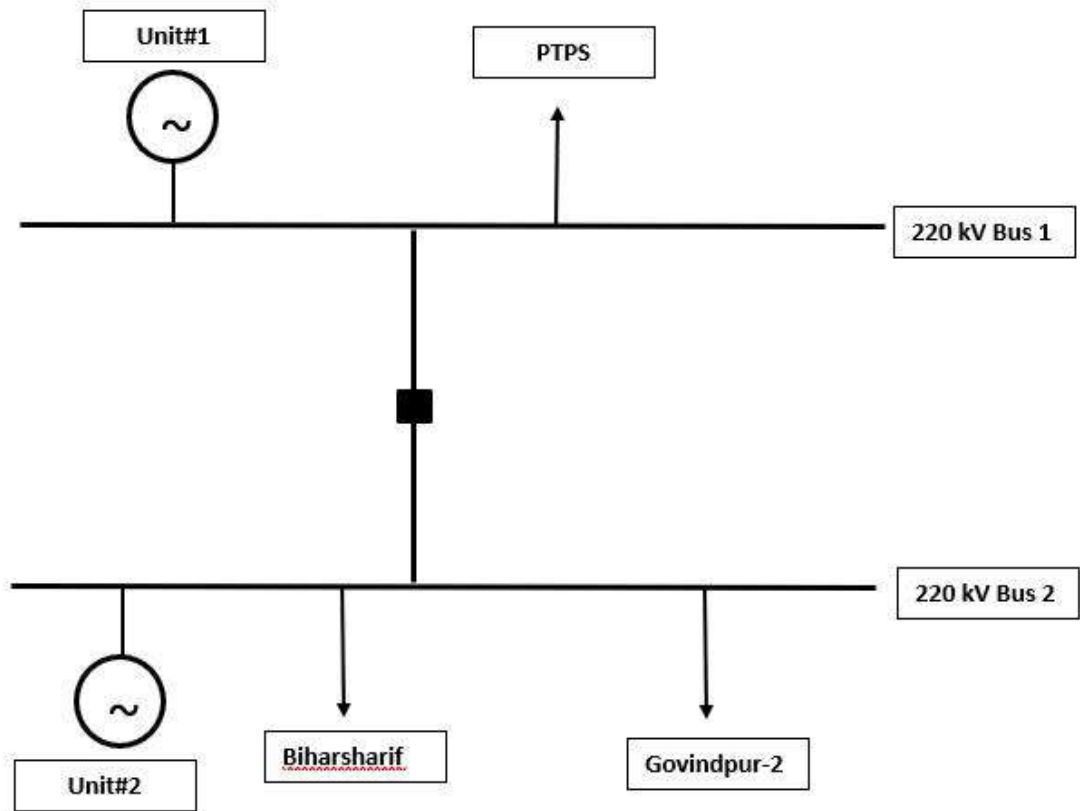
220 kV Bus arrangement at Tenughat

He explained that there might be a simultaneous fault occurred in 220 kV Bus at Tenughat at the same time which resulted in tripping of 220 kV Tenughat-Biharsharif line from Biharsharif end in zone 2 protection. The relay at Tenughat end for 220 kV Tenughat-Biharsharif sensed the fault in zone 4. For 220 kV Tenughat-PTPS, PTPS end sensed the fault in zone 1 and got tripped and Tenughat end sensed the fault in zone 4 however tripping was not observed from Tenughat end.

- **Antecedent Condition:** 220 kV Tenughat-Govindpur-2 was radially feeding Govindpur and downstream areas as 220 kV Tenughat-Govindpur-1 was switched off under voltage regulation and 220 kV Maithon-Dumka D/c was under continuous shutdown.

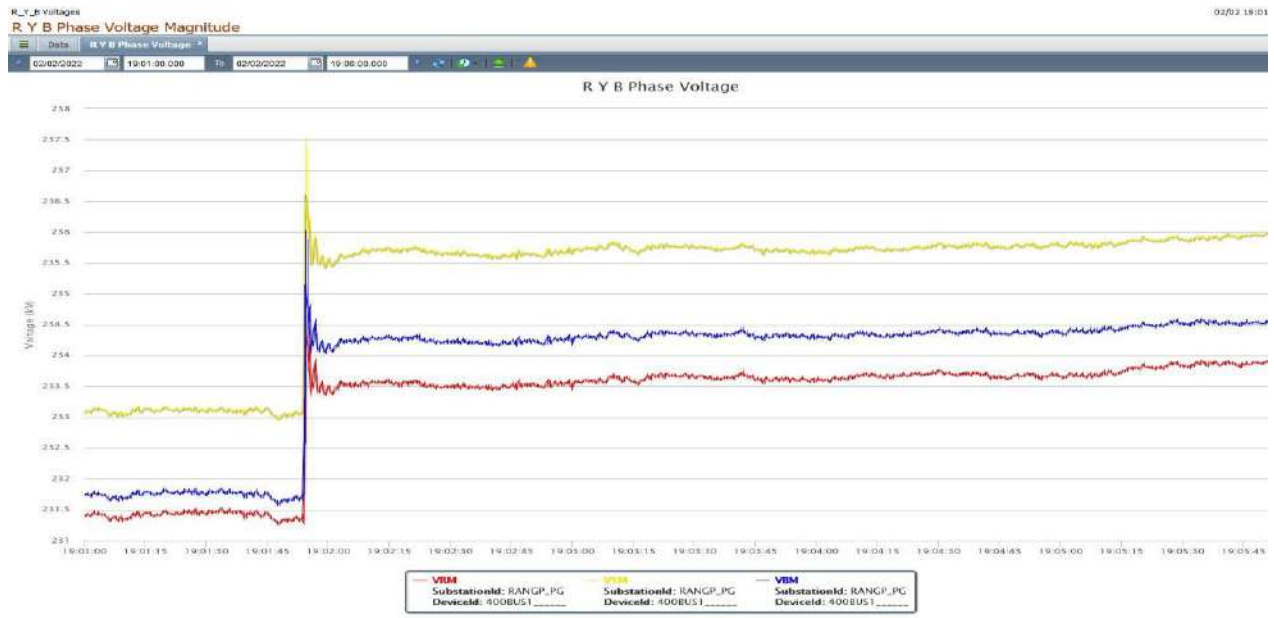
Figure 3: PMU voltage snapshot of 400/220 kV Rangpo S/s

समय	नाम	उप केंद्र 1 रिले संकेत	उप केंद्र 2 रिले संकेत	पीएमयू पर्यवेक्षण
19:02	U#1,U#2,U#3 at Teesta-5	Loss of auxiliary supply	-	2 kV rise in each phase at Rangpo

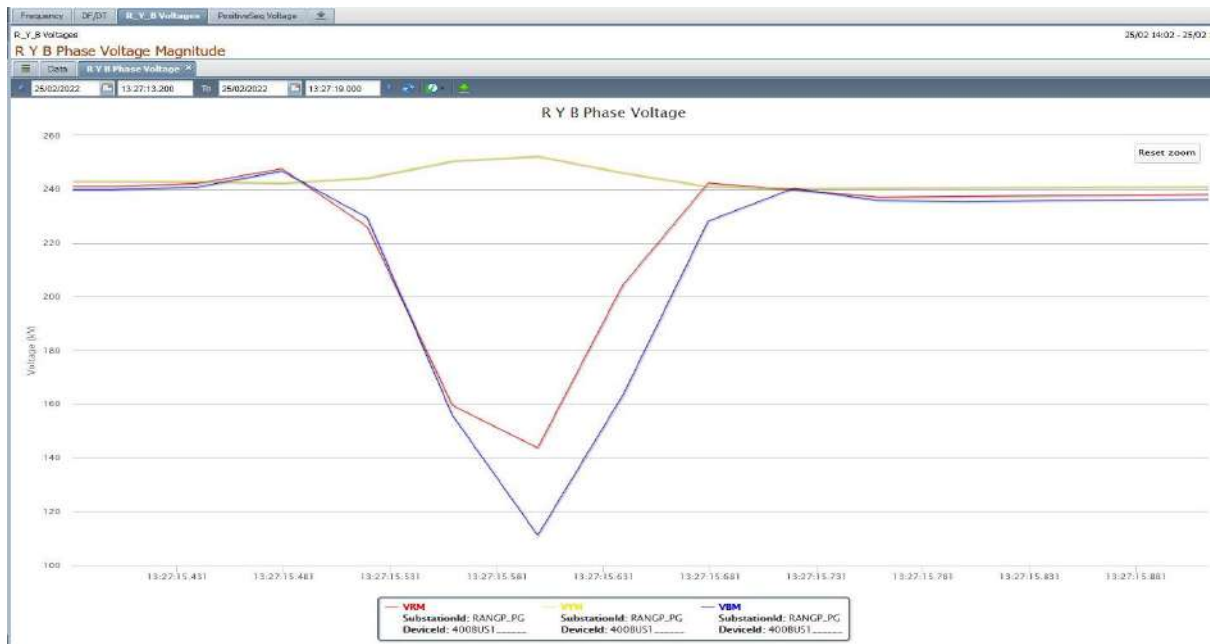
Figure 3: PMU voltage snapshot of 400/220 kV Rangpo S/s

They added that the overvoltage setting was kept at of 120% per phase (277 kV) and during incident per phase voltage of 311 kV was observed which led to relay initiation.

समय	नाम	उप केंद्र 1 रिले संकेत	उप केंद्र 2 रिले संकेत	पीएमयू पर्यवेक्षण
13:27	400 kV Teesta 3-Rangpo-1	Teesta 3: R_B_N, Zone 1, 4.2 km,	Rangpo:R_B_N, Zone 1, 63.5 km, Ir: 6.2 kA, Ib: 3.9 kA	97 kV dip in R_ph and 126 kV dip in B_ph voltage at Rangpo
	400 kV Teesta 3 Dikchu	Teesta 3: O/V St-2	Dikchu: R_B_N, Zone-1, Ir: 3.89 kA, Ib: 4.1 kA
