Agenda  
for  
**119<sup>th</sup> PCC Meeting**

## **AGENDA FOR 119<sup>th</sup> PROTECTION COORDINATION SUB-COMMITTEE MEETING TO BE HELD ON 18.10.2022 AT 11:00 HOURS AT ERPC, KOLKATA**

#### **ITEM NO. B.1: Total Power failure at 220 kV CTPS A and CTPS B (DVC) S/s on 24.09.2022 at 10:55 Hrs**

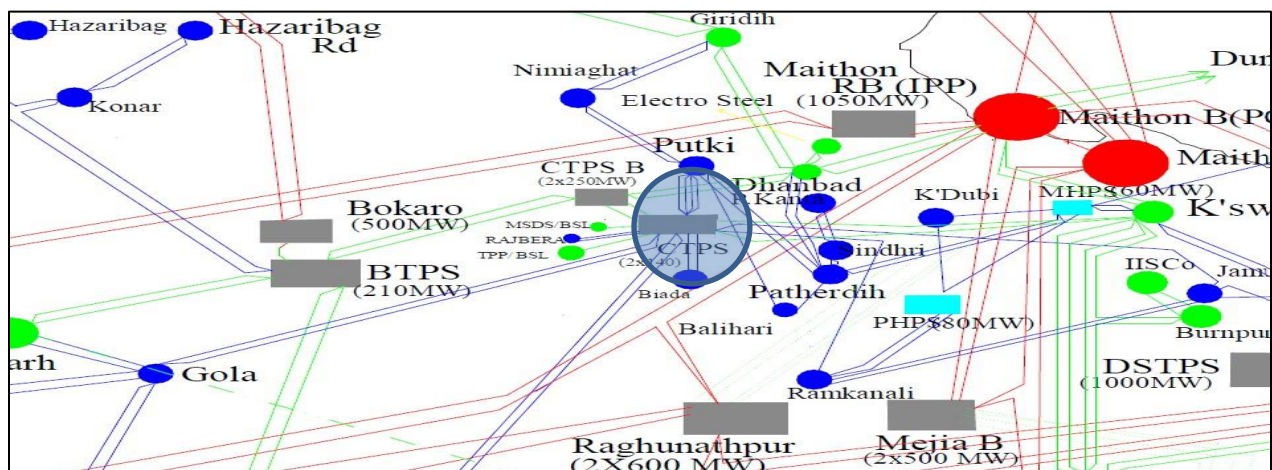
Figure 1: Network across affected area

AT 10:50 Hrs, 220 kV CTPS B-BTPS (Bokaro B)-2 was hand tripped to control loading of 2\* 315 MVA 400/220 kV ICTs at Bokaro. At 10:55 Hrs, 220 kV CTPS B-BTPS (Bokaro)-1 was also hand tripped to further reduce loading of those ICTs. However, Y\_ph CB of this line got stuck at CTPS B end, LBB operated and this gave tripping command to all elements in both buses. At 11:03 Hrs, 220 kV CTPS A-Kalyaneshwari also got tripped which led to total power failure at 220 kV CTPS A S/s also. Both running units at CTPS B tripped leading to 360 MW generation loss. Around 400 MW load loss also reported.

- Reason for the same was due to stuck breaker condition, Broken conductor protection operated and resulted into lockout relay operation which further initiated Operation of LBB as Y pole was stuck and LBB gave tripping command to each element from Main Bus -1.

- But it also gave tripping command to all the elements from Main bus -2 as there is DMT scheme it was later known that, ST#8 was at MB#2 but both CT switching relays of MB-1 & MB-2 of this bay was operated condition hence It caused tripping of all bays of MB-2 through 96 relays. Supervision and different schemes may be explored to avoid both CT switching overlap with both buses. **DVC to explore till implementation of low impedance busbar.**

- Operation of Broken conductor protection needs to be checked in detail as it led to lockout relay operation and initiation of LBB which led to bus tripping.

- Broken conductor operates on the ration of  $I2/I1 > 20\%$  as one pole was only stuck so  $I2=I1$ .
- Since sensitive settings have been employed, it can be expected that the element will operate for any unbalance condition occurring on the system for example, during a single pole auto reclose cycle. Hence, a long time-delay is necessary to ensure co-ordination with other protective devices. **Normally 4- 5 second time-delay is provided for Broken Conductor Protection.**

- As Y pole tripped after 3 seconds, Broken conductor protection should have not operated, Generally Broken conductor is used for only alarm purpose. So it can be used for only alarm instead of tripping. **DVC to explain and check.**

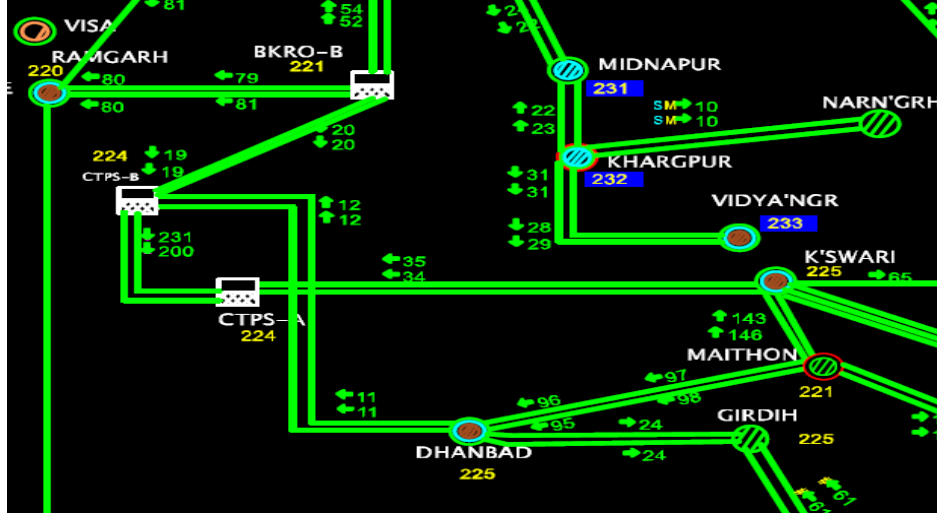
Figure 2: SCADA snapshot of the system

- Loading of 2\*315 MVA ICT at Bokaro touched up to 280 MW each and to reduce the loading of ICT ,BTPS-CTPS (B)-I was opened at 10:50 Hrs ,but ICT loading did not reduced as load was shifted to ckt -2 as observed from above scada plot .
- At 10:55 Hrs ckt-2 was also opened but Y pole CB at CTPS (B) got stuck and did not opened which can also be seen from below PMU plot of line current plot. Y phase current became zero after 3 seconds ,Probably after PD operation.

- Under such condition of stuck one pole of breaker PD should have operated and tripped the remaining phase but apart from this all other lines with main bus-1 and 2 at CTPS B tripped.

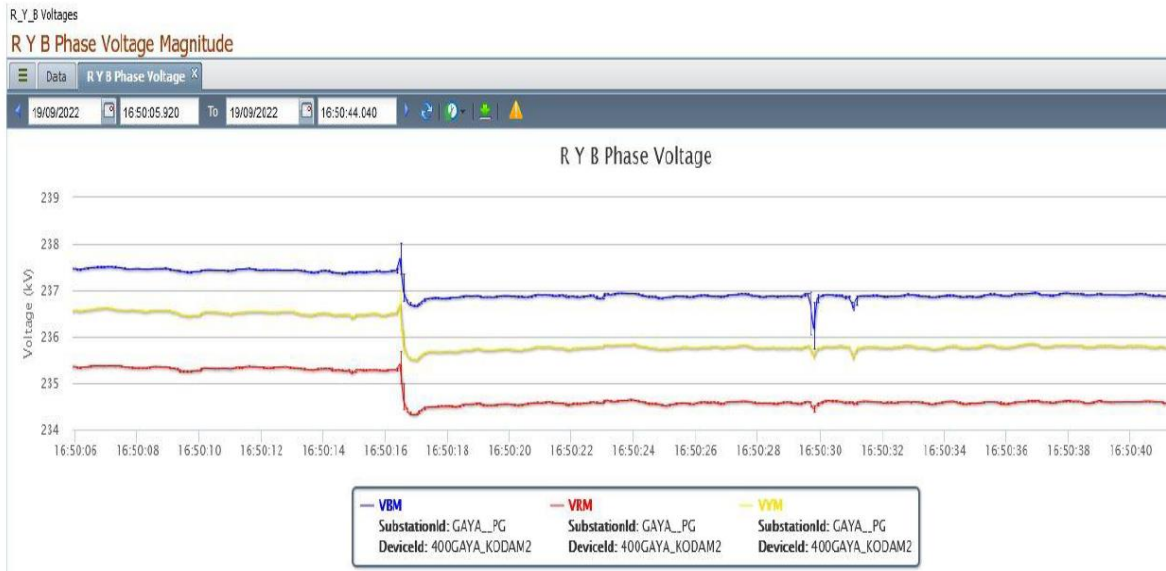
Figure 2: PMU Voltage snapshot of 765/400/220 kV Gaya S/s

- During testing work in 400 kV Bus-1 at Chandwa, 400 kV Bus-2 tripped. No fault observed from PMU data.
- External trip command triggered as per DR. PG ER-1 may share root cause analysis of the incident along with lessons learnt.

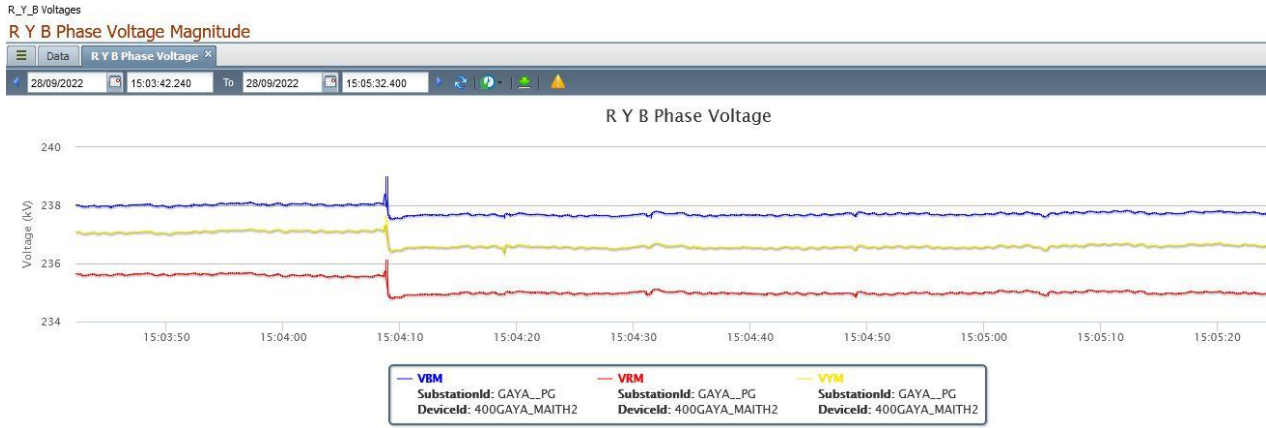
Figure 2: PMU Voltage snapshot of 765/400/220 kV Gaya S/s

- During testing work in 400 kV Bus-2 at Chandwa, 400 kV Bus-1 tripped. No fault observed from PMU data.
- Same kind of incident occurred on 19<sup>th</sup> September 2022 also. PG ER-1 may share root cause analysis of the incident along with lessons learnt.

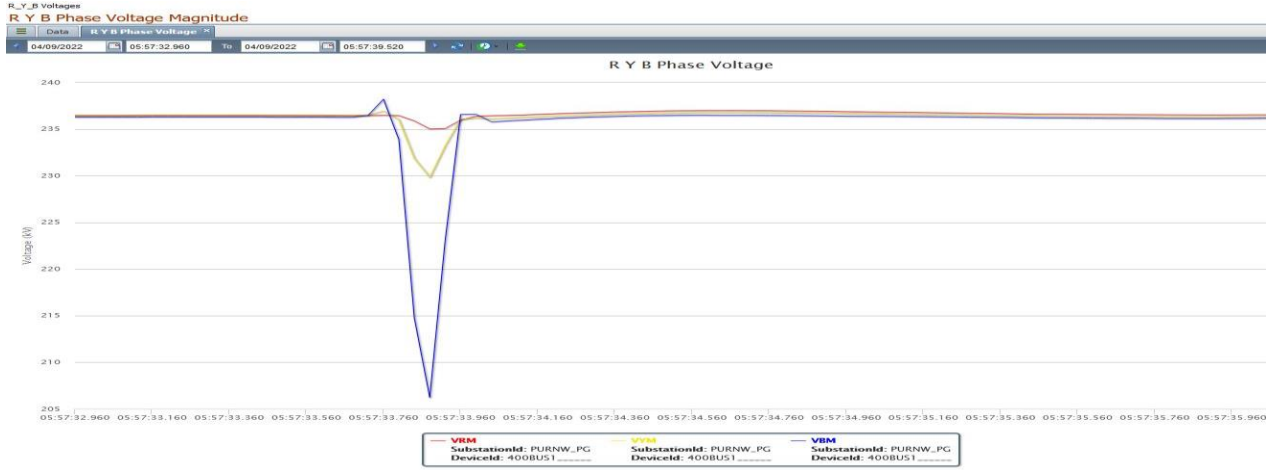
Figure 2: PMU Voltage snapshot of 400/220 kV New Purnea S/s

समय	नाम	उप केंद्र 1 रिले संकेत	उप केंद्र 2 रिले संकेत	पीएमयू पर्यवेक्षण
05:57	400 kV Bu-1 & 2 at Malda	Bus bar protection operated at Malda		30 kV dip in B_ph voltage at New Purnea. Fault Clearance Time: 100 msec
	400 kV Farakka-Malda-1			
	400 kV Farakka-Malda-2			
	400 kV Malda-New Purnea D/c			
	400/220 kV 315 MVA ICT-3 & 5 at Malda

- As per the previous action taken the annunciation came in the panel just before the event.
- Before any corrective action the fault happen in 400 kV Farakka-Malda line and that's why as per bus bar logic again both the bus tripped.
- Check Zone of bus bar protection remained in disabled condition.

- As the Bus coupler bay is very old it may be replaced at the earliest along with control cable.
- Old control cable may be replaced.
