**Eastern Regional Power Committee**

**Sub: Minutes of the 119th PCC meeting held on 18.10.2022.**

Minutes  
of  
**119<sup>th</sup> PCC Meeting**

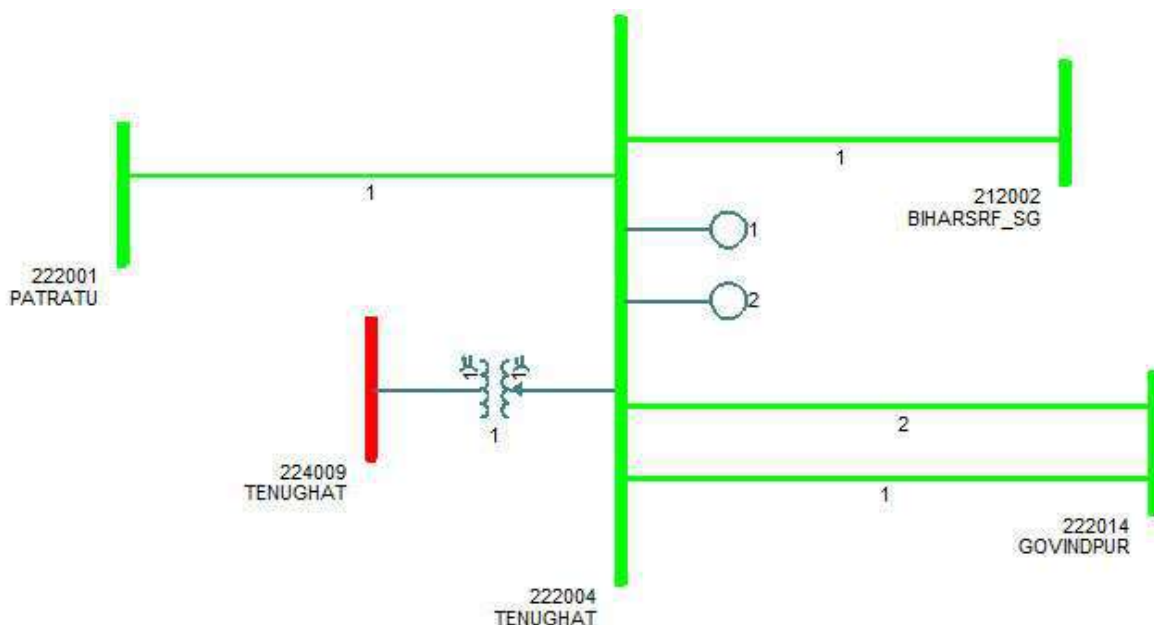
At 12:55 Hrs, R\_B\_N fault struck at 220 kV Tenughat-Govindpur D/c line. 220 kV Govindpur-Dumka-1 and 210 MW Unit 2 at Tenughat also got tripped at the same time.

*Regarding fault location, JUSNL representative stated that patrolling was carried out under the line however no physical fault was found. He added that clearance issues might had resulted in the incident.*

*During the above disturbance, relay at Dumka end for 220 kV Dumka-Govindpur-1 sensed the fault in zone-3, however tripping occurred within 100 ms as T1(timer of zone-1) had picked up. This is observed from disturbance recorder of the relay.*

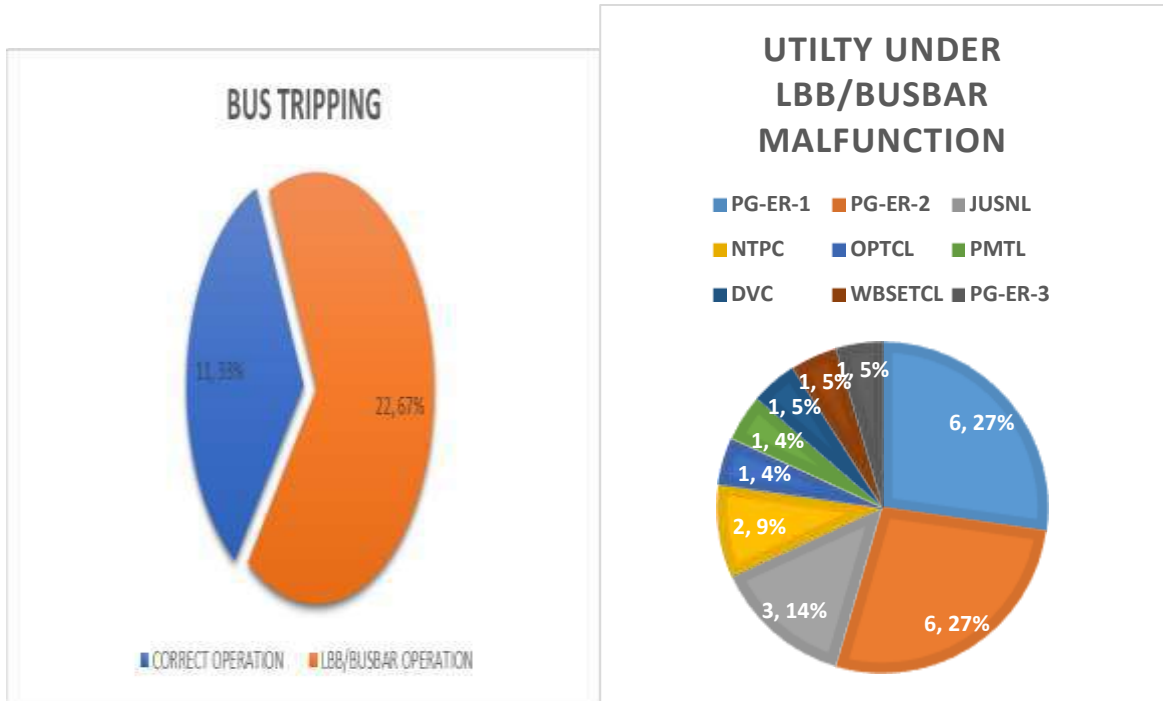
For the year 2022 it had been observed that the Bus tripping's are mostly occurring due to mal operation of LBB & Busbar protection.

ERLDC representative informed that for the year 2022, it had been observed that bus bar protection had mal-operated for 22 number of bus tripping incidents out of total 33 incidents which clearly shows that false tripping had occurred most of time which affect reliability of protection system of eastern region. He stated that bus bar protection system should not mal- operate in healthy condition as it result in huge load loss. He added that most of the spurious bus tripping incidents had been observed in Powergrid ER-1 and Powergrid ER-2 system.

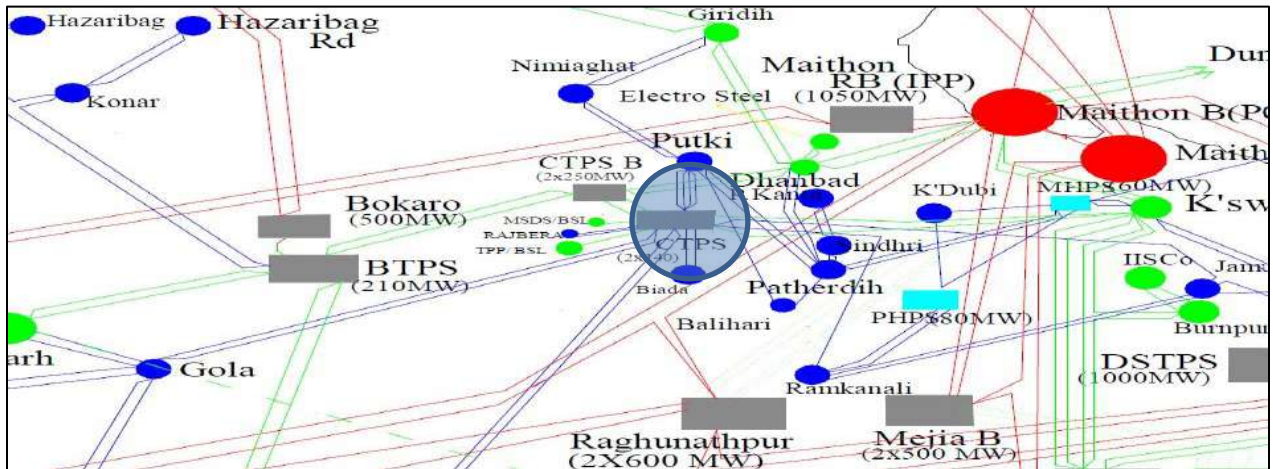
Figure 1: Network across affected area

At 11:03 Hrs, 220 kV CTPS A- Kalyaneshwari also got tripped which led to total power failure at 220 kV CTPS A S/s also.

- *Due to stuck breaker condition, broken conductor protection operated and resulted in lockout condition of relay which initiated LBB operation.*
- *LBB relay issued trip command for all elements connected to main Bus-1. But it also gave tripping command to all the elements from Main bus -2. It was later found that, ST#8 was at MB#2 but both CT switching relays of main bus-1 & main bus-2 of this bay was operated condition hence it caused tripping of all bays of main bus-2 through 96 relays.*

- After tripping of 220 kV CTPS -Kalyaneswari -2, loading for circuit-1 increased to 300 MW but after 30 seconds it reduced to 190 -200 MW. Thereafter this line also developed a R-Y phase fault which was cleared by tripping of relay from both end in 100 ms and resulted in total power failure at CTPS A.

Members of PCC opined that broken conductor protection is usually set in alarm mode instead of tripping. PCC observed that the settings adopted by DVC for broken conductor protection is quite conservative and not the usual practice as followed by other utilities. PCC advised DVC to submit the criteria/philosophy behind such setting and further advised to review the setting and the broken conductor protection may be set in alarm mode instead of issuing tripping command.

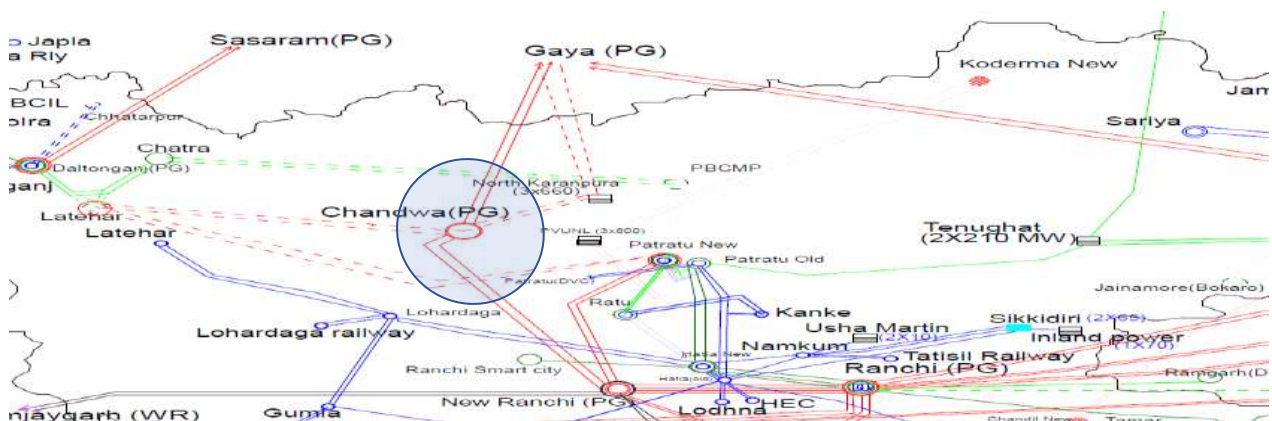
Figure 1: Network across the affected area

At 16:50 Hrs, 400 kV Bus-2 at Chandwa got tripped during testing work on 400 kV Bus-1 which was under shutdown for interconnection of existing bus with new bus. Subsequently total power failure occurred at 400 kV Chandwa S/s. DMT Scheme is present at Chandwa S/s.

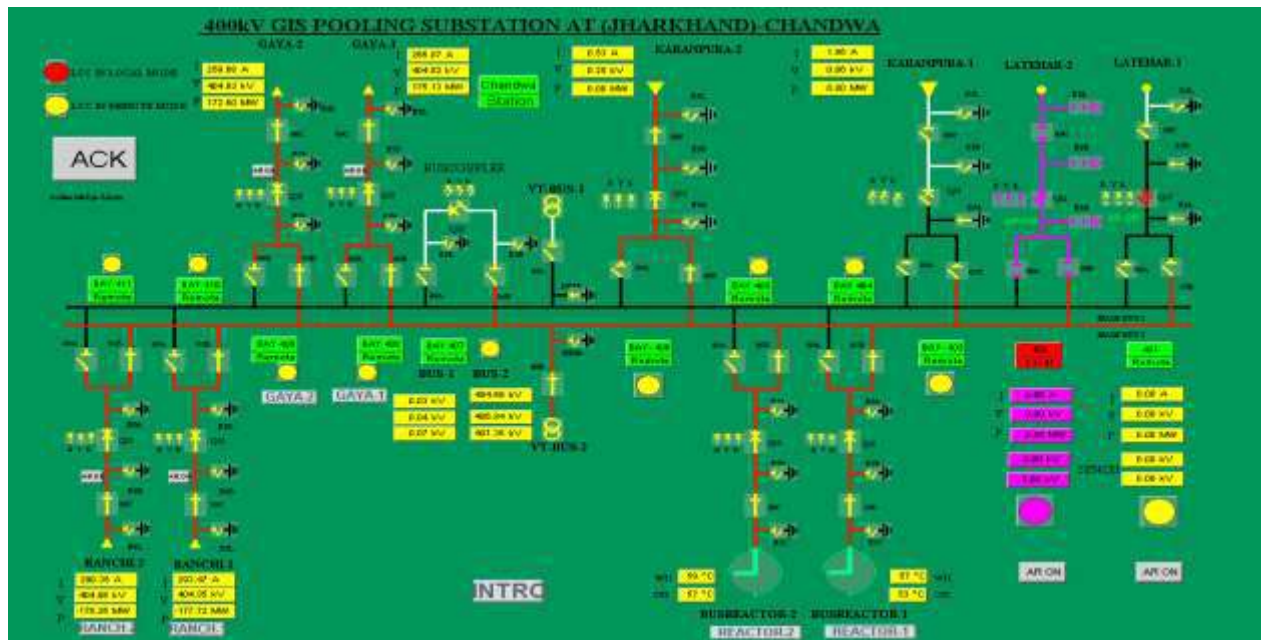
**SLD of Chandwa SS:**

Powergrid representative explained that prior to incident, 400kV Bus-1 was under shutdown for GIS bay extension works. During the process for interconnecting the GIS modules, Gas pressure in 403 Bus modules was reduced up to 0.3 MPa. Due to this reduction in pressure the Zone-A trip from M1 & M2 Busbar relay was already in operated condition since 17:09 hrs. of 16.09.2022, however as the status of all the Bus-1 isolators was open, the tripping was not extended to any feeder. On day of incident, due to disturbance in positive supply for the binary input status of isolators, its open status which was high (1) changed to low (0) in Busbar Relay. The closed status for isolators was already low (0) and hence it sensed as an intermediate status subsequently after

**REPORT ON TRIPPING OF 400 KV BUS-2 AT CHANDWA SUBSTATION ON  
DTD:19.09.2022 AT16:50HRS.**

Date	Time	Event
16.09.2022	14:39:40	S/D of 400kV Bus-1 availed
	17:08:32	40352 Gas Low Stage 1 alarm
	17:09:06	40352 Gas Compartment combined trip
	17:09:06	Zone A external trip
19.09.2022	16:50:16	Zone Interconnected alarm
	16:50:16	Busbar trip R-ph/Y-h/B-ph
	16:50:17	Primary Object status alarm for all bays

- In Busbar Relay setting the “Scheme1 RADSS” has been changed to “Scheme 2 INX” on 21.09.2022 and the isolator status for some bays was checked on sample basis and found as per the scheme.

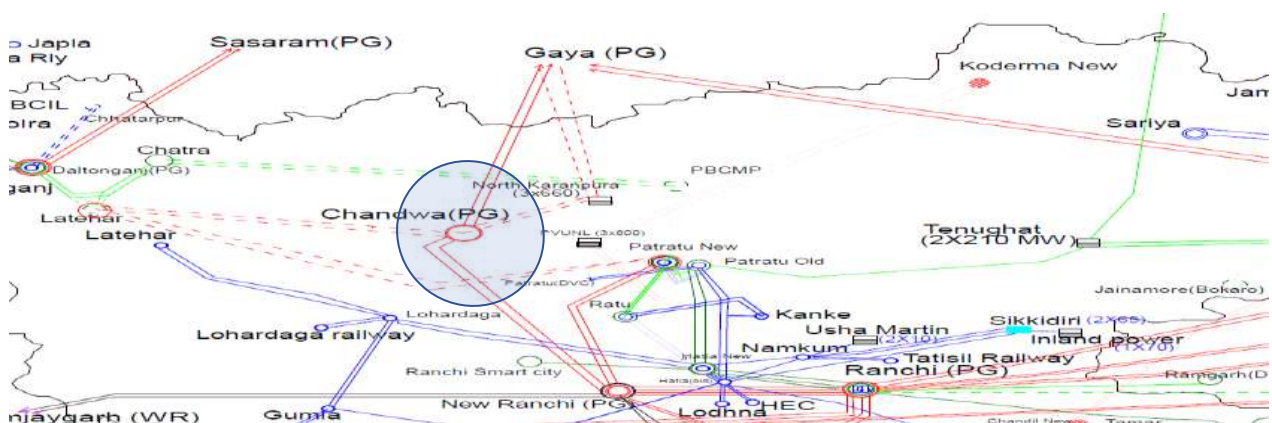
Figure 1: Network across the affected area

At 15:04 Hrs, 400 kV Bus-1 at Chandwa got tripped during testing work on 400 kV Bus-2 at Chandwa which was under shutdown for interconnection of existing bus with new bus. Subsequently total power failure occurred at 400 kV Chandwa S/s.

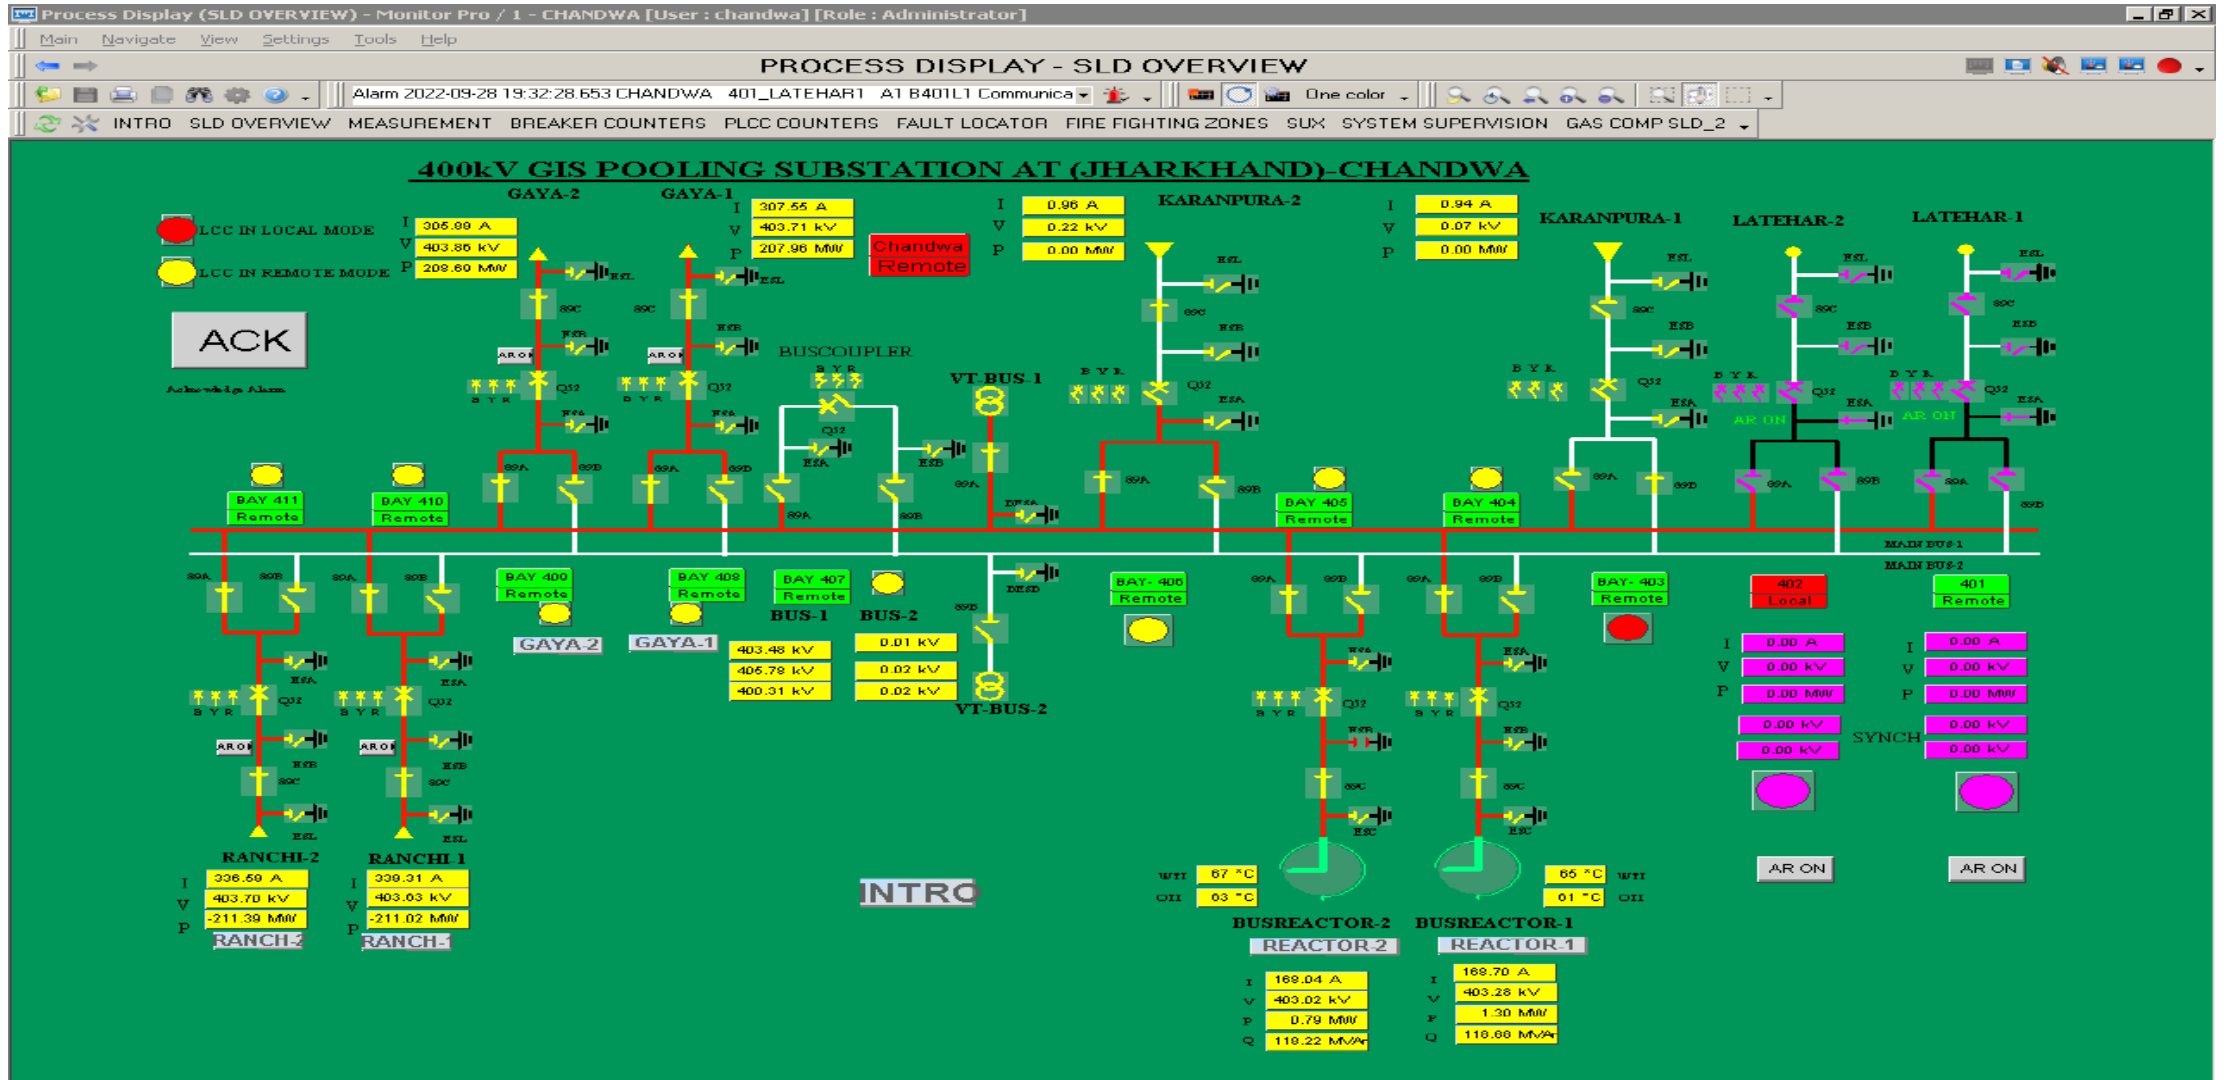
# SLD of GIS Chandwa

He added that as per investigation carried out after the incident, they found that as per approved scheme for bay extension, during gas zone tripping for 89A,89B, CTB & CB Gas zone sections initiation was extended to both Zone-I & Zone-II of Busbar protection and resulted in bus tripping.

- Main Bus-II was under shutdown for interconnection of extended bus (Bay 401 & 402 Bays) for Latehar bays.
- Tripping Date- 28.09.2022
- Tripping Time- 15:04 hr.
- Fault type- SF6 Gas Compartment Zone trip
- Cause of tripping- while Top up of gas in 402 89B, B phase GD22 section , SF6 Gas Compartment Zone trip extended and caused tripping of Bus Bar-I.

1. Main Bus I was already extended and charged on 23.09.2022 and Zone-I tripping was wired in Busbar panel from 401 & 402 bays.
2. All the bus interconnection work (including SF6 gas filling) of Main Bus II was also completed on 27.09.2022.
3. While top up of gas in 402 89B B phase GD22, the Gas zone tripping was initiated for Busbar Zone-I trip and 400 KV BUS I (in service) got tripped.
4. On investigation it has been found that as per approved scheme for bay extension during gas zone tripping for 89A,89B,CTB & CB Gas zone sections, initiation is getting extended to both Zone-I & Zone-II of Busbar protection.

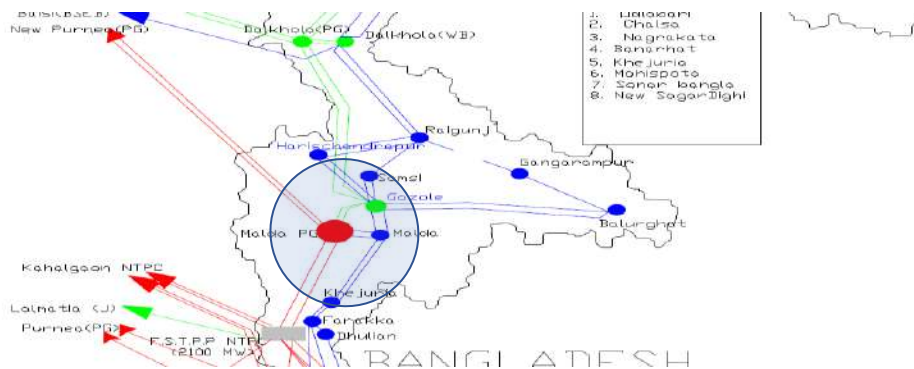
Figure 1: Network across the affected area

- 400 kV Bus-1 & 2 at Malda
- 400 kV Farakka-Malda D/c
- 400 kV Malda-new Purnea D/c
- 400/220 kV 315 MVA ICT-3 & 5 at Malda

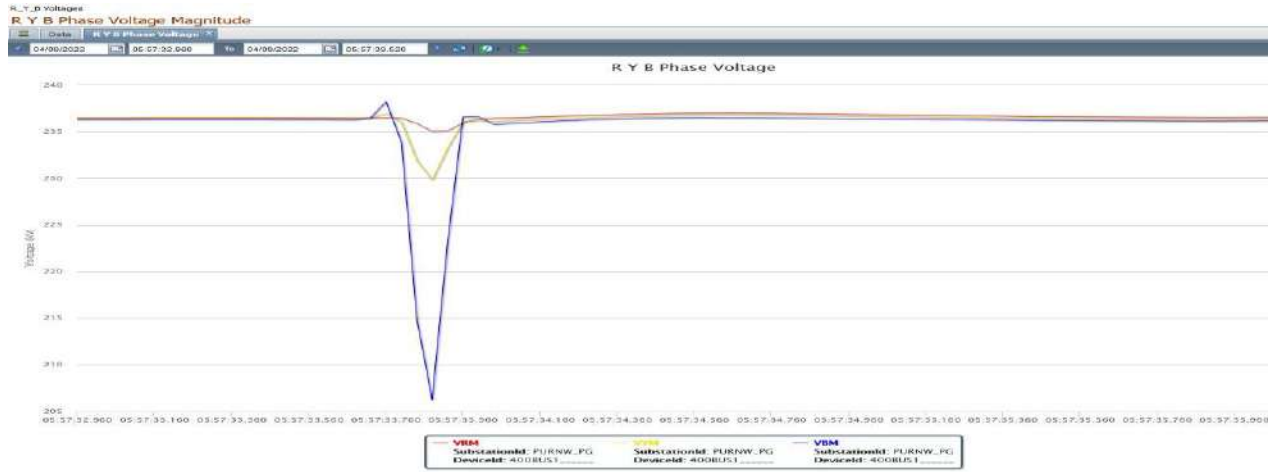
Figure 2: PMU Voltage snapshot of 400/220 kV New Purnea S/s

समय	नाम	उप केंद्र 1 रिले संकेत	उप केंद्र 2 रिले संकेत	पीएमयू पर्यवेक्षण
05:57	400 kV Bu-1 & 2 at Malda	Bus bar protection operated at Malda		30 kV dip in B_ph voltage at New Purnea. Fault Clearance Time: 100 msec
	400 kV Farakka-Malda-1			
	400 kV Farakka-Malda-2			
	400 kV Malda-New Purnea D/c			
	400/220 kV 315 MVA ICT-3 & 5 at Malda

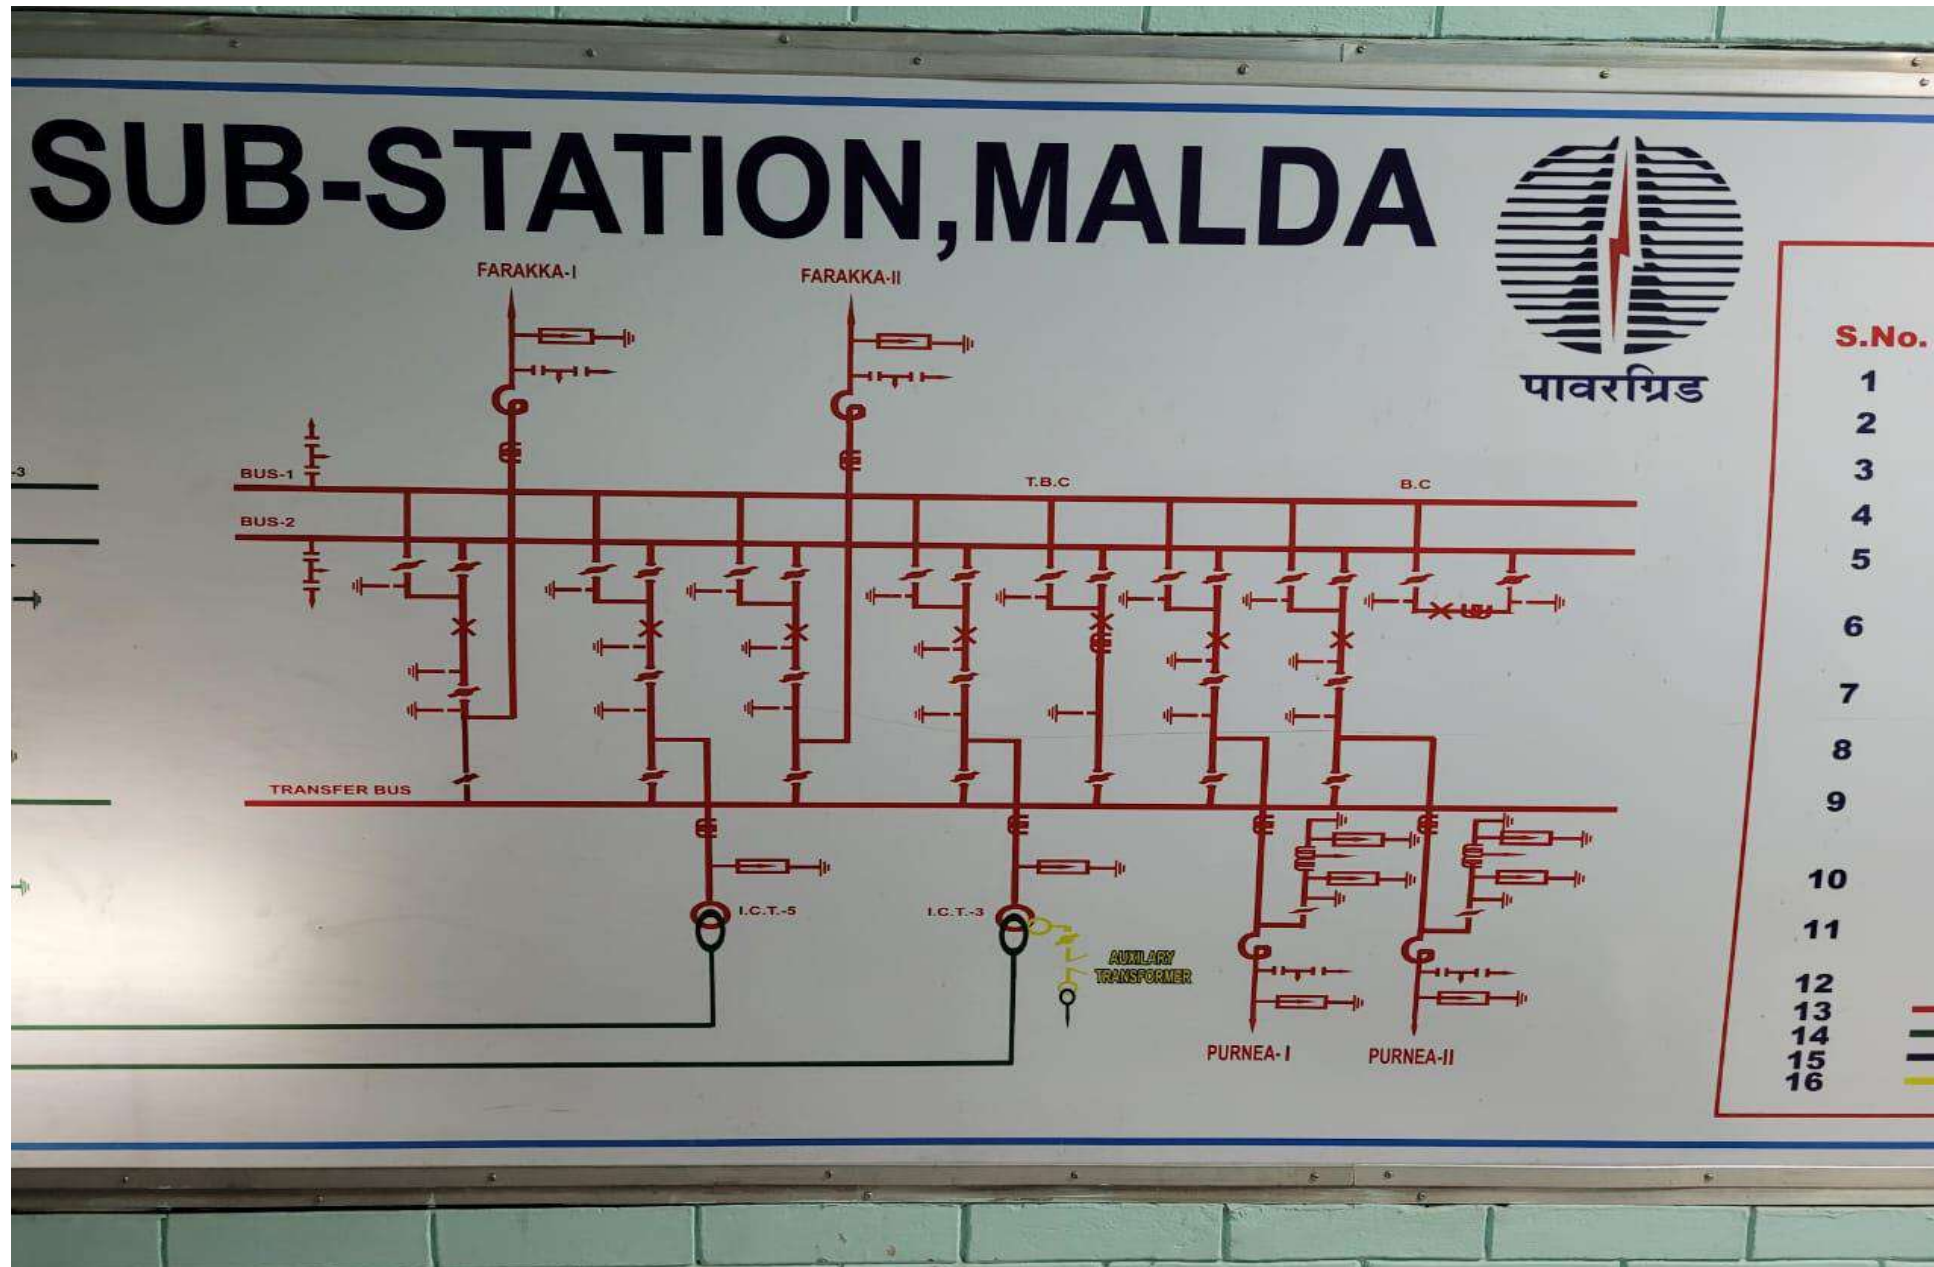
# Single line Diagram of 400 kV BUS

- Malda Substation is almost 40 years old. 400 kV Bus coupler CB and isolator and Purnea-I & II Isolators have crossed their useful life and require replacement.
- Also the control cables for bays are very old and their insulation level have degraded significantly. This causes DC earth fault in the substation.
- In both the 2022 and 2018 event DC earth fault is the primarily responsible for the mal operation. DC earth fault led to wrong status of B/C CB , consequently the bus bar protection mal operated during external fault.
- Check zone feature was disabled in REB670 relay by default. This was also one of the reason for Bus Bar mal operation.
- As many useful engineering drawing are lost during 1998 flood, therefore operation of Malda substation is very much challenging and require highly skilled manpower for its safe operation.

- The main issue observed during both the events of 2018 and 2022 was the bus coupler circuit breaker NC contact dropping. In REB 670 relay the Bus coupler (B/C) CT current is excluded from both the zones when the circuit breaker status doesn't come to the relay.

- However, during 2022 event the annunciation came just prior to the event and control person did not get adequate time to attend it.
- After investigation it was found that Check zone was also not enabled. This was not in operation since 2016 when the bus bar protection upgradation took place and in REB relay check zone by default is not enabled in setting and that's why it remained inactive.

- However, the main issue is ageing of equipment. The B/C CB condition is very much vulnerable and new CB is ready for replacement at site.
- Also Due to ageing, the condition of control and power cable of bays are very critical and prone to failure. Failure of circuit breaker status repeatedly is indicting the same. Therefore, not only the CB but also the control cable upgradation in required in long run.

- As the Bus coupler bay is very old it may be replaced at the earliest along with control cable.
- Old control cable may be replaced.

- For Bus coupler replacement both bus shut down is required due to proximity of both main buses. As the observation of the team it is found that as shut down time of individual element could be minimized opening the Bus jumpering of the end bus section where the B/C situated.
- Also the Transfer Bus coupler bay LBB relay is old electromechanical relay, which also maloperated in recent past and needs to be replace. POWERGRID expressed that relay is ready at site for installation and testing they need shut down of any one feeder for checking whether LBB can trigger other line tripping correctly or not.
