Agenda
for
120th PCC Meeting

EASTERN REGIONAL POWER COMMITTEE

AGENDA FOR 120th PROTECTION COORDINATION SUB-COMMITTEE MEETING TO BE HELD ON 16.11.2022 AT 10:30 HOURS THROUGH MS TEAMS ONLINE MEETING PLATFORM

ITEM NO. B.1: Repeated Disturbance at 220 kV Chatra(JUSNL) S/s

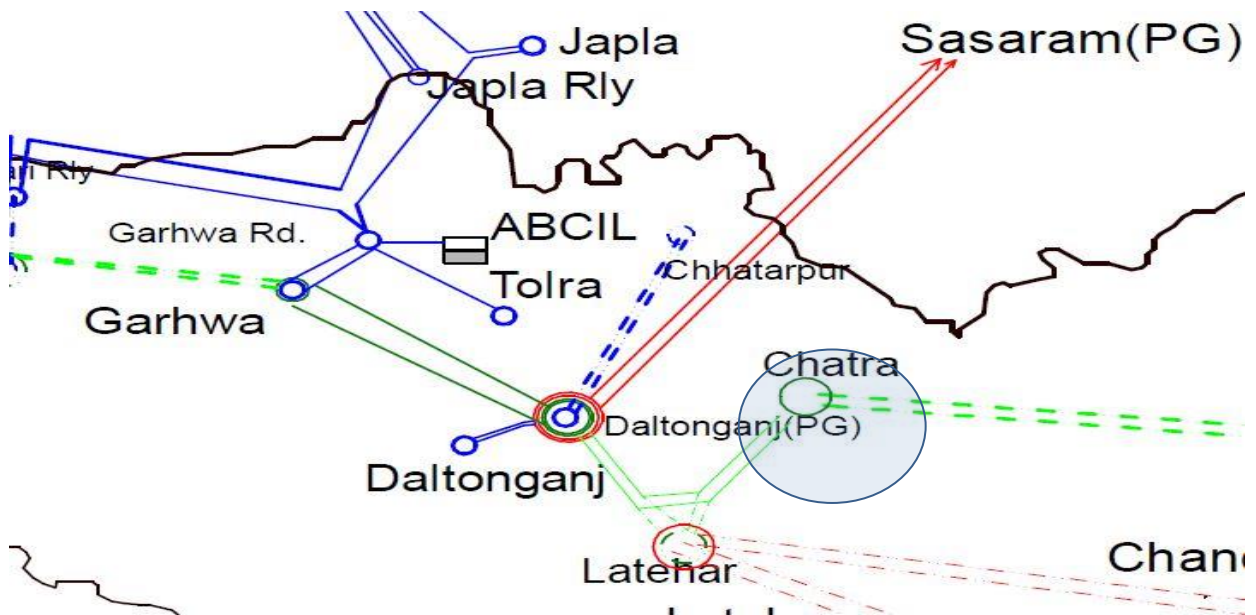
Figure 4: Network across the affected area

Event 3: At 15:09 Hrs on 19.10.2022, 220 kV Daltonganj-Chatra-tripped due to Y_N fault. Total power failed at Chatra S/s as it is being fed radially through only one circuit. 220 kV Daltonganj-Chatra-2 is LILoed at Latehar, however, 220 kV Latehar-Chatra is not charged yet. 10 MW load loss reported at Chatra by Jharkhand SLDC.

- In 1st and 2nd event, A/r was successful from Daltonganj only. Issue of Non-A/r at Chatra end has been flagged multiple times. JUSNL may update.
- In 3rd event, fault was cleared from Daltonganj in Zone-2 time, suggesting failure of carrier protection. JUSNL may explain.
- Both LILO portions of 220 kV Daltonganj-Chatra-2 at Latehar has not been charged yet, hence affecting reliability of power supply at Chatra. JUSNL to explain the reason for delay in charging of the line.
