# Agenda for 121<sup>st</sup> PCC Meeting

**Date:16/12/2022**  
**Eastern Regional Power Committee**  
**14, Golf Club Road, Tollygunge**  
**Kolkata: 700 033**

**AGENDA FOR 121<sup>st</sup> PROTECTION COORDINATION SUB-COMMITTEE MEETING TO  
BE HELD ON 16.12.2022 AT 10:30 HOURS THROUGH MS TEAMS ONLINE  
MEETING PLATFORM**

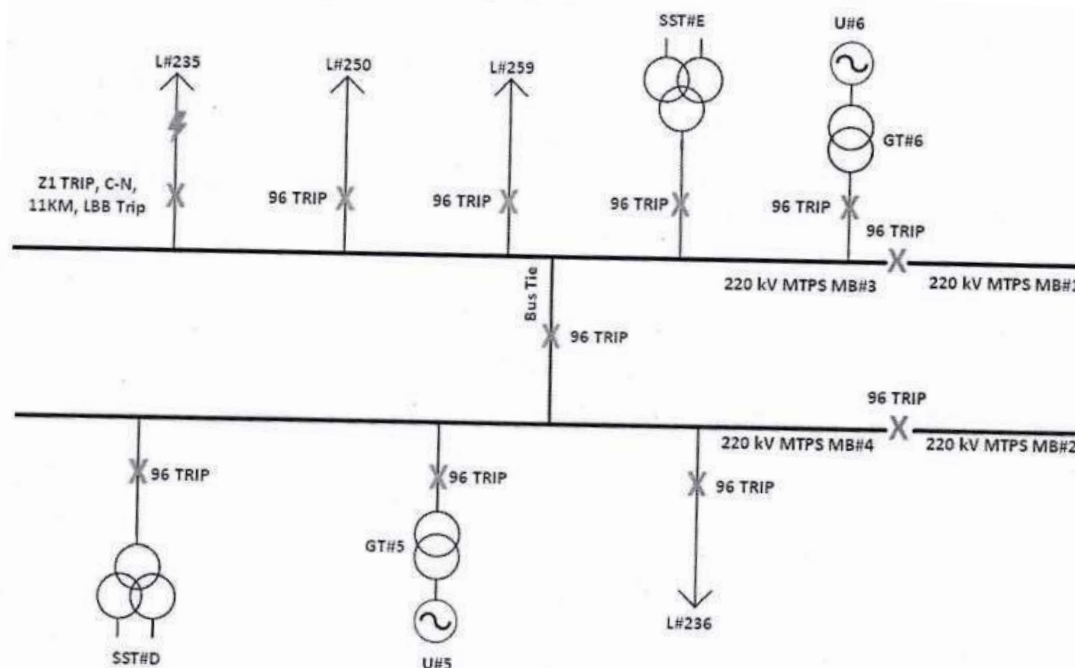
220 kV Mejia-Durgapur (DVC) tripped around 10:40 hrs. from both end due to B phase fault. At the same time due to maloperation of LBB relay of the above line bay at MTPS end, all elements connected to 220 kV Bus-3 also tripped. Further due to defective CT switching relay of SST #D bay, trip command was extended to the elements connected to 220 kV Bus-4 and tripped the connected elements.

- A single-phase fault (B-Earth) struck 220 kV Mejia-Durgapur-1 at 11 km from Mejia which was cleared within 100 msec. However, LBB of this CB operated immediately leading to tripping of all elements connected to 220 kV Bus-3. As reported, LBB relay was found faulty.

- As reported, CT switching relay of 220 kV Bus coupler was also found faulty.
- Detailed report received from DVC is attached at **Annexure-3**.
