Eastern Regional Power Committee

Sub: Minutes of the 127th PCC meeting held on 22.06.2023

Minutes of 127th PCC Meeting

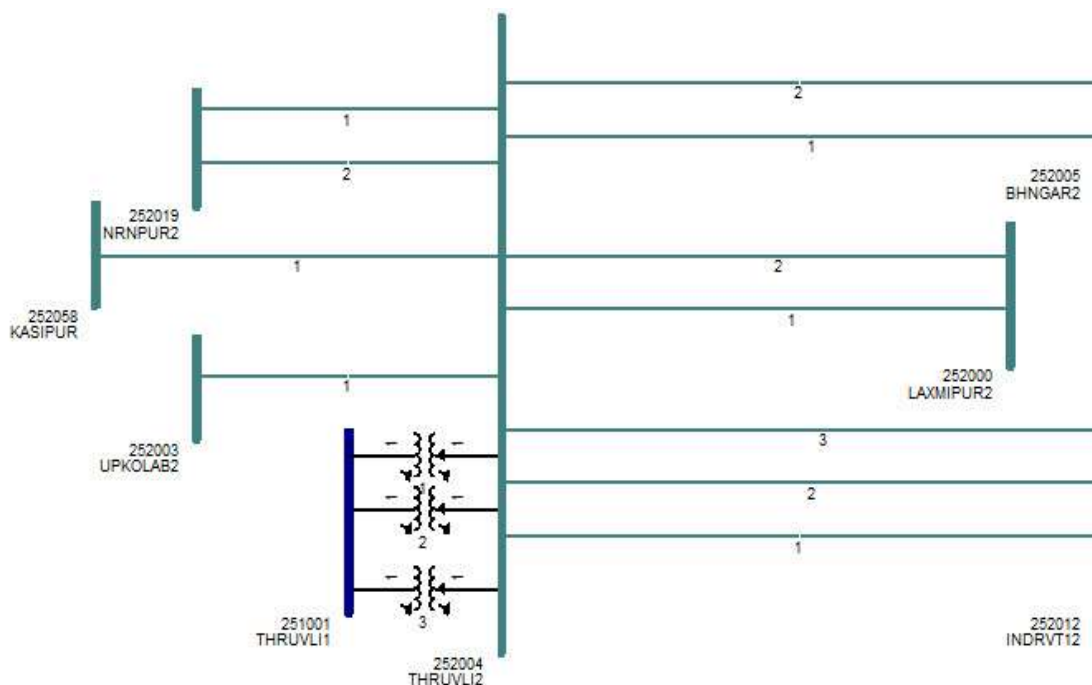
As reported, the fault was created due to snapping of OPGW wire of 220 V Therubali-Lakshmipur-2 line between location no. 1209 & 1210. The fault was not cleared from Therubali end which led to tripping of all associated feeders at Therubali. Subsequently total power failure occurred at 220kV Therubali, 220kV Kasipur & 220kV Jaypatna sub-stations in south Odisha.

He informed that, OPGW wire of 220 kV Therubali-Laxmipur-2 snapped between location no. 1209 & 1210 which resulted in fault and subsequent disturbance at Therubali S/s. The fault was not cleared from Therubali end subsequently all associated feeders at Therubali end tripped and total power failure occurred at 220kV Therubali, 220kV Kasipur & 220kV Jaypatna sub-stations in south Odisha.

Main and tie CB of 220 kV Therubali-Laxmipur-2 at Therubali end did not operate during the fault in the line. On detailed investigation it was found that spring charge indication bulb terminal got shorted in the main CB which caused fuse blown of control circuit in CR panel and resulted in failure of DC supply to the panel. This ultimately led to non-operation of breaker. OPTCL representative explained that as the fault current feed by individual 220kV feeders i.e Upper Kolab/Indravati 1,2 3& 4/Bhanjanagar 1&2/ Narendrapur 1 &2 is very less, so fault continued upto 70 sec due to delay in fault clearance from ends.

PCC observed that as the substation is quite old(more than 40 years), renovation and upgradation of the control and protection system should be taken up on priority basis for reliable and secure operation of the system.

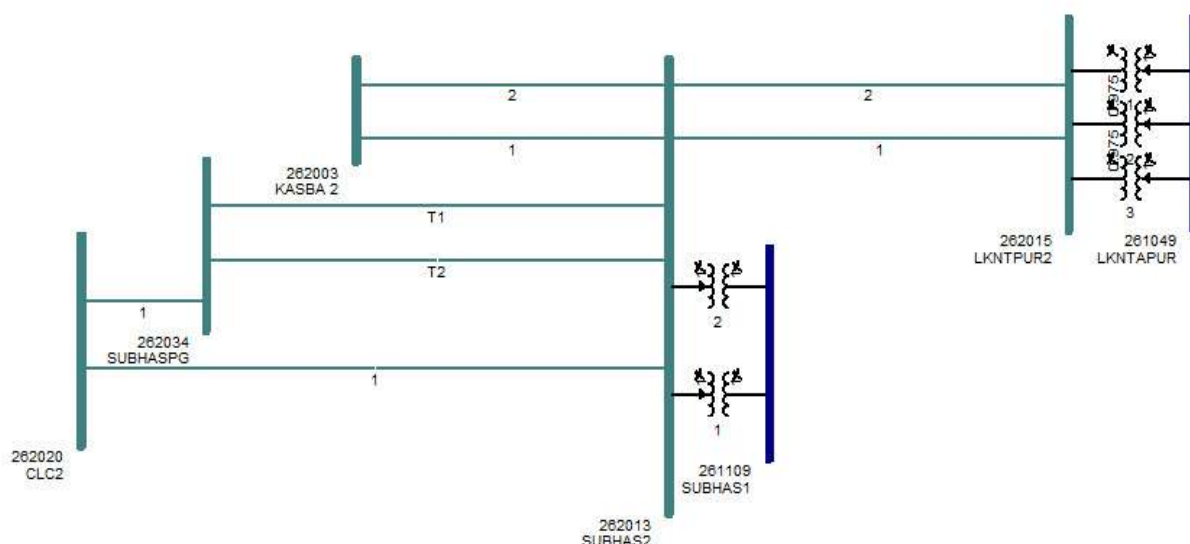
On 23rd May 2023 at 02:36 Hrs, 220 kV Subhashgram (WB)-Lakshmikantpur-2 got tripped due to Y phase fault. At the same time, 220 kV main bus-2 at Subhshgram (WB) and 220 kV Subhashgram-Lakshmikantpur-1 also got tripped leading to total power failure at Lakshmikantpur which is radially fed through 220 kV Subhshgram (WB).

WBSETCL representative intimated that the disturbance was caused due to snapping of R phase conductor of 220 kV Subhashgram-Lakshmikantpur-2 at loc. 208(at 1 km from Subhasgram end) and subsequently touched Y phase and ground. The line got tripped on Y-N fault from both end in zone 1 distance protection within 100 msec.

He added that at the same time snapped conductor of circuit 2 touched circuit 1 due to which 220 kV Subhashgram-Lakshmikantpur-1 also got tripped within 100 msec from both ends with relay indication of R_N fault. This led to total supply failure at Lakshmikantpur S/s and downstream areas.

He informed that during the incident 220 kV Bus-2 at Subhashgram (WB) also tripped on operation of Bus bar differential protection. Thorough testing was done for this unwanted busbar operation and it was found that the differential relay was operating for much lower current than the set value suggesting mal operation during close in faults.

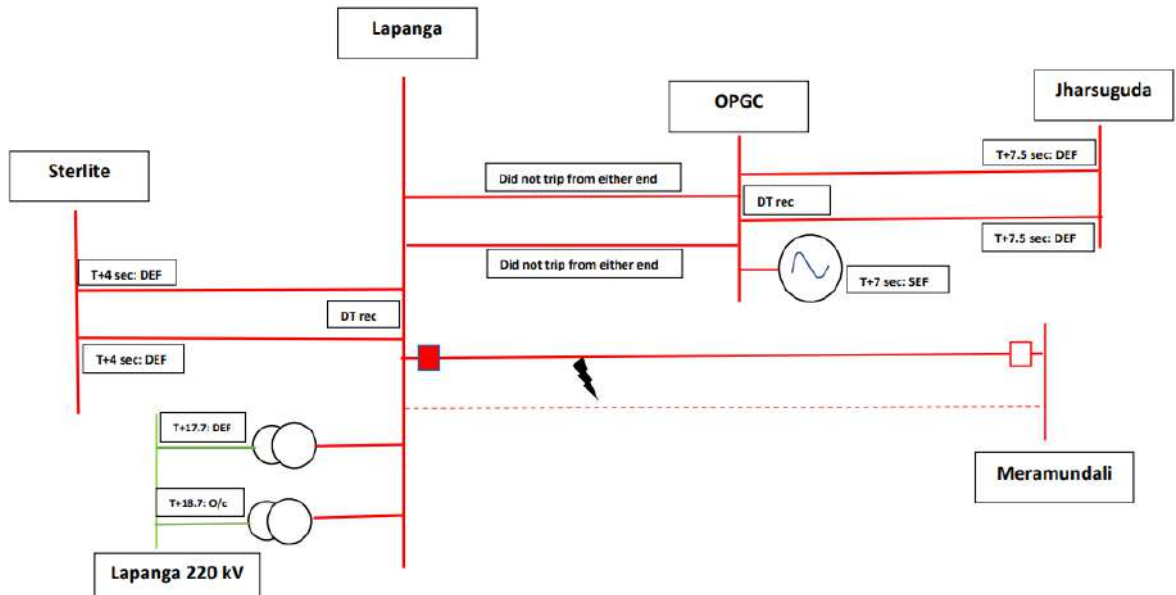
Disturbance at Lapanga, OPGC at 17:27 hrs on 10.06.2023

- *Due to due to bad weather conditions and localized storm, tower collapse occurred for 400 kV Meramundali-Lapanga D/C line at 16:21 hrs.*
- *At 17:26 Hrs, while charging attempt was made for 400 kV Meramundali-Lapanga-1 from Meramundali end, line got tripped in distance protection instead of SOTF protection. Subsequently after 1 minute charging attempt was again done from Lapanga end however line tripped after persistence of fault for 17-18 second.*
- *As fault was persisted for 17-18 seconds, other feeders also at 400 kV Lapanga S/s got tripped which led to total power failure at 400 kV Lapanga and OPGC S/s.*

ERLDC representative enquired OPTCL about reason for taking charging attempt of line from Lapanga end even after failed attempt from Meramundali end to which OPTCL representative informed that due to communication gap between the two S/s, charging attempt was repeated for line.

It was observed that instead of sufficient fault current, neither distance protection nor DEF operated for 400 kV Meramundali-Lapanga-1 at Lapanga end due to which fault got persisted for 17-18 seconds and led to tripping of other feeders from remote end.

GT of unit 4 at OPGC tripped in SEF protection in T+7 second. Further due to non- tripping of 400 kV OPGC -Lapanga-d/c from both ends, 400 kV OPGC – Jharsuguda d/c tripped in DEF from Jharsuguda end in T+7.5 second with DT sent to OPGC end. This led to total power failure at 400 kV OPGC S/s.

PCC advised SLDC Odisha to ensure proper coordination between substations during charging of the line and advised OPTCL to sensitize the substation personnel for adhering the standard procedure during the charging of the line. This would avoid unwanted tripping and disturbance in the system which may affect reliability and security of the grid.

PCC advised OPTCL for root cause analysis of the event and a report along with DR/EL shall be submitted to ERPC/ERLDC. The issue would be discussed in next PCC Meeting.

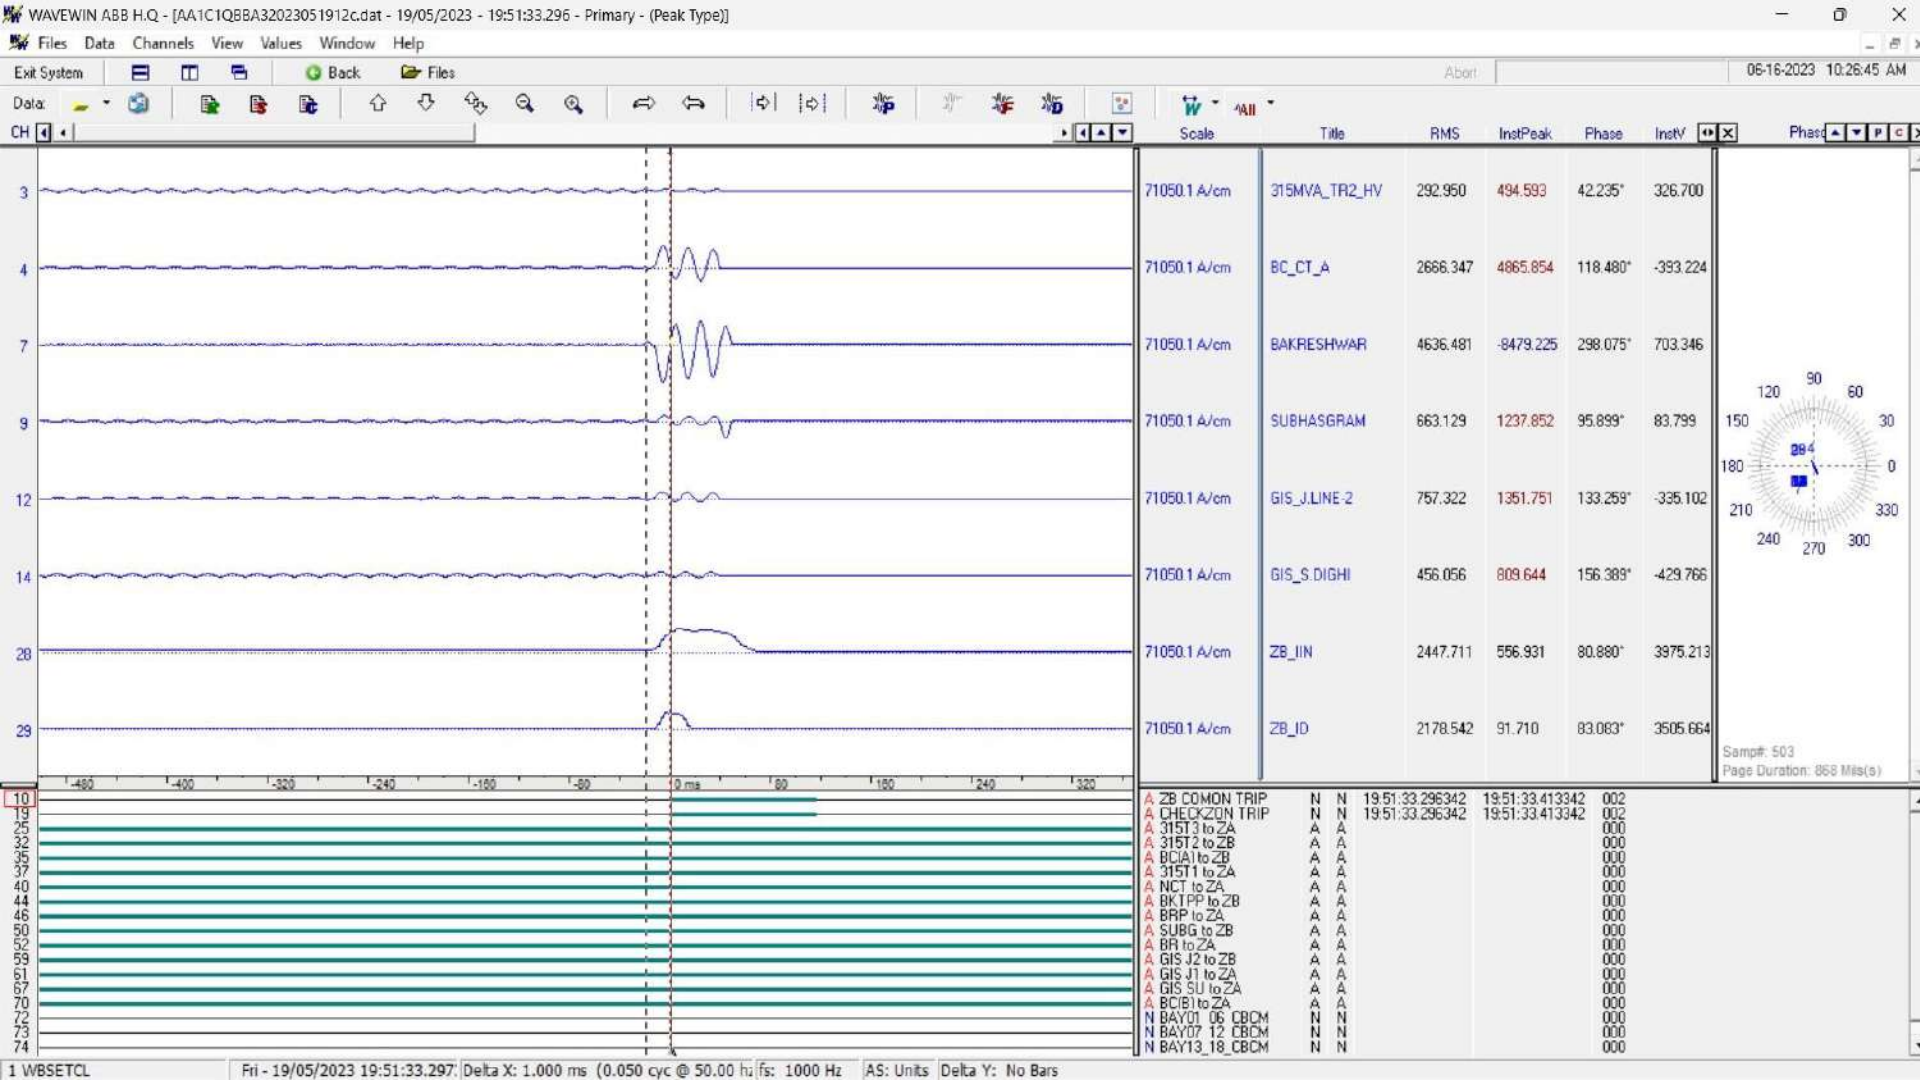
DATE OF INCIDENT 19/05/2023 TIME 18:51 HRS

- ▣ Place-Jeerat 400 KV Substation.
- ▣ Date-19/05/2023
- ▣ Time 18:51 hrs
- ▣ Incident-During charging of faulty BKTPP 400 KV line,400 KV bus 2 tripped on Busbar Differential Protection.
- ▣ Relay-ABB REB670.

Reason for Busbar tripping

- CB open status stays during charging of BKTPP bay.
- CB close command did not come.
- As per relay configuration , current fed by BKTPP bay during charging(4.6 KA) could not be counted to BUS B.

Corrective measures taken

- ▣ CB close command was checked and it was found CB discrepancy switch Close Contact for Busbar relay was found faulty.
- ▣ CB Discrepancy switch will be replaced upon getting shutdown.

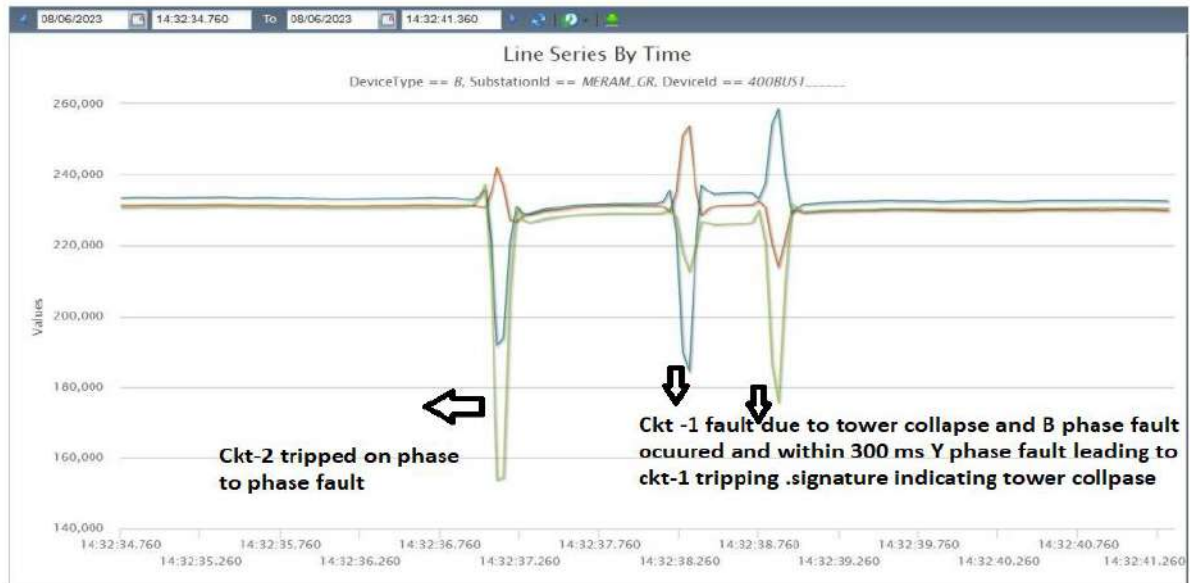
Event 1(8th June at 14:32 Hours):-

- 400 kV Meramandali-New Duburi D/C tripped at 14:32 hrs of 08.06.2023 due to inclement weather. Tower collapse reported at location number 131 approximately 31 Kms from Meramandali.
- PMU plot attached also shows the Signature of tower collapse

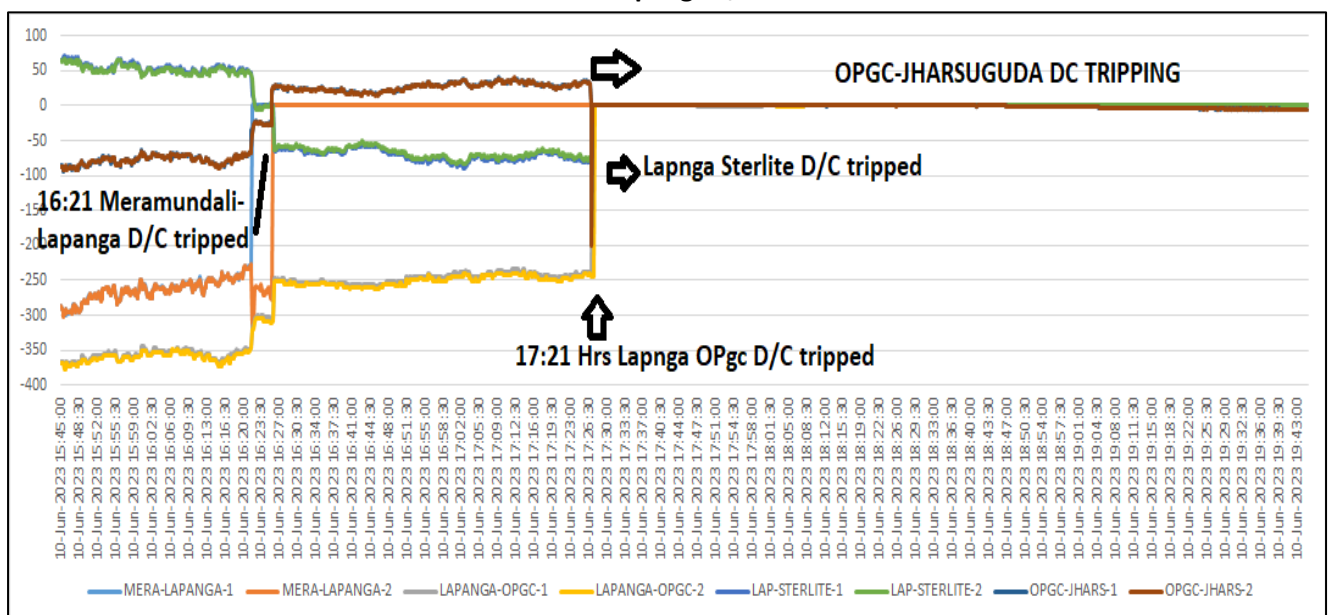
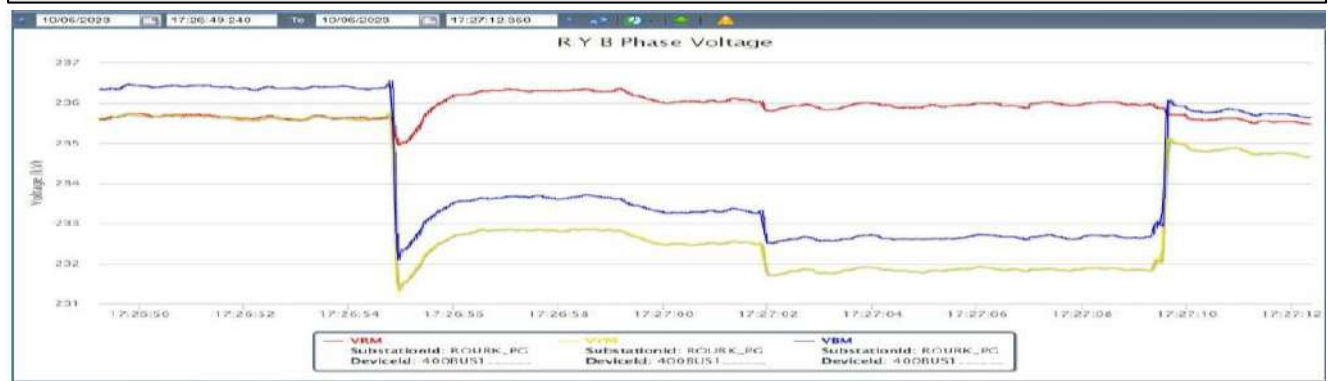
Event 3(10th June at 17:27 Hrs) :-

Further at 17:27 Hrs, while charging 400 kV Meramundali-Lapanga-1, fault persisted for 11 sec seems protection did not operated properly which led to tripping of all lines from Lapanga and disturbance occurred at 400 kV OPGC and 400 kV Lapanga S/s.

Lapanga and OPGC became dead with above tripping.

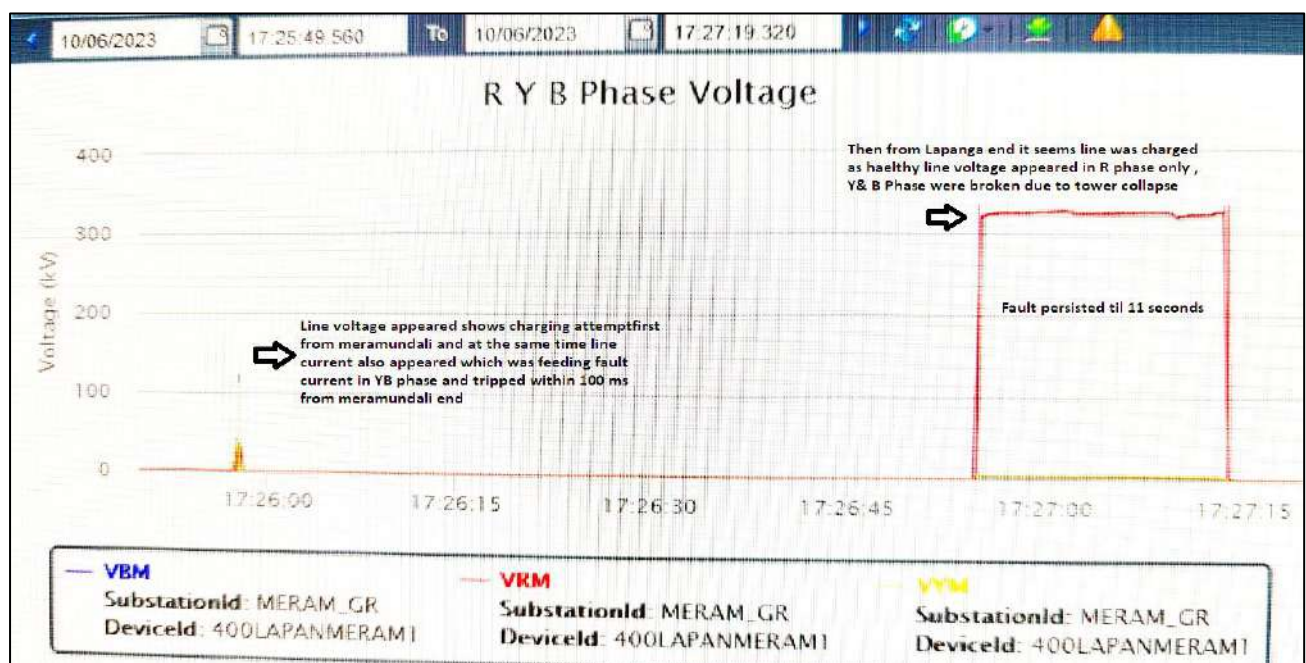
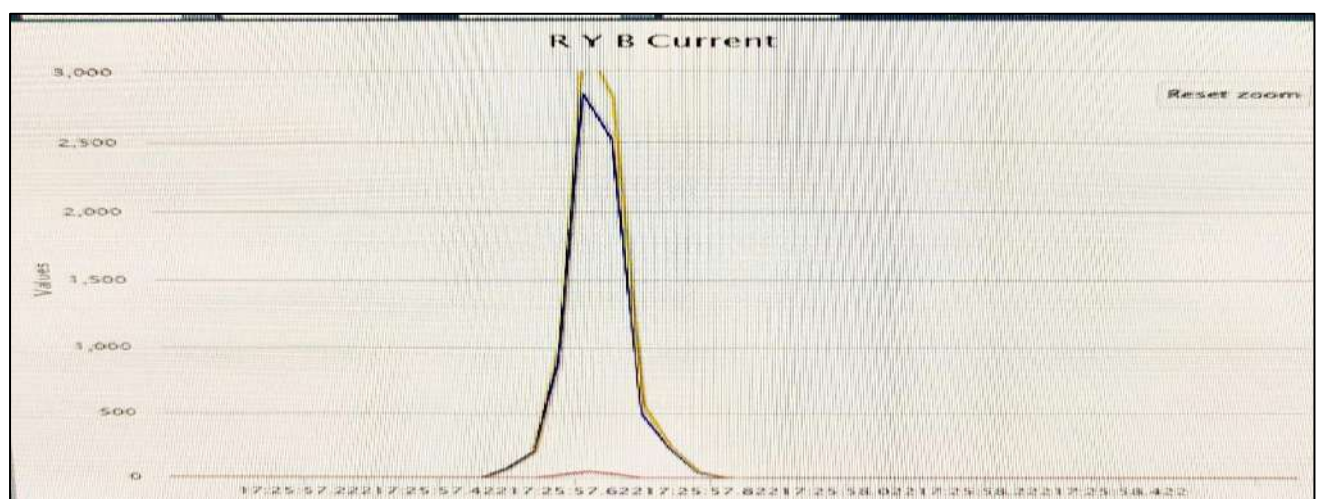
- It appears first line was charged from Meramundali end but line did not hold protection operated perfectly and fault was isolated but later after 1 minute it was again charged from lapanga end and fault persisted till 11 seconds as protection did not operated .
- Below is the Line voltage & current plot at Meramundali end:
- Line voltage appeared shows charging attempt first from meramundali and at the same time line current also appeared which was feeding fault current in YB phase and tripped within 100 ms from meramundali end.
- Then after 1 minute at 17:27 Hrs from lapanga end line was charged as healthy R phase line voltage appeared as Y&B Phase were already broken due to tower collapse and may be only R phase was through. At this instant line current at Meramundali end was zero also indicating charging was done from lapnga .
