भारत सरकार
Government of India
विद्युत मंत्रालय
Ministry of Power
पूर्वी क्षेत्रीय विद्युत समिति
Eastern Regional Power Committee
14, गोल्फ क्लब रोड, टालीगंज, कोलकाता-700033
14 Golf Club Road, Tollygunj, Kolkata-700033

Sub: Minutes of the 147th PCC meeting held on 28.05.2025

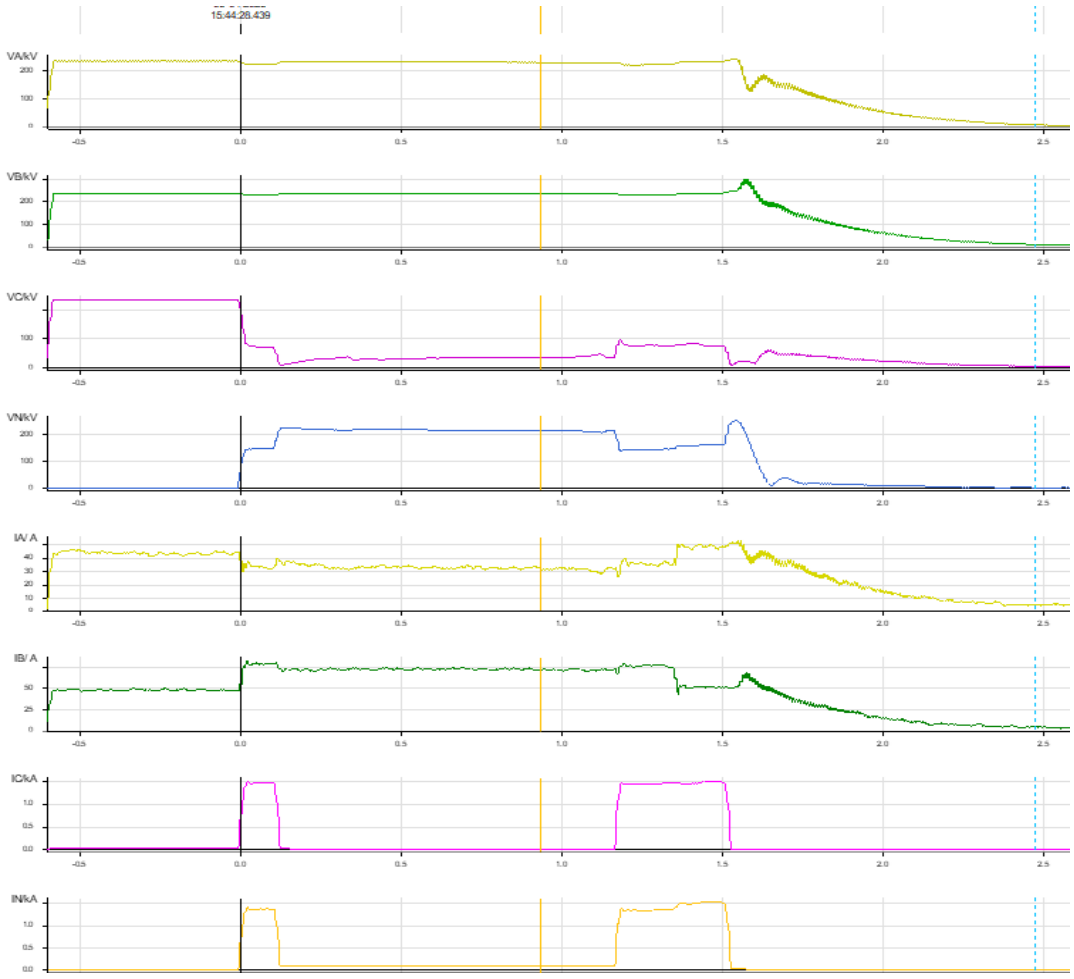
Figure 2: DR of 400kV Tenughat-PVUNL at Tenughat

- Prior to the event PVUNL drawing 4 MW start power radially from Tenughat.
- As per information received from Tenughat, at 14:45 Hrs on 05/04/2025, 400 kV Tenuhat-PVUNL tripped due Overvoltage stage-1 protection from Tenughat end but as per DR and PMU R-phase to ground fault occurred and A/r attempted but after 350 msec, line tripped on Z-2 protection form Tenughat end.
- At the A/R instance from Tenughat it tripped after zone-2 time as no carrier received from Patratu end because Patratu is radial and no sources is there.

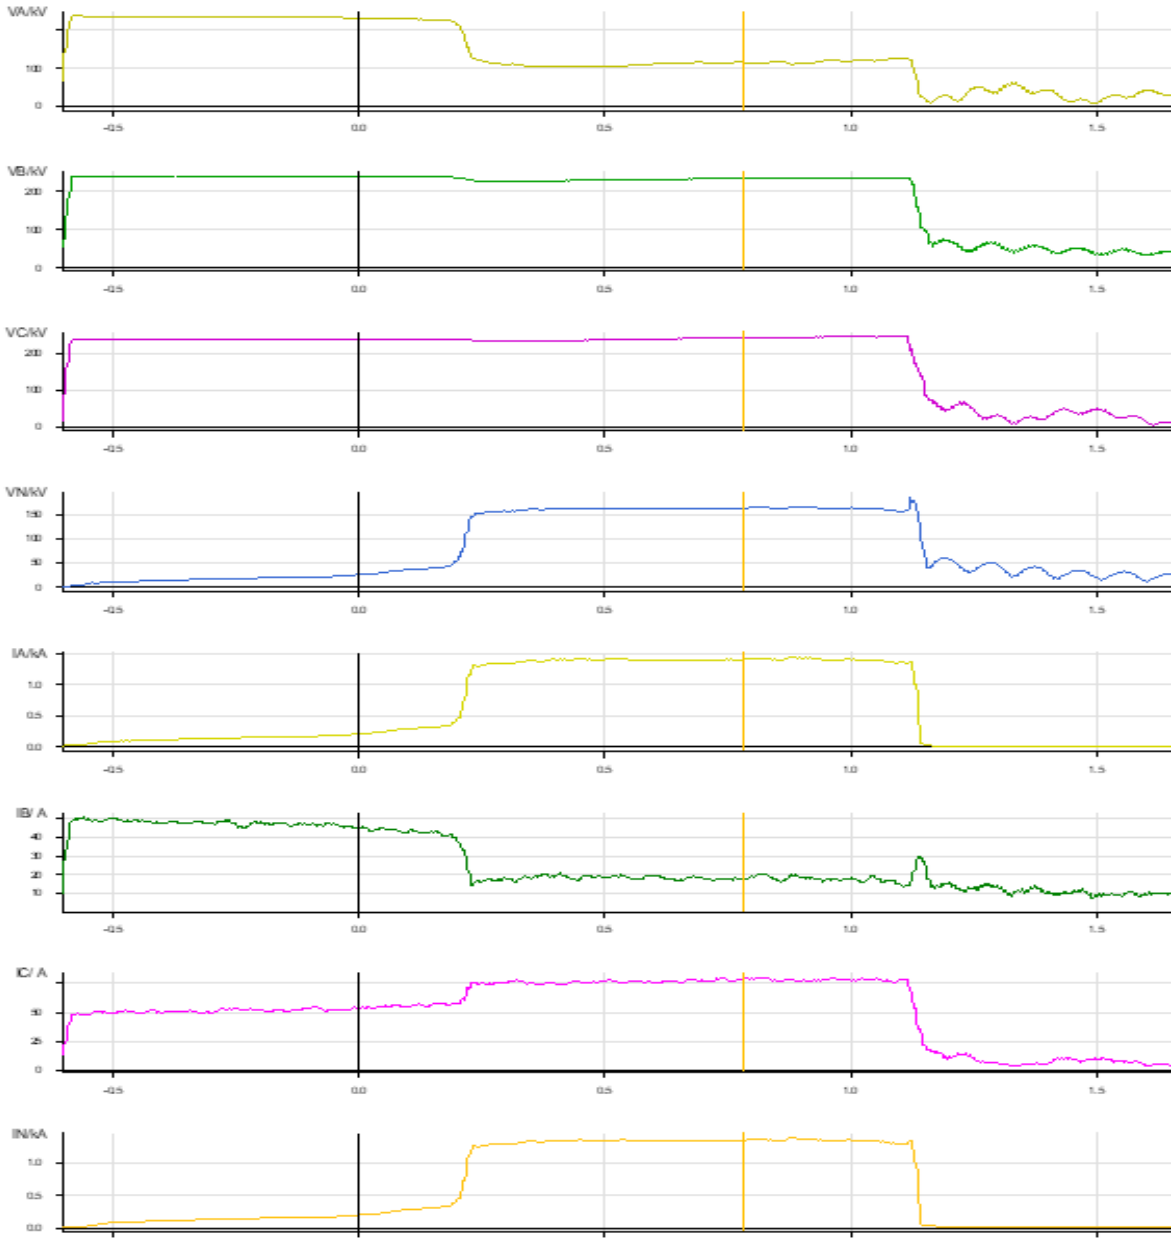
Figure 4: DR of 400kV Tenughat-PVUNL at Tenughat

- Prior to the event PVUNL drawing 4 MW start power radially from Tenughat.
- At 15:45 Hrs on 10/04/2025, R- phase to ground fault occurred and fault sensed in Z-3 protection and after 1 sec line got tripped.
- As PVUNL drawing start power radially from Tenughat end.
- 400kV PVUNL became dead, and 4 MW load loss occurred.

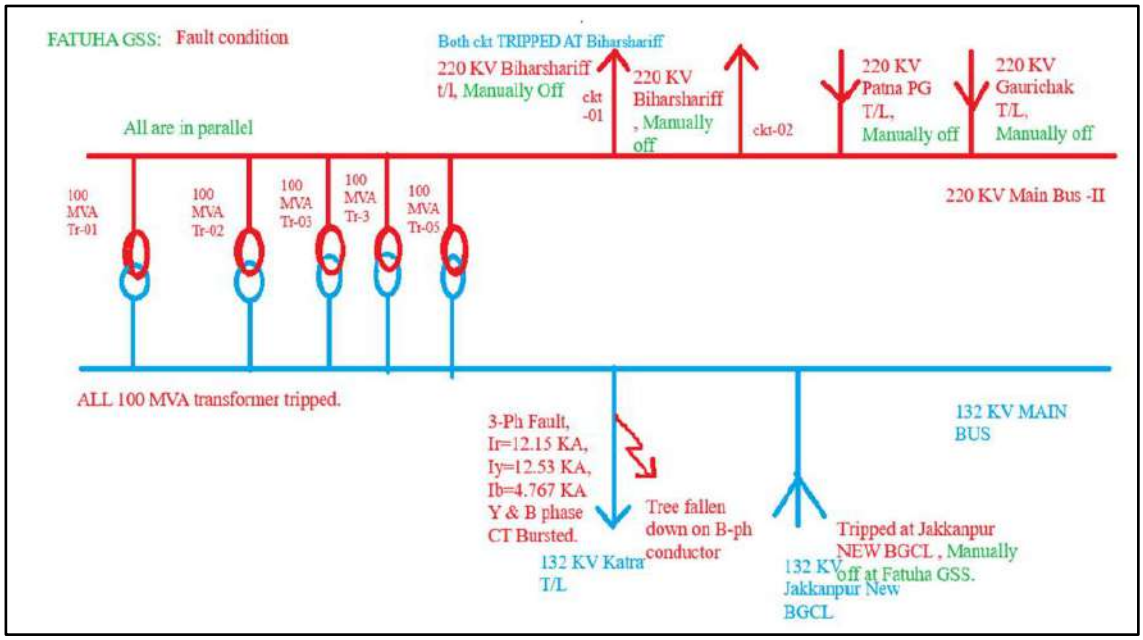
Figure 2: SLD of Fatuha S/s

On 9th April 2025 at 16:05 Hrs, 132 KV Fatuha-Katra got tripped on B phase fault. While charging attempt of said line at 16:20 Hrs, line didn't hold and 132 KV Y-ph and B-ph CT at Fatuha GSS got brust and fire was observed in control cable of 220/132kV ICTs 1 & 2. Further,220/132kV ICTs at Fatuha got tripped and later all emanating lines from Fatuha were hand tripped for safety purpose. Thus, 220/132kV Fatuha S/s became dead.

On enquiry from ERPC representative regarding reason behind failure of CT, BSPTCL representative replied that CT was quite old (Year of manufacture- 2009) and fault current was very high during the disturbance hence it got failed. He further added that CT was completely destroyed hence it is not possible to do detailed investigation behind its failure.

- At 16:05 Hrs 132 KV Fatuha-Katra T/L tripped on B_N fault. (As reported tree fell on C-phase conductor near tower location number 24-25 from Fatuha S/s).
- At 16:20 Hrs charging attempt of 132 KV Fatuha-Katra line was taken and line didn't hold due to persistent 3 phase fault and Y & B phase CT burst at Fatuha S/s.
- Due to CT bursting all 220/132kV ICTs tripped on master trip.
- 132kV Jakkanpur circuit tripped from remote end in Z-2 protection.
- 220kV Biharsariff D/C tripped on backup over current from remote end.
- Due to CT bursting fire was observed in control cable of 100 MVA ICT#1 & 2 and all emanating line from Fatuha end hand tripped for safety purpose.
- 220kV Fatuha S/s became dead.
- Total load loss of 100 MW occurred at Fatuha S/s
- Power was restored at 16:45 Hrs by extending power from 220 KV Fatuha Sipara line.

- It is requested to review over current setting in your jurisdiction to avoid such type of unwanted tripping. Action in this regard to be taken for all substation and adherence to **CEA protections standards** to be ensured**. If Overcurrent to be enabled, it has to be kept in AND logic with VT fuse failure and Pickup to be at least 120% of Thermal Rating.**
- **Root Cause analysis for CT blast to be done and to be reported to RLDC/RPC and CEA.**

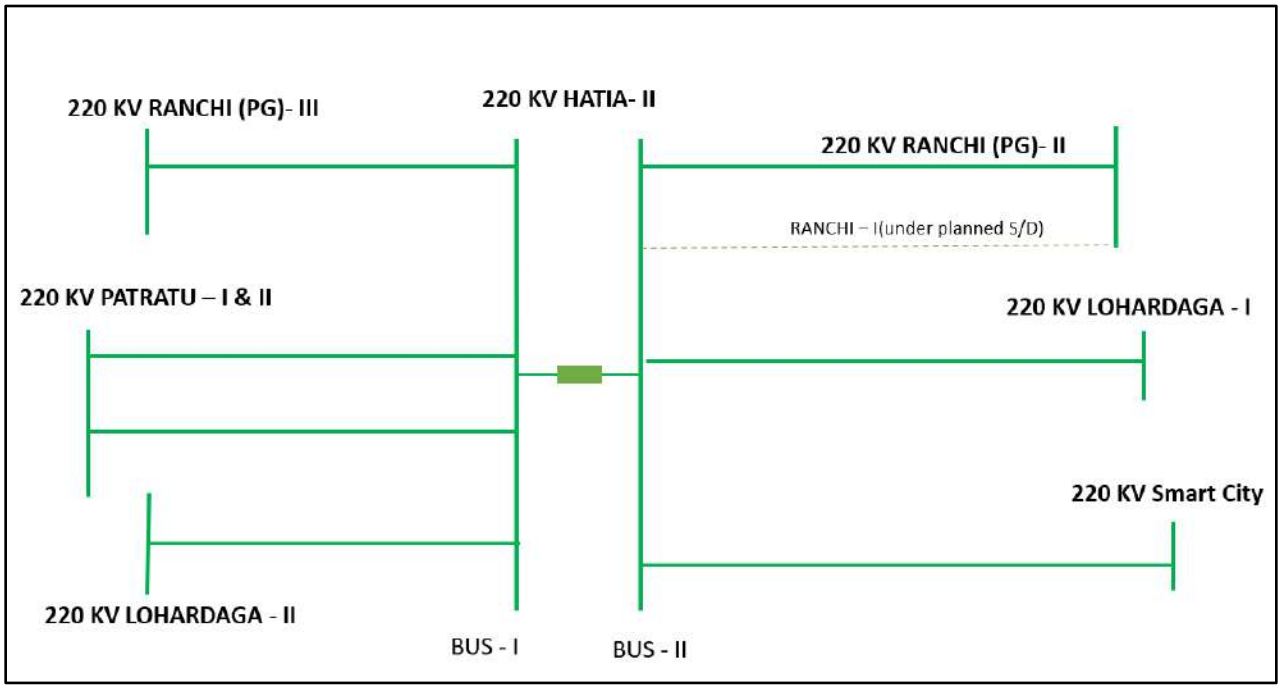
Figure-2: Single Line Diagram of Hatia S/s

- Prior to disturbance 220kV Hatia-Ranchi #1 was under planned S/D.
- At 18:36 Hrs R-Earth fault occurred in 220kV Hatia-Lohardaga #2 which was idle changed from Hatia end.
- This fault sensed by Hatia in reverse zone-4 protection instead of forward zone-1 protection **due to reverse polarity of CT at Hatia end**.

- 220kV Hatia-Patratu D/C and Ranchi #2 & 3 tripped on Z-2 protection from remote end.
- 220kV Hatia-Patratu D/C, Lohardaga #2 and Ranchi #3 tripped on Z-4 protection from Hatia end.
- Bus coupler tripped in Z-4 protection after 500 msec.
- Bus bar was unhealthy due to improper isolator status.
- After tripping of bus coupler fault in Lohardaga line cleared and 220kV bus#2 connected through 132kV system.
- 220kV Hatia-Smart City, Lohardaga #1 and Ranchi #2 which was connected to 220kV bus#2, tripped on over voltage protection from Hatia end.
- All emanating lines from Hatia tripped and 220kV Hatia S/s became dead.
- Total load loss of 150 MW occurred at Hatia and.

- CT polarity of 220 kV Hatia II – Lohardaga – II feeder for both Main – 1 & 2 core was found reverse. This has been rectified on 17.04.2025.

The setting of these feeders were revised as per idle charge (no load) condition on 16.04.2025.

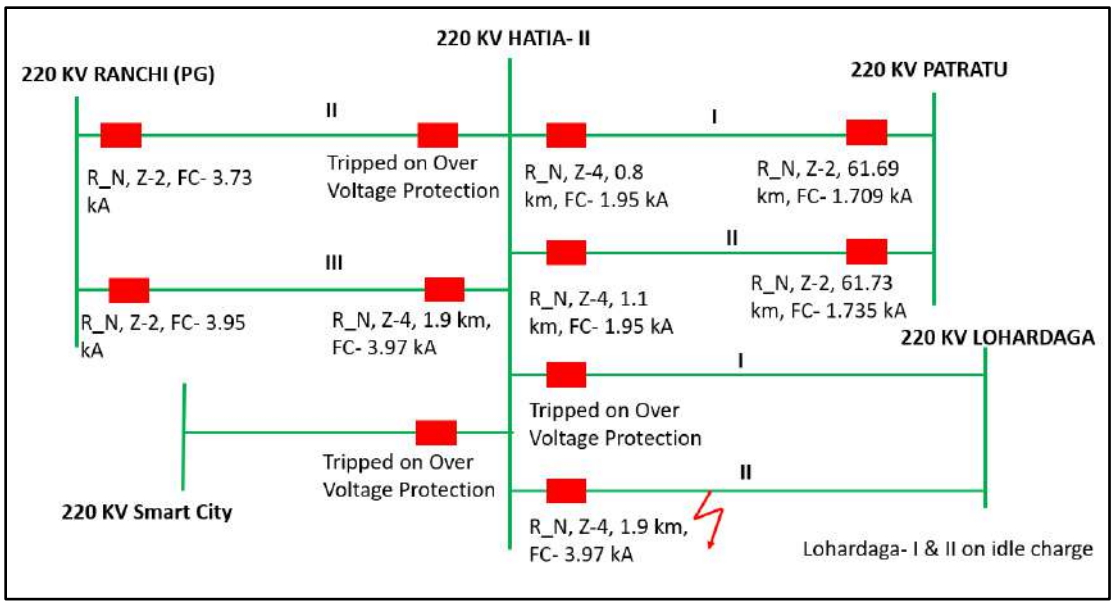
Figure-4: SLD of Hatia with tripping details

Prior to the disturbance 220kV Hatia-Ranchi-2 was under plan shutdown. On 15th April 2025 at 18:36 Hrs R phase fault occurred in 220kV-Hatia- Lohardaga -2(220kV Hatia- Lohardaga D/C were kept idle charged from Hatia end) which was sensed by Hatia end in reverse zone-4 instead of forward zone-1 due to reverse polarity of CT at Hatia end. Subsequently all emanating lines from Hatia tripped in Z-2 protection from remote end and 220kV Hatia S/s became dead.

JUSNL representative informed that bus bar protection is available however due to non-availability of isolator status in particular bay it got blocked during the incident. On investigation issues was found with auxiliary contacts of isolator.

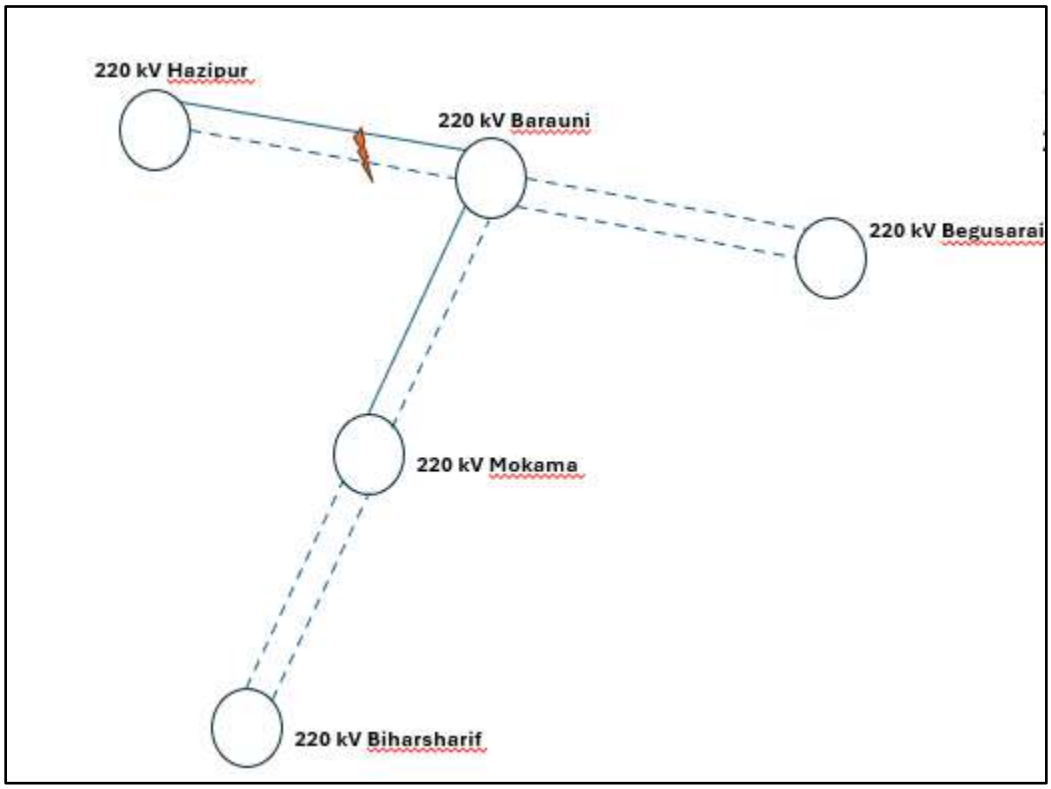
Figure-3: Event Log of Hatia-Lohardaga #2 at Hatia

- Since its breaker phases were already open, LBB protection operated after 200 msec which led to tripping of 220 KV barauni bus 2 leading to generation loss of Unit 8 and connected lines like Mokama ckt 2 and hazipur ckt 2.

- LOCAL CT earthing to be ensured for line which is under Shutdown so that for a fault in Parallel line induced current in CT should not cause LBB Operation.
- Operational SOP to be prepared for closing Biharshariff -Mokama line .

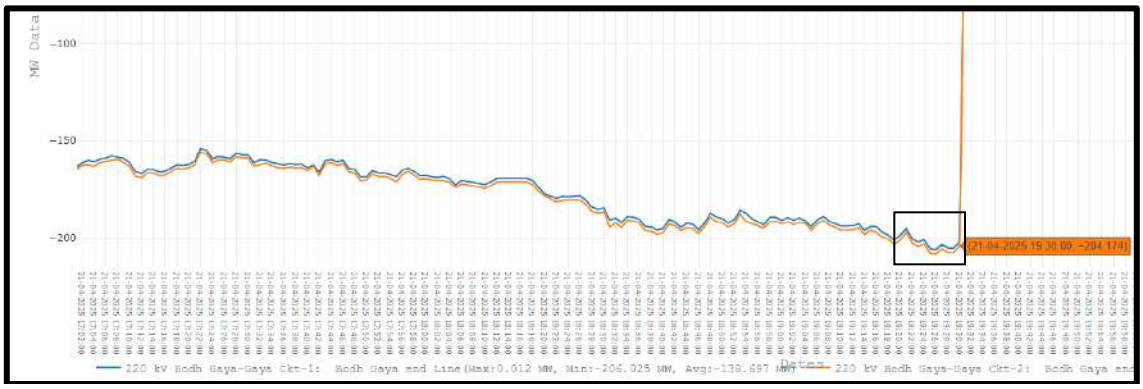
Figure-2: Power flow of 220kV Gaya Bodhgaya D/C as per SCADA

On 21st April 2025, prior to the disturbance, 220kV Gaya – Bodhgaya D/C got tripped at 19:30 Hrs from Bodhgaya end on over current protection. As per SCADA 202 MW power flow was observed in each circuit. At 19:42 Hrs 220 kV Khizersarai-Bodhgaya D/C got tripped from Bodhgaya end due to snapping of R-phase conductor and 220kV Bodhgaya S/s became dead.

- 132 KV Chandauti (PMTL)-Chandauti D/C was under S/D due to some work at PMTL end, and Chandauti (BSPTCL) was radially connected from 132 kV Bodhgaya S/s.
- 220 KV Gaya (PG)-Bodhgaya circuit-3 & 4 anti-theft from Bodhgaya end due to defective BCU at Gaya (PG) end (Bays are being maintained by BSPTCL).
- At 19:30 Hrs 220kV Gaya – Bodhgaya D/C tripped from Bodhgaya end on over current protection (As per SCADA 202 MW power flow in each circuit and over current setting kept at 0.7, CTR-800/1 A, TMS- 0.4).

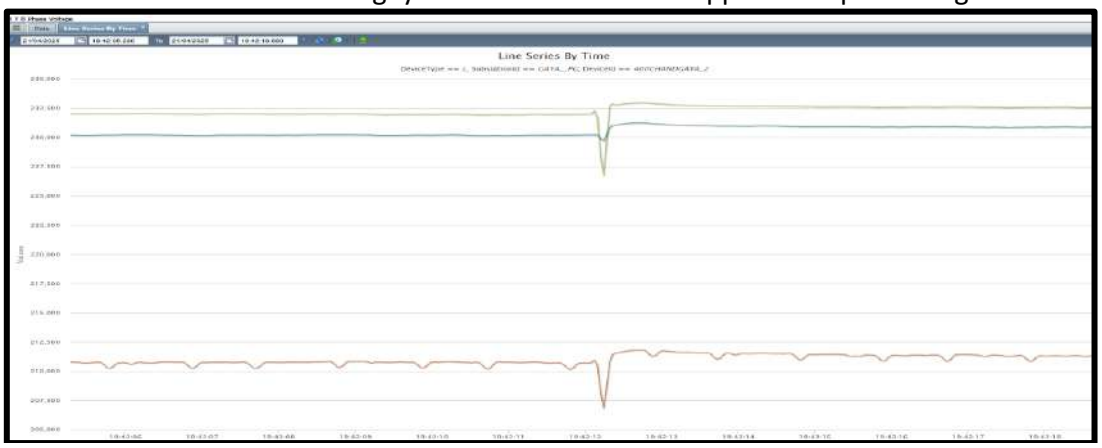
Figure-3: PMU of Gaya Voltage

- At 19:42 Hrs 220kV Bodhgaya-Khizersarai D/C tripped from Bodhgaya end due to snapping of R-phase conductor of 220 KV Khizersarai-Bodhgaya #1.
- At the same time 220kV Bodhgaya-Khizersarai #2 also tripped on Y-phase to ground fault.
-

- 220kV Bodhgaya-Khizersarai D/C tower collapsed was reported at tower location no 92-93.
- 220kV Bodhgaya S/S became dead.
- Total load loss of 310 MW occurred at Bodhgaya.
- Power was extended through Gaya-Bodhgaya D/C at 20:06 Hrs.

- As per SCADA maximum power flow in 220kV Gaya Bodhgaya D/C touched 202 MW which was below its thermal limit, but due to incorrect O/C setting both circuits tripped, and disturbance occurred. Over current setting was enabled and kept at 0.7, CTR-800/1 A, TMS- 0.4.
- It is requested to review over current setting in your jurisdiction to avoid such type of unwanted tripping. Action in this regard to be taken for all substation and adherence to **CEA protections standards** to be ensured**. If Overcurrent to be enabled, it has to be kept in AND logic with VT fuse failure and Pickup to be at least 120% of Thermal Rating.**
- Reason of non-availability of DR at Bodhgaya S/s may be submitted and status of DR extracting status may be submitted.
- Detailed report received from BSPTCL is attached in Annexure:2

Backup-Overcurrent to be disabled at all 220 KV and above stations where Main 1 and Main-2 protections are present. This is violation of CEA standards and leading to unwanted tripping and disturbances.

If Overcurrent to be enabled, it has to be kept in AND logic with VT fuse failure and Pickup to be at least 120% of Thermal Rating.

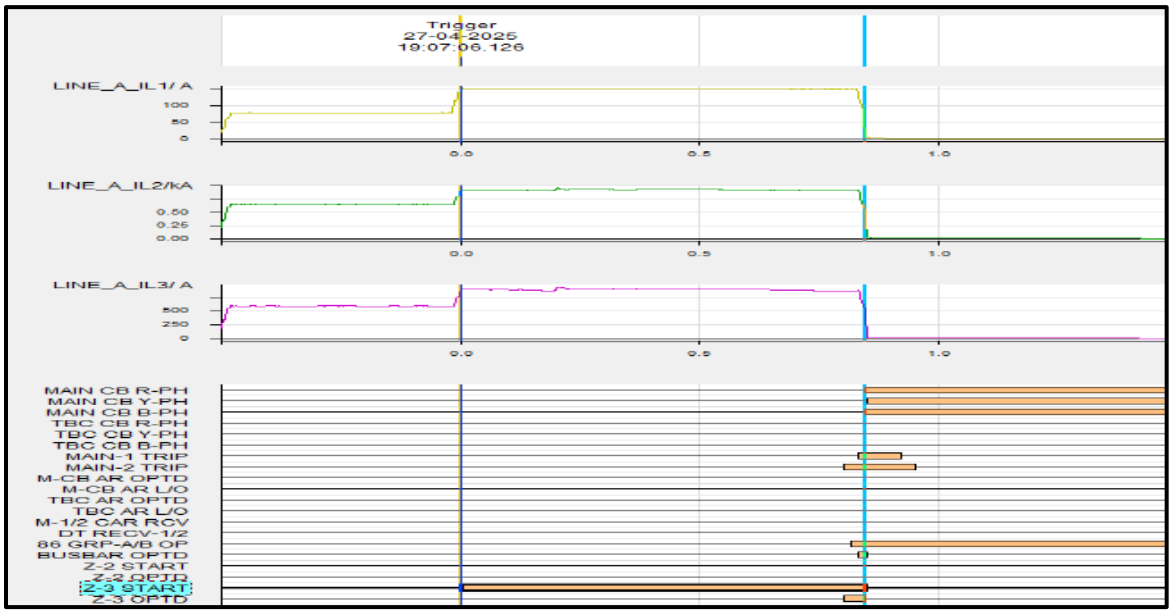
Figure 2: DR of 220kV Daltongunj -Chatra at Daltongunj

- Prior to disturbance 220kV Chatra load was radially connected to Daltongunj and Latehar S/s.
- At 19:08 Hrs Y-B phase fault occurred in 220kV Chatra-Latehar line.
- Fault was not cleared from Chatra end, and same fault was sensed in Z-3 protection from Daltongunj end.

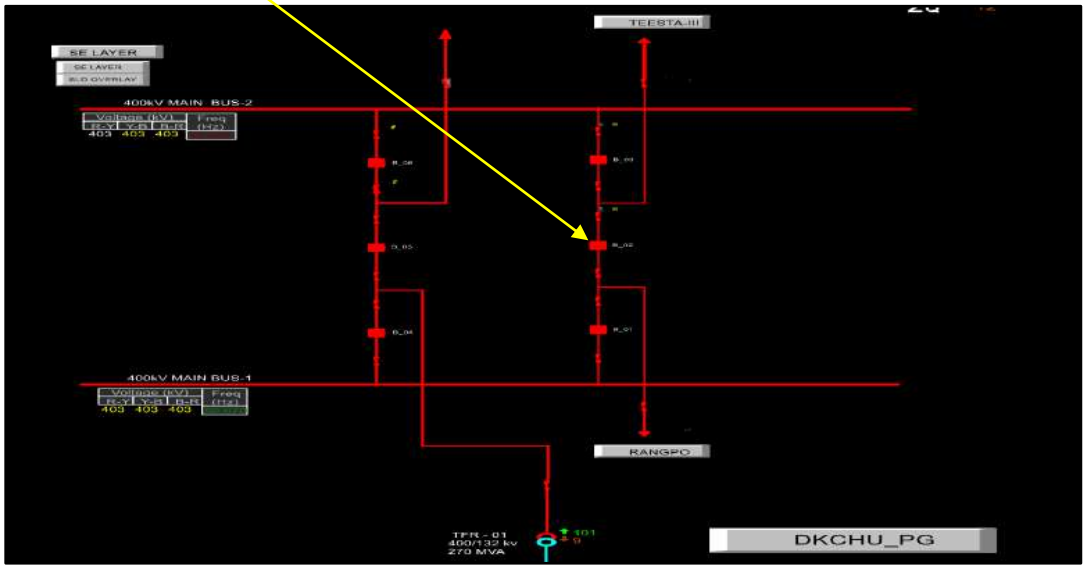
Figure 2: SLD of 400kV Dikchu S/s

- Tie bay of Rangpo & Teesta-III at Dikchu was out of service due to long outage of 400kV Rangpo-Teesta-III circuit so Dikchu -Rangpo was only connected with Main Bay.
- Dikchu generation was radially evacuated through 400kV Rangpo-Dikchu S/c.

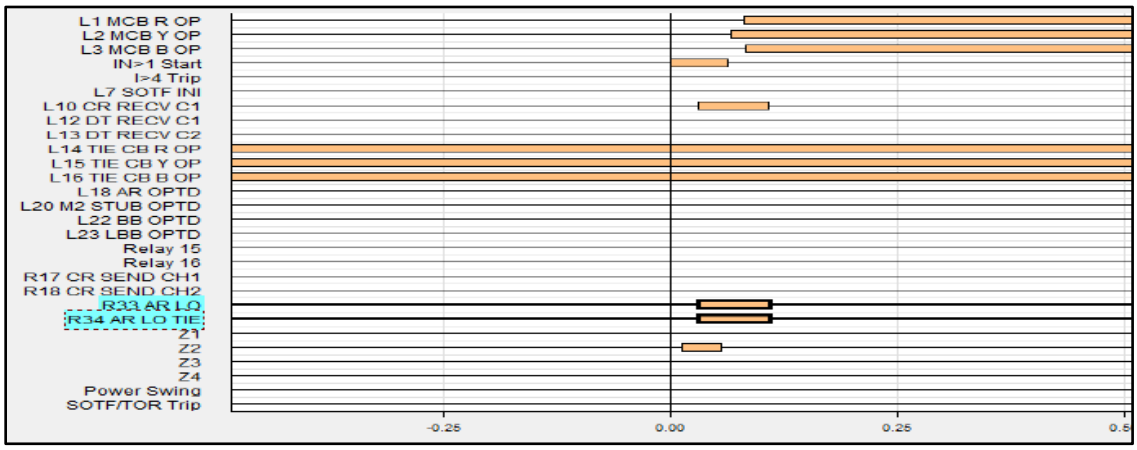
Figure 3: DR of 400kV Rangpo-Dikchu at Dikchu

- At 20:34 Hrs Y-phase to ground fault occurred and A/r successful from Rangpo end.
- Fault was sensed in zone-2 and Carrier was received at Dikchu and instantaneous Three phase tripping occurred instead of single-phase tripping.
- As per DR Tie A/r lockout signal also became high before tripping which led to three phase tripping from Dikchu end and Non-operation of A/R attempt.

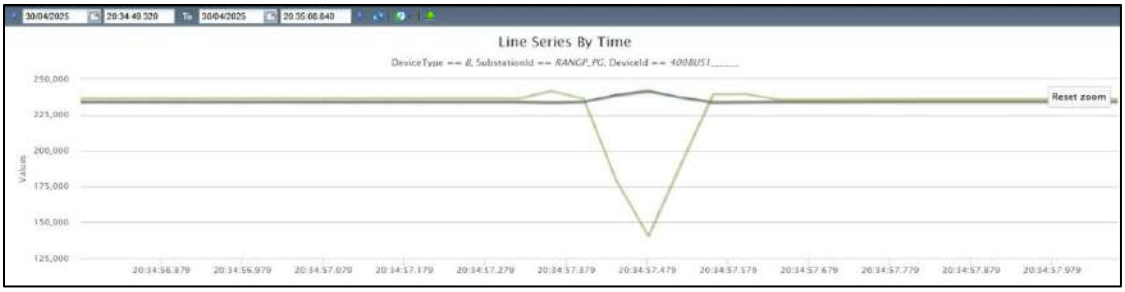
Figure-4: PMU of Rangpo voltage

- Dikchu Unit#1 & 2 tripped on Overspeed protection due to loss of evacuation path.
- 400kV Dikchu S/s became dead.
- Total 96 MW generation loss occurred at Dikchu generating station.
- 400 kV Rangpo-Dikchu charged at 21:26 Hrs. Dikchu Unit#1 & 2 synchronized at 21:34 Hrs and 21:49 Hrs respectively.
