Agenda
for
66th PCC meeting

AGENDA FOR 66TH PROTECTION SUB-COMMITTEE MEETING TO BE HELD AT ERPC, KOLKATA ON 25.04.2018 (WEDNESDAY) AT 10:30 HOURS

Summary: This report is highlighting the issue of multiple blackouts of 220 kV Tashiding and 220 kV Jorethang substations due to multiple line tripping on a single transient fault. Apart from these, several other tripping on various faults has also occurred on 220 kV Tashiding-New Melli and 220 kV Tashiding-Rangit in last few months. Important tripping incidents occurred in the month of March, 2018 in this corridor are also mentioned in this report to raise the concern among the utilities for taking appropriate actions.

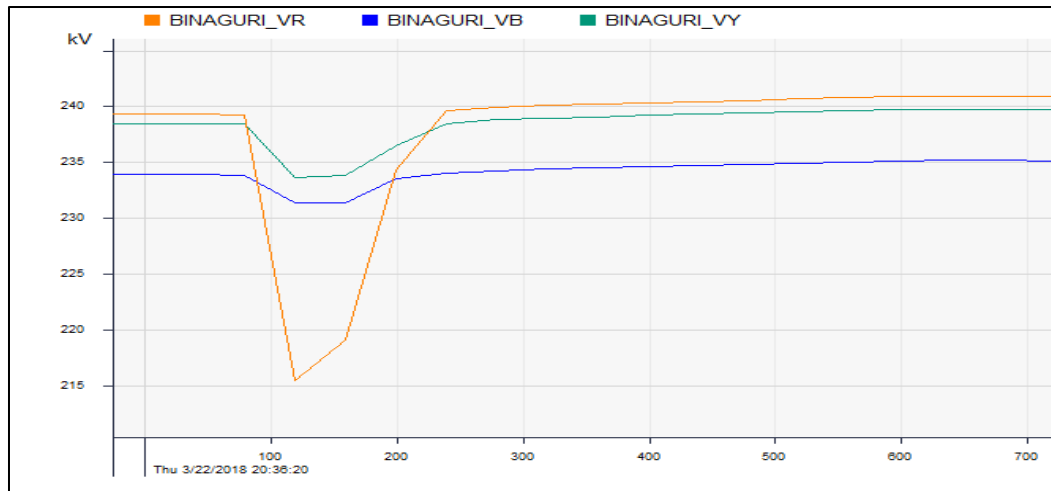
Figure 2: 400 kV Bus voltage at Binaguri indicating the fault during the disturbance

From 400 kV Binguri Bus voltage from PMU (Ref Fig 2), only one fault was observed in R phase at 20:36:20.080 hrs which got cleared within 100 ms. Based on the information, it is assumed that the fault was on 220 kV Jorethang - New Melli D/C. However, at the same time, 220 kV Rangpo - Tashiding S/C and 220 kV Tashiding –New Melli circuit have tripped from Tashiding end. Further, 220 kV Rangpo-New Melli circuit has performed successful A/R from Rangpo end for this fault.

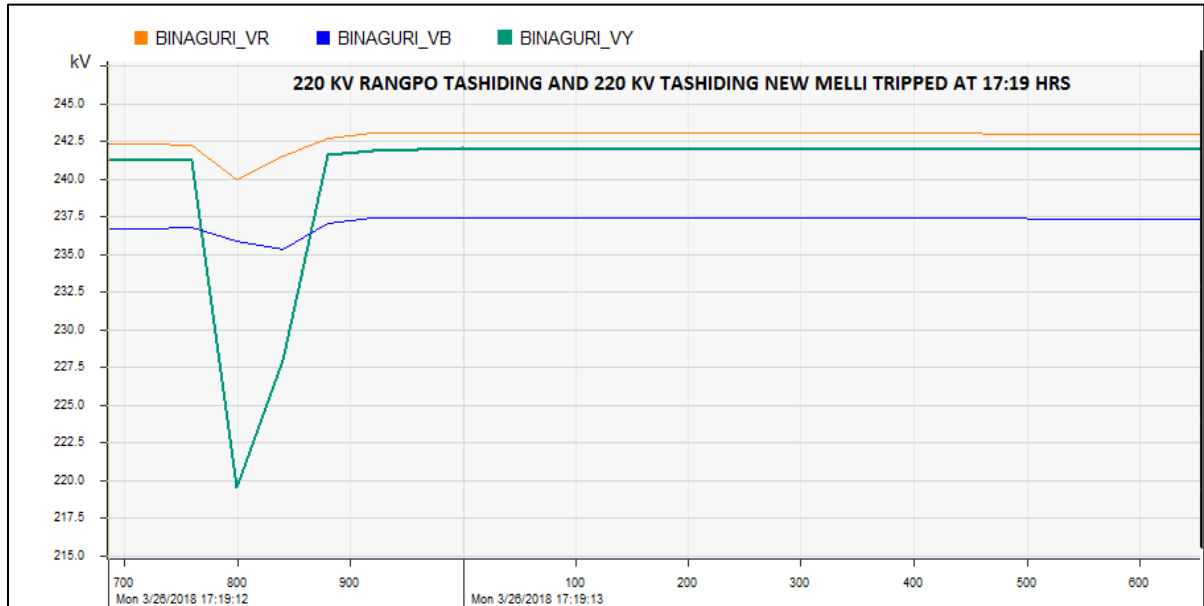
Figure 3:400 kV Bus voltage at Binaguri indicating the Y phase fault during the disturbance

From 400 kV Binaguri Bus voltage from PMU (Ref Fig 3), only one fault was observed in Y phase at 17:19:12.760 hrs which got cleared within 100 ms. Based on relay indication, it is observed that fault was on 220 kV Rangpo-Tashiding circuit.
