Agenda
for
149th PCC Meeting

AGENDA FOR 149th PROTECTION COORDINATION SUB-COMMITTEE MEETING TO BE HELD ON 15TH JULY 2025 AT 10:30 HRS THROUGH MS TEAMS

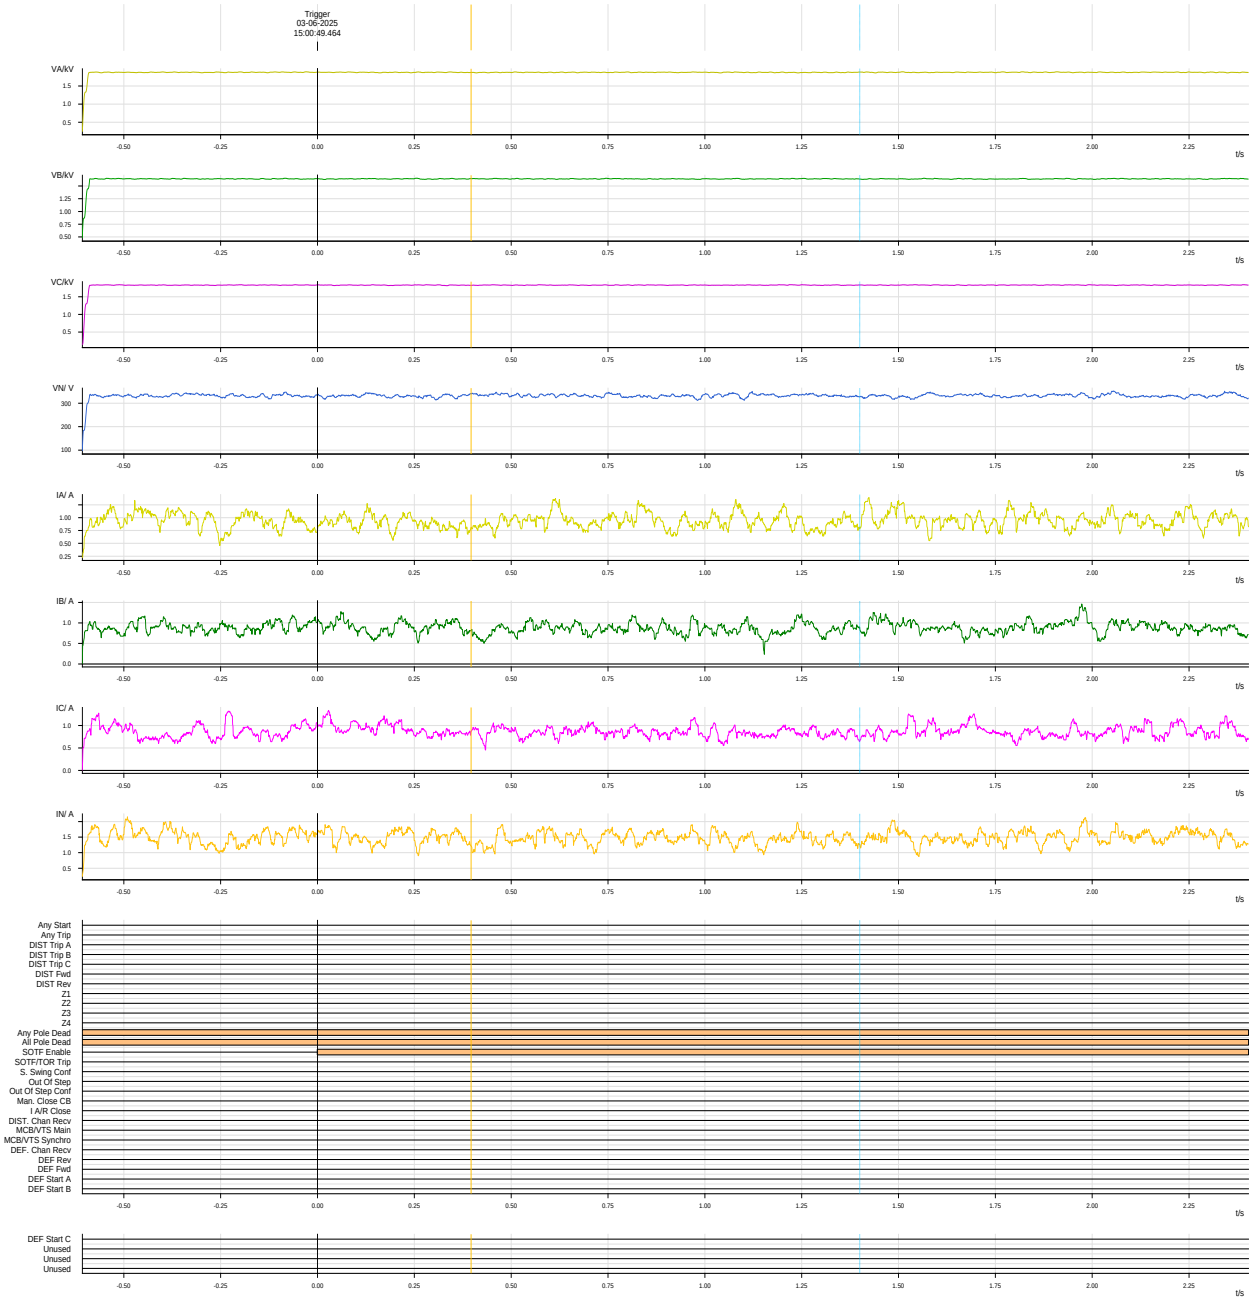
DR of 220kV Jorethang-N Melli #1 at Jorethang

Jorethang S/s is radially connected to New Melli through 220kV Jorethang-N Melli D/C. Prior to the disturbance, unit 1 was generating 48 MW. At 14:49 Hrs, during relay testing at Jorethang S/s, bar bar protection mal-operated, resulting in total power failure at 220kV Jorethang S/s.

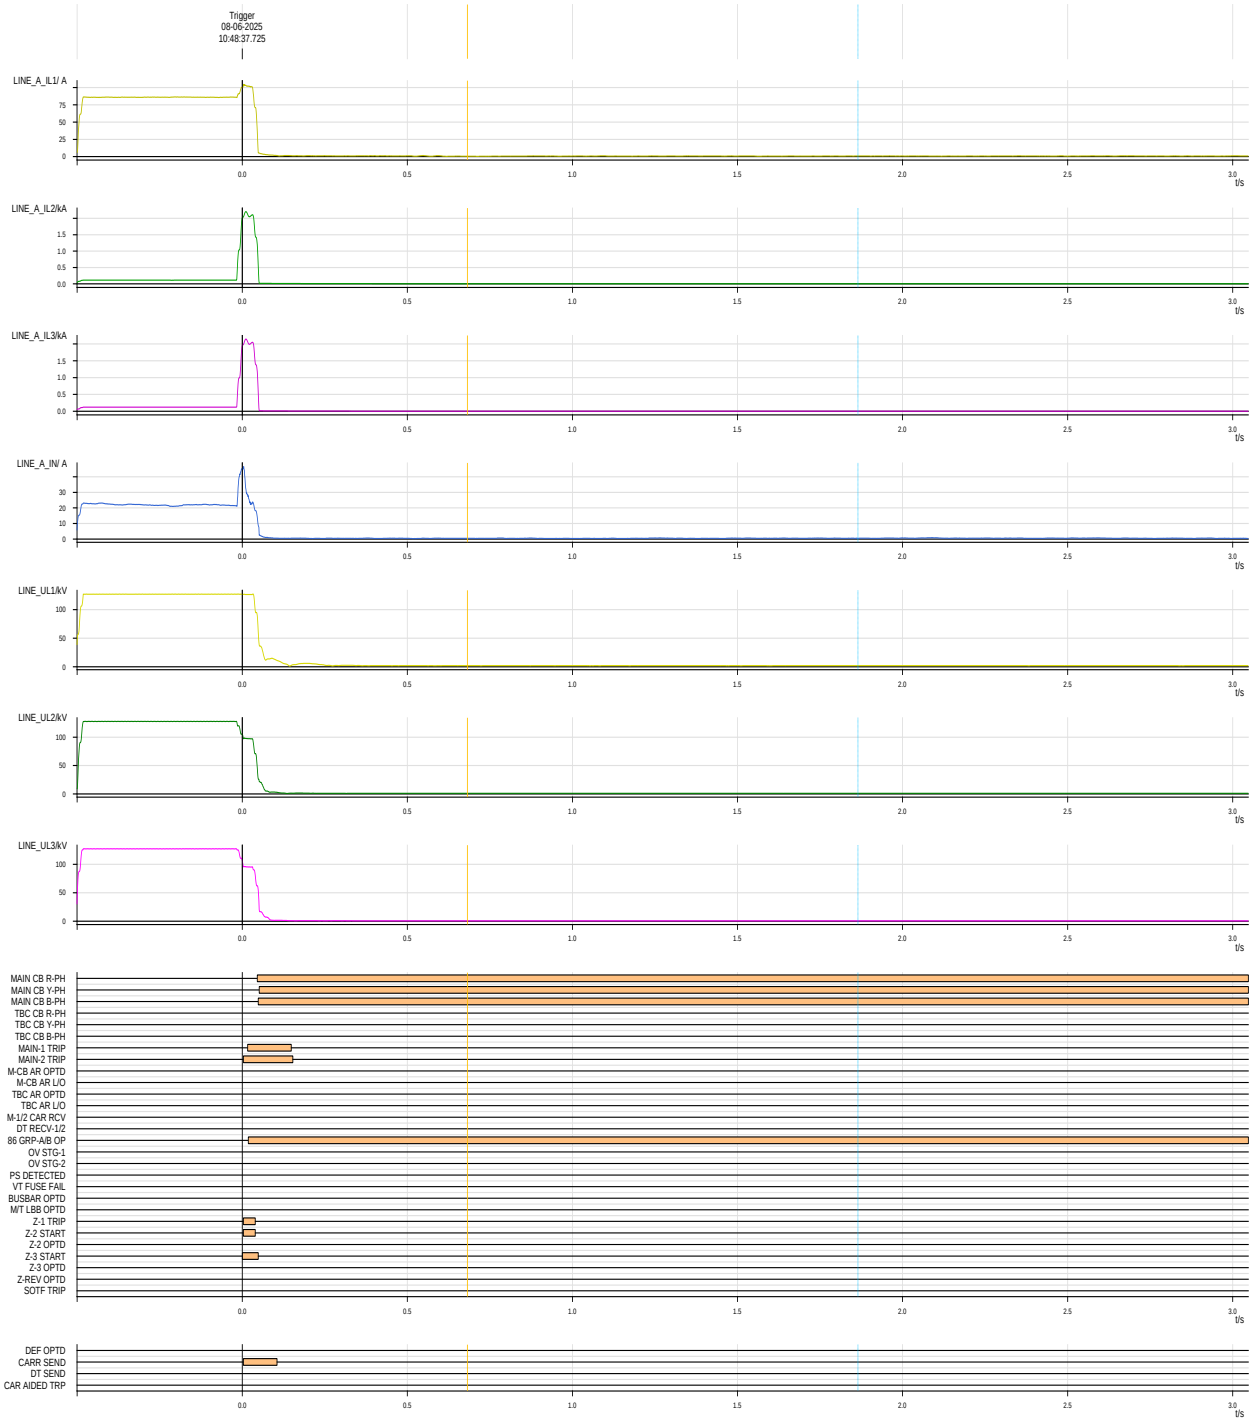
DR of 220kV Daltongaunj-Chatra at Daltongaunj:

Prior to the disturbance Chatra S/s radially connected to 220kV Chatra-Daltongunj S/C (220kV Chatra-Latehar under tripped condition from 10:43 Hrs_08-06-2025 on Y-B fault). **At 10:48 Hrs** 220kV Chatra-Daltongunj tripped on Y-B fault. Due to tripping of radial connected line, Chatra S/s became dead. Total load loss of 24 MW reported at Chatra S/s.
Power was extended through 220kV Chatra-Latehar circuit at 11:09 Hrs.

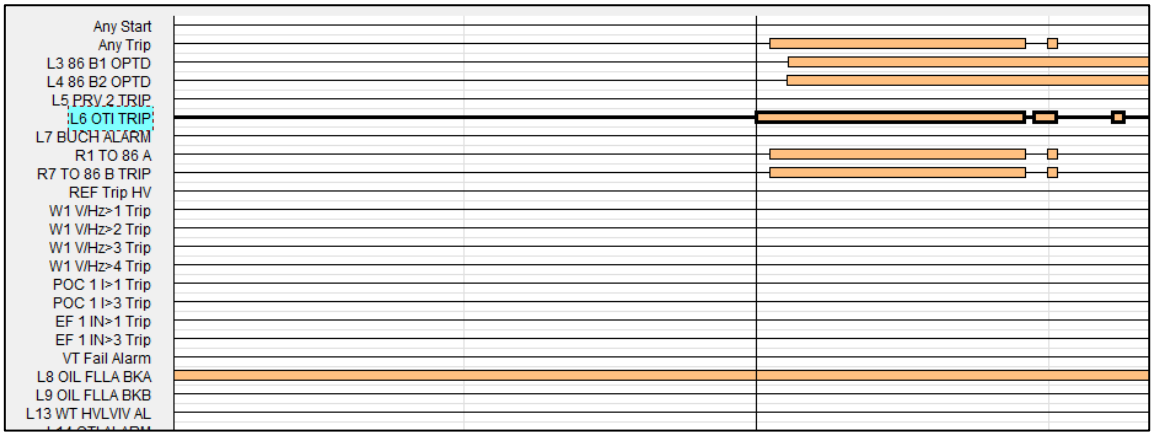
Figure 2: DR of 400/220kV ICT#2 at Tenughat

- Prior to the event PVUNL drawing 5 MW start power radially from Tenughat through 400/220kV ICT#2 at Tenughat.
- 400/220kV ICT #1 at Tenughat was under long outage condition.
- At 05:06:50 Hrs on 10/06/2025 ICT#2 tripping due to OTI (Oil Temperature Indicator) protection operated.

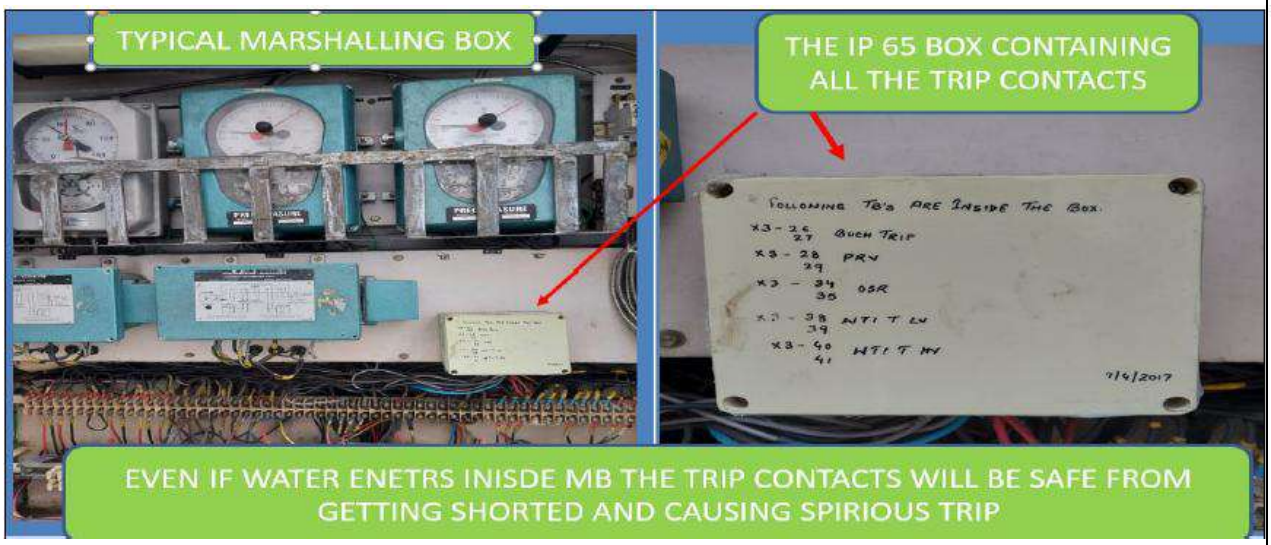
- As per tripping report OTI operated multiple times without any internal fault in ICT (Maximum temperature was below 55 degree). As per verbal communication and report received from Tenughat, **ICT tripped due to moisture and bad weather**.
- Following practice was adopted by MPL to avoid unwanted tripping of ICT: To avoid moisture-related issues, the trip contacts should be placed in a separate box within the marshalling box. The OTI and WTIs should be enclosed in a metallic cage to prevent the displacement of mercury-based OTI/WTIs, as shown in the figure.

Due to bad weather and moisture, it was observed that mal operation of mechanical type relay (WTI, OTI, PRV and Buchholz relay) was reported in most of the ICT tripping. To avoid such type of mal-operation **mercury float switch relays may be replaced by magnetic reed relays and proper sealing may be done** to avoid spurious operation of relays due to transformer vibration, moisture, water ingress and bad weather etc.

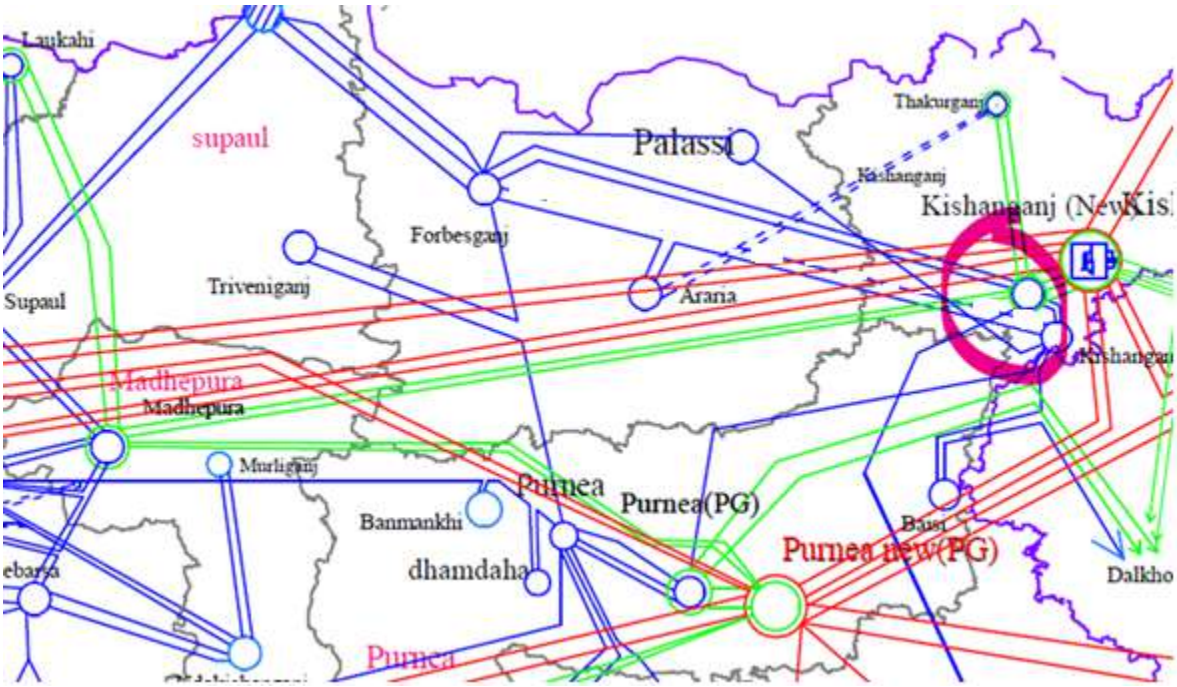
Figure 1: Network across the affected area

At 18:24 Hrs of 12/06/2025, HV side B phase CT of 160 MVA ATR-3 burst at 220/132kV GSS Kishanganj New (BSPTCL), which evolved to a three phase fault, resulting in a bus fault at 220 kV Kishanganj New and tripping of all connected lines, which led to total power failure at Kishanganj (BSPTCL) area of Bihar Power System.Power extended at 19:40 Hrs through 220 kV Kishanganj (BSPTCL) – Kishanganj (PG) -1.

9. Details of Equipment Failure (if any during the event) (उपकरण विफलता का विवरण): HV side B-Phase CT of 160 MVA ATR-3 at Kishanganj New S/S

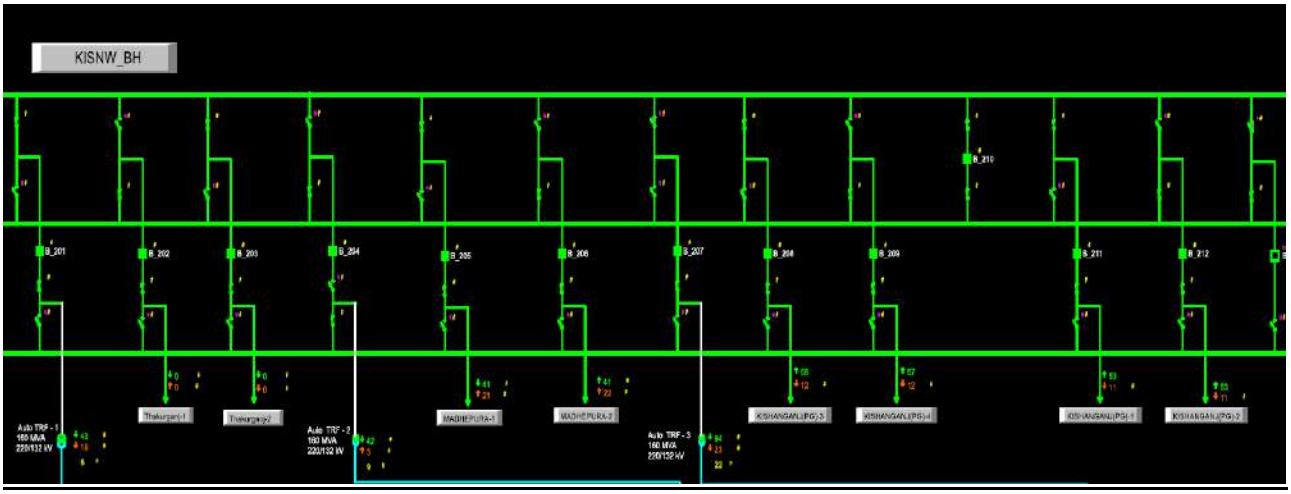
Fig 2: SLD of 220 kV Kishanganj S/S

160 MVA 220/132 KV Autotransformer 3		Tripped on B ph Differential protection		12:35 Hrs 16/06/25

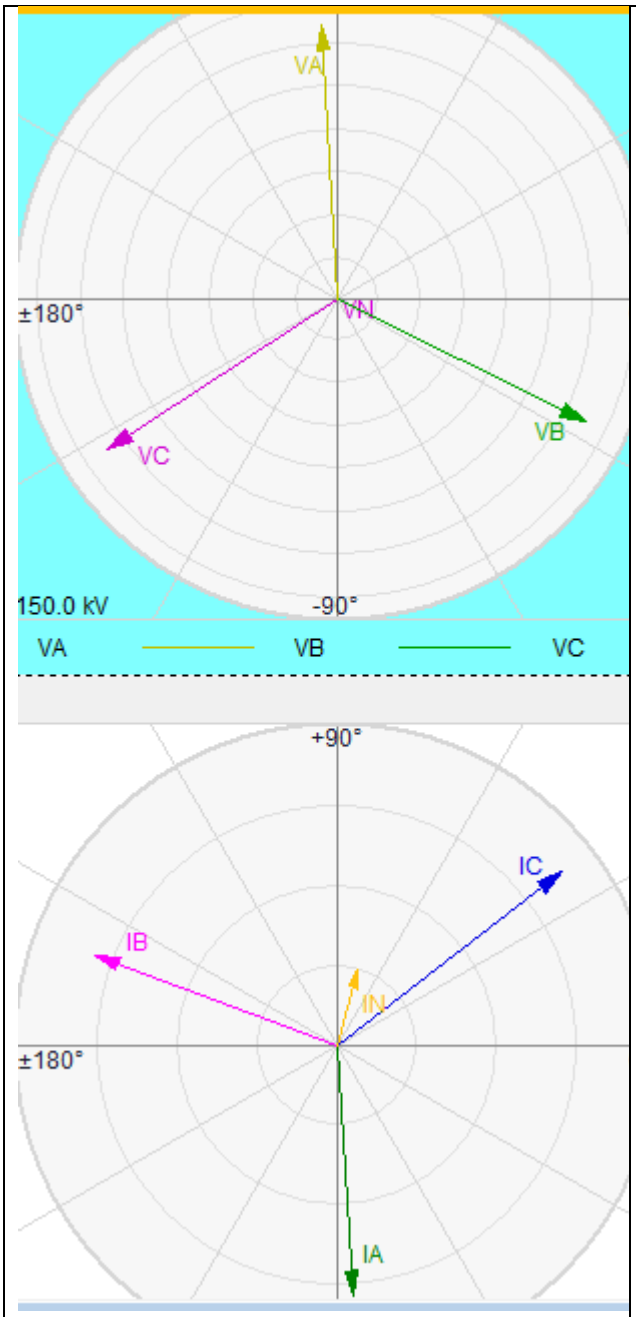
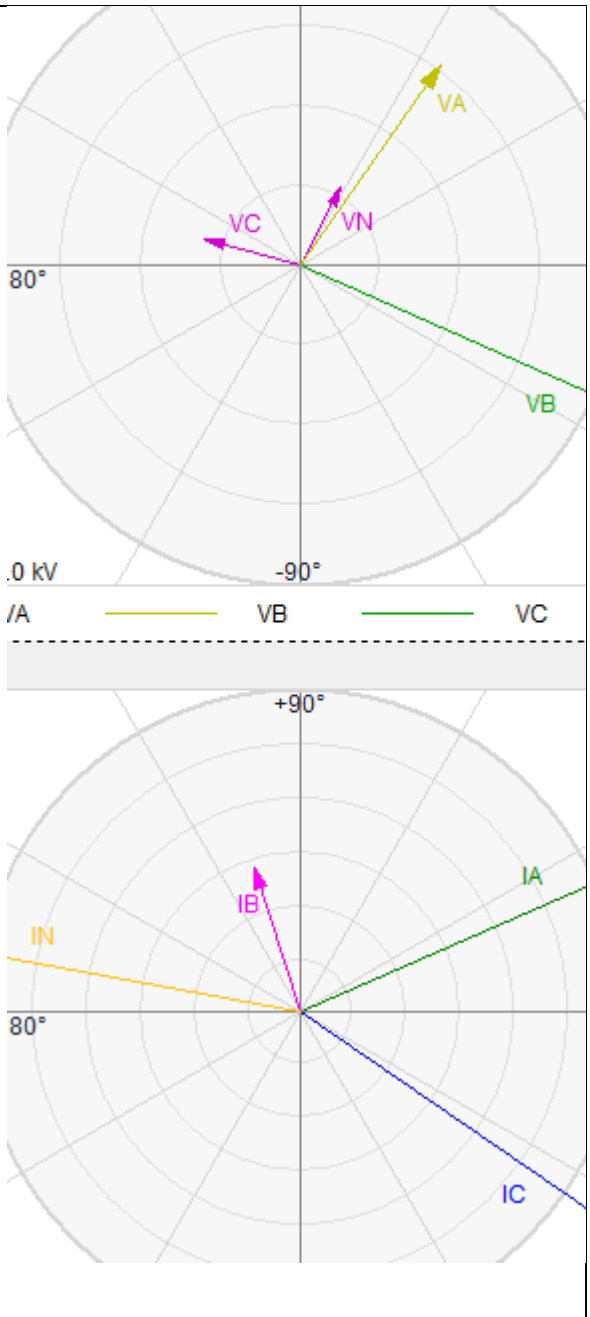
Fig 3: Phasor angle comparison between instants showing impedance trajectory in ckt 3 at Kishanganj new going from reverse to forward zone

- 220 KV Thakurganj ckt 1 feeder is radially fed,so no tripping there at remore end.220 KV
- 220 KV Kishanganj New Kishanganj (PG) ckt -3 initially detected the fault in Z-4 at Kishanganj New(BSPTCL) end. However, impedance trajectory went out of reverse zone and entered Zone 1, leading to tripping in Z-1 at Kishanganj New end and carried aided trip at Kishanganj(PG) end . This happened because the arc near line CT of ATR 3 ionised the air around and led to catching of fire in wave trap connected to line 3 since lince 3 is situated adjacent to ATR 3. Thus, fault came in forward zone of line 3.Following figure below shows the change in current direction vis a vis voltage in Ckt 3-

Fault as seen in reverse zone in ckt 3 BSPTCL end

Fault seen in forward zone in ckt 3 BSPTCL end

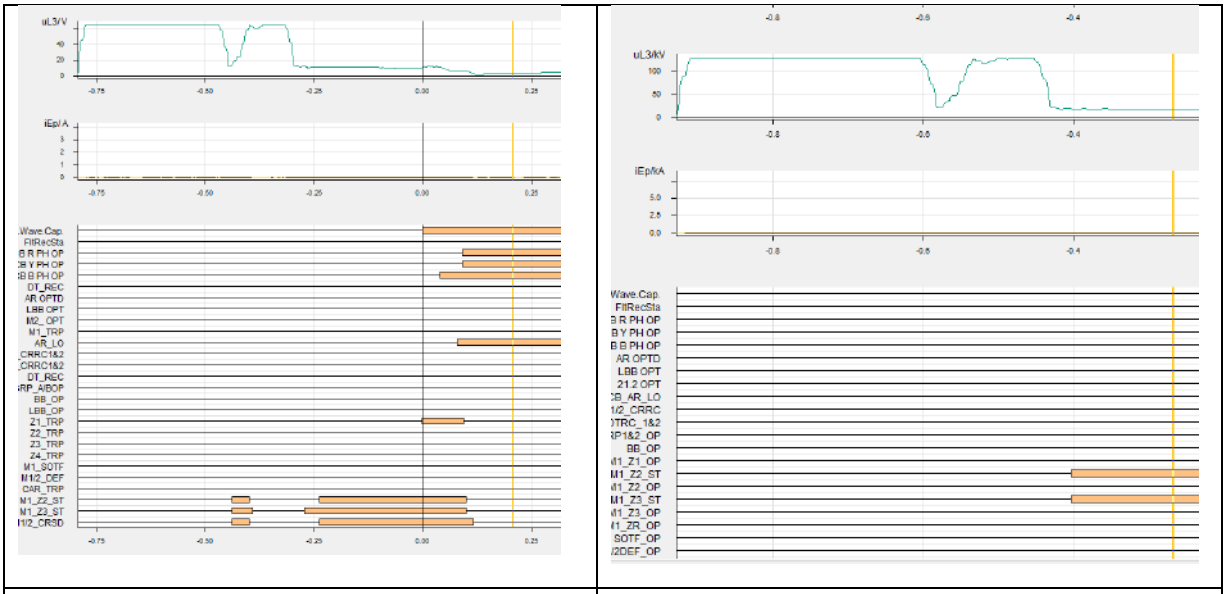
Fig 4: DR of Kishanganj (PG) end for 200 KV Kishanganj New ckt 4 and ckt 2 showing reason for delayed Z-2 operation

- DR of 220 KV Madhepura end ckt 1 and 2 is awaited. Also, that 132 KV Forbisganj end for Forbisganj Kishanganj new d/c is awaited. Now to explain 450 msec fault clearing time, Out of the 220 KV Kishangang PG ckts 1, 2 and 4, which tripped on remote end on Z2, zone 2 of ckt 4 dropped midway and picked up 120 ms later as seen in figure below, thus making overall fault clearing at 450 msec, though after 2nd picking it tripped by 350 msec.

- In case of ckt 2, zone 2 pick-up is delayed by 204 msec. Ckt 1 zone 2 clearing time is 350 msec

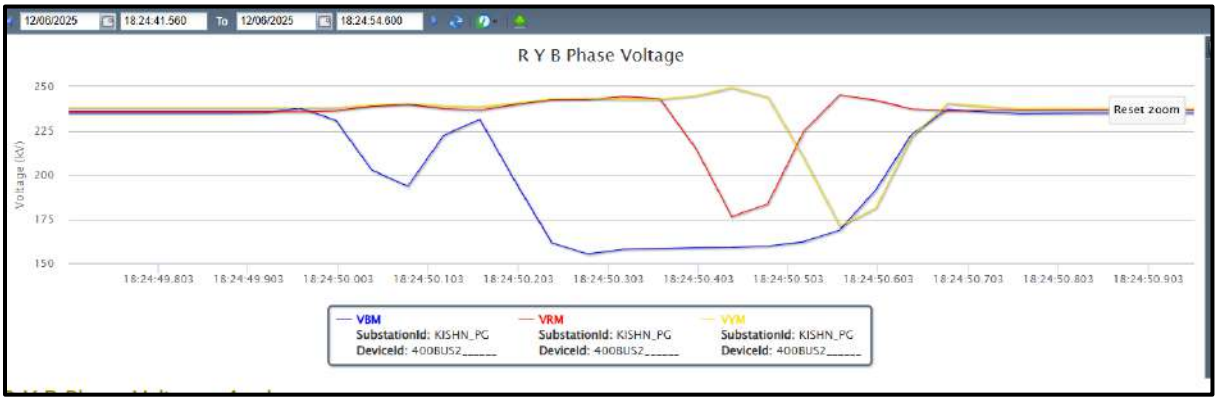
Fig 5: PMU plot at 400KV Kishanganj Bus Voltage

- Bus bar protection not operational on 12/06/25 at 220 KV New Kishanganj due to blowing of DC power supply fuse. It was informed that the same was taken into service by next day. BSPTCL may confirm the healthiness of BB protection.
- DR at 220 Kishanganj New bus bar relay is not time synchronized as observed from another event next day. The DR to be time synchronised with the GPS for proper analysis.
- Fault clearing is almost 450 msec which means some remote end zone 2 clearing took that time instead of 350 msec. BSPTCL and Powergrid ER-I may respond.

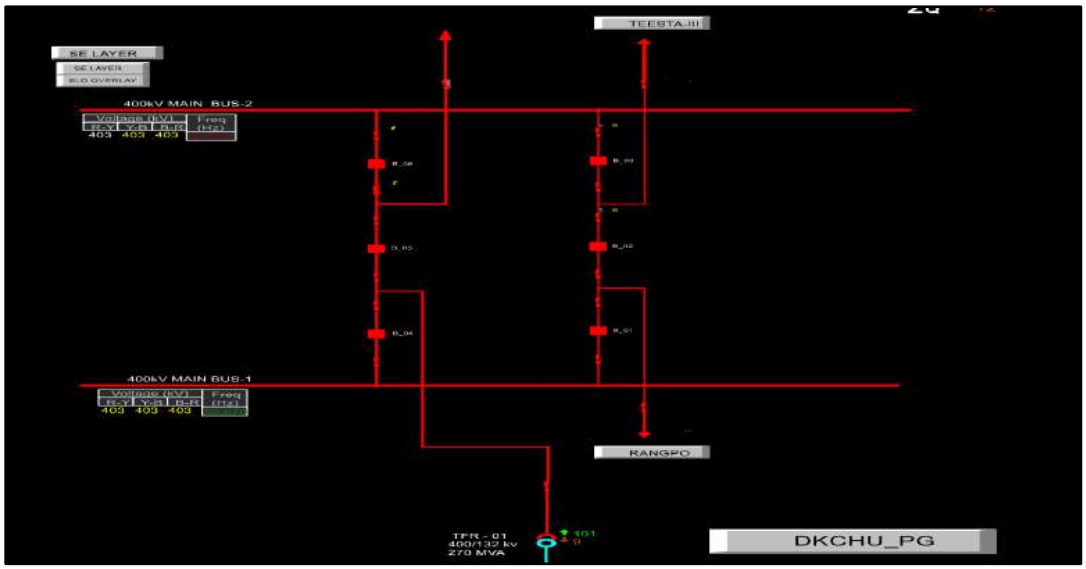
Figure 2: SLD of 400kV Dikchu S/s

- Dikchu generation was evacuated through 400kV Rangpo-Dikchu S/c and 400kV Rangpo-Dikchu (Bypassing Teesta-III) Line.

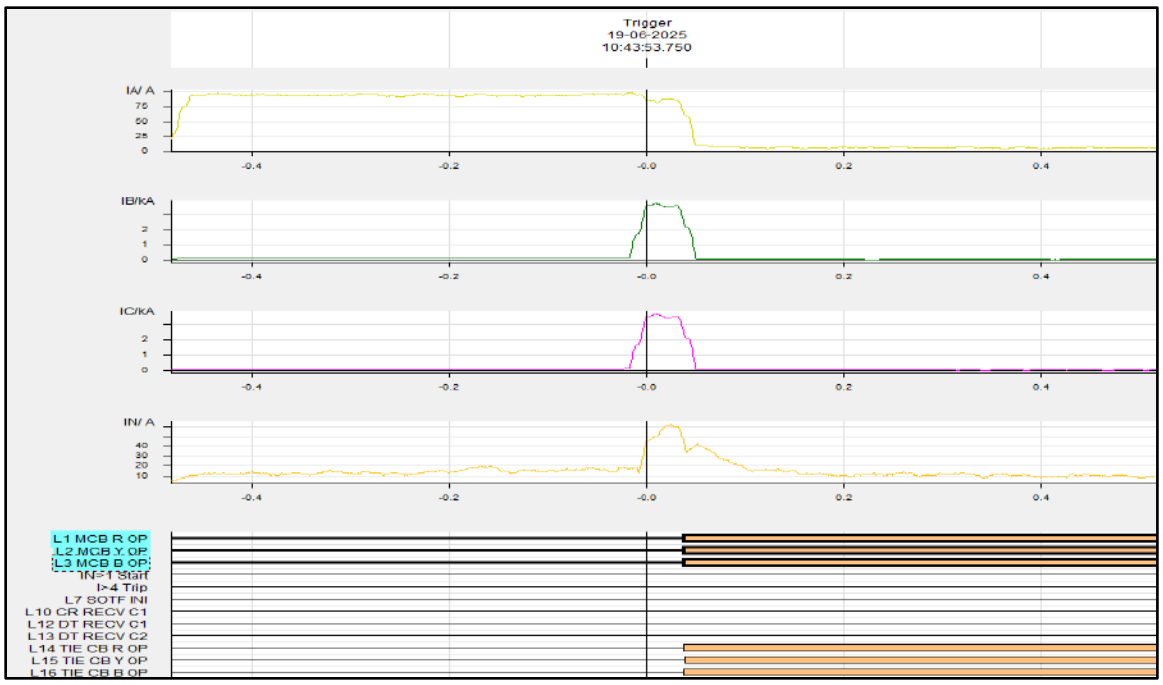
Figure 3: DR of 400kV Rangpo-Dikchu at Dikchu

- At 10:44:53 Hrs, Y-B fault occurred in 400kV Rangpo-Dikchu line and line got tripped from both end in Zone-1 protection within 100 msec.

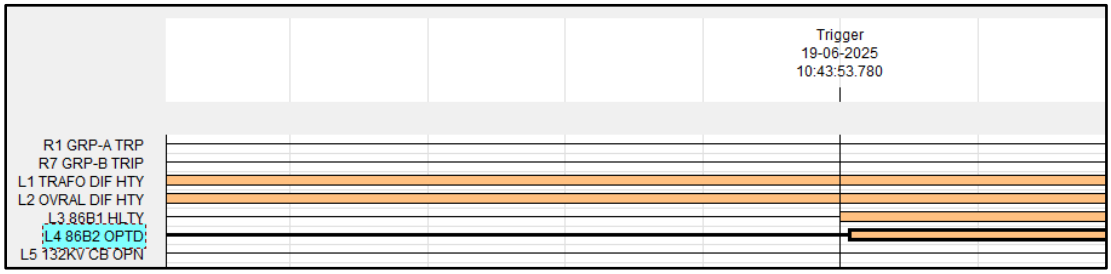
Figure 5: DR of 400/132kV ICT at Dikchu

- At the same time, 400/132kV ICT at Dikchu also got tripped on over current protection in 132kV LV side and master trip command extended to HV side of ICT.

- Due to tripping of 400/132kV ICT at Dikchu, Dikchu unit#1 & 2 got tripped on overspeed/ over frequency protection due to loss of evacuation path.
