Minutes of 93rd PCC Meeting

EASTERN REGIONAL POWER COMMITTEE

MINUTES OF 93RD PROTECTION SUB-COMMITTEE MEETING TO BE HELD ON 17.08.2020 AT 10:30 HOURS

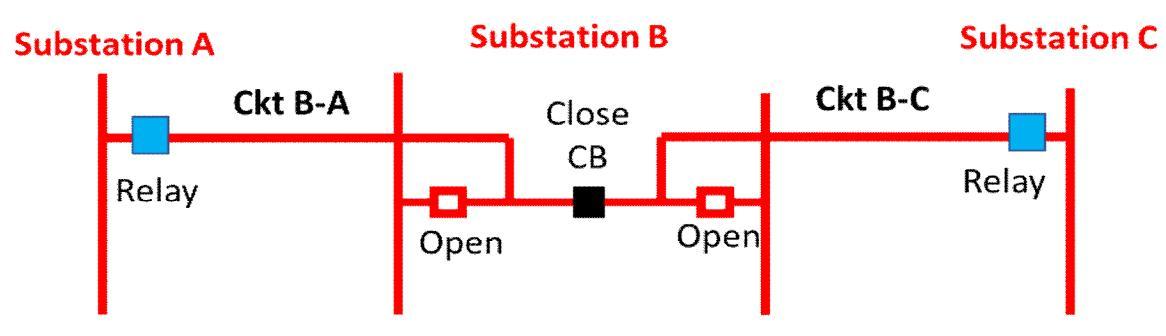
Many a times in one and half breaker substation due some issues like breaker issue, double bus shutdown or any large contingency event leading to tripping of both Main buses CB, the elements in the same diameter are in charge condition through tie CB. This results in one aspect of protection issue as now the long and short lines for remote end will change and will become the same line. However, it is observed that neither ends have any ready relay group setting for such eventuality (although rare but has happened) to ensure protection coordination. This was also faced during recent shutdown of 400 kV Bus 3 & 4 at Kahalgoan NTPC substation on 12th Aug 2020 and at the end all lines were made out which itself impact the system reliability. Thus, in view of taking full advantage of one and half breaker scheme substation and ensuring reliability for such eventuality, all Transmission and generation owner of Eastern region may also prepare such group setting by confirming regarding the element in their diameter at remote end one and half substation to ensure proper operation. Below figure is provided to elaborate the issue.

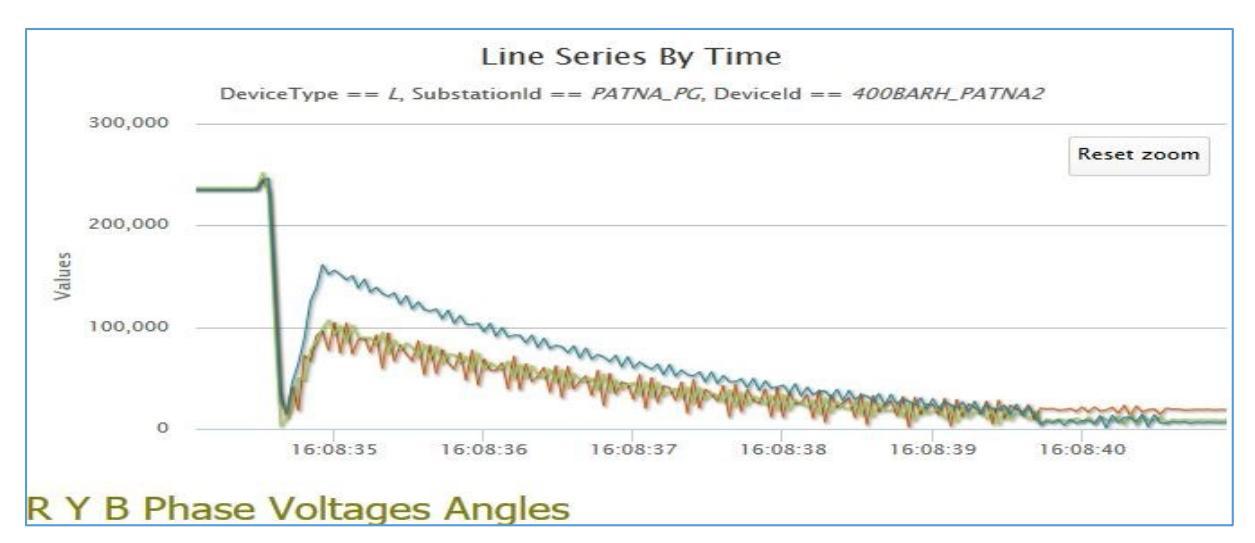
(1)PATNA – BARH –II: No DR received so PMU plot is attached for reference.

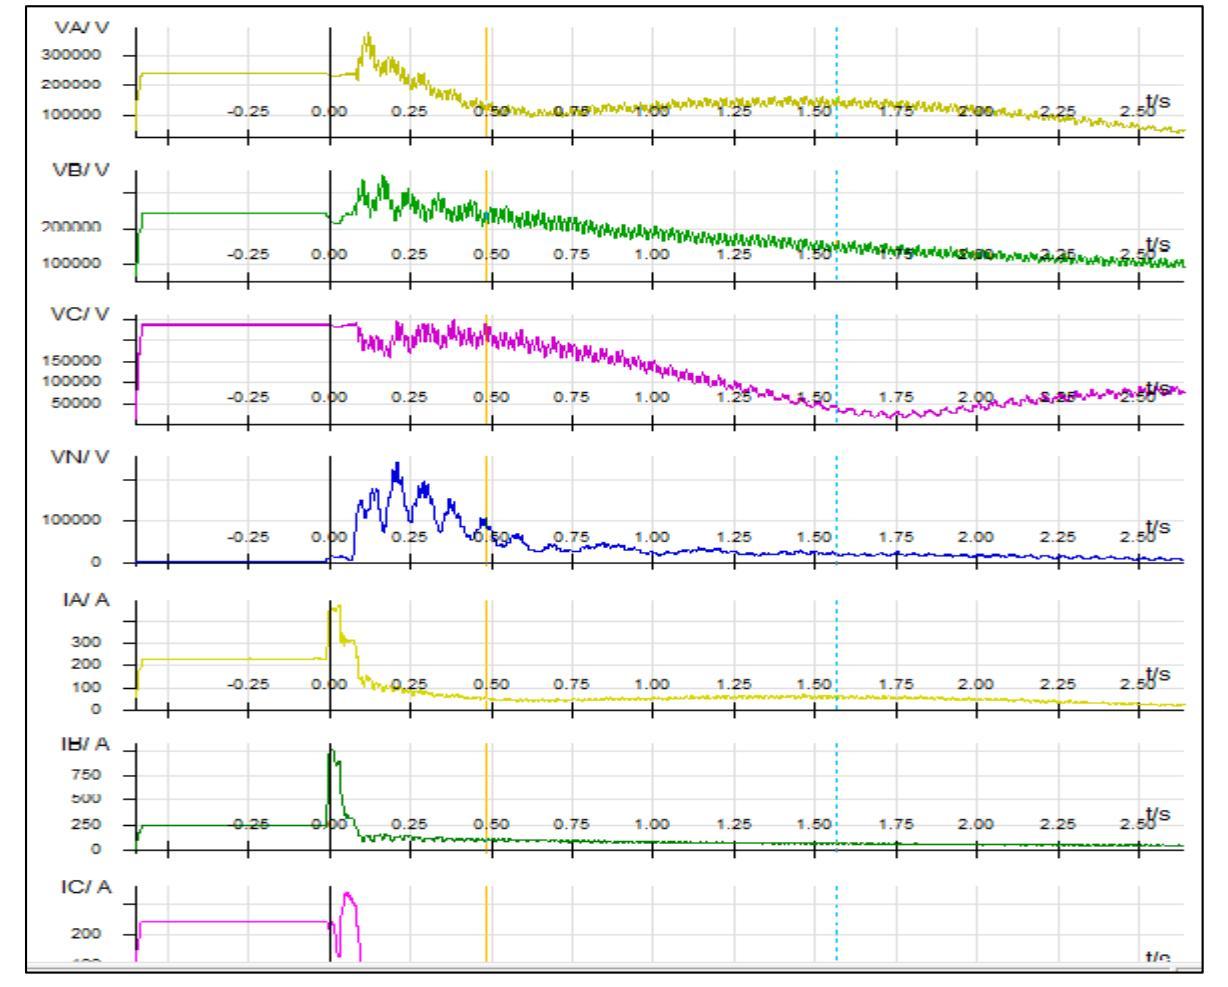
(2)Tripping of BIHARSHARIFF – VARANASI -2 on 04/07/2020: Reactor Ringdown observed : Whether Reactor was tripped due to REF operation or was intact as after 3 pole opening resonating 3 phase line voltage of 28-29 Hz was present .

Line is having 321 Km long twin moose with 50 Mvar L/R at Biharshariff end . Charging MVAR generated by line is 321*0.55=176 Mvar, K=50/176=0.284, (K)^{0.5}= 0.534, Fosc= F*(K)^{0.5}=0.534*50=**27Hz**.

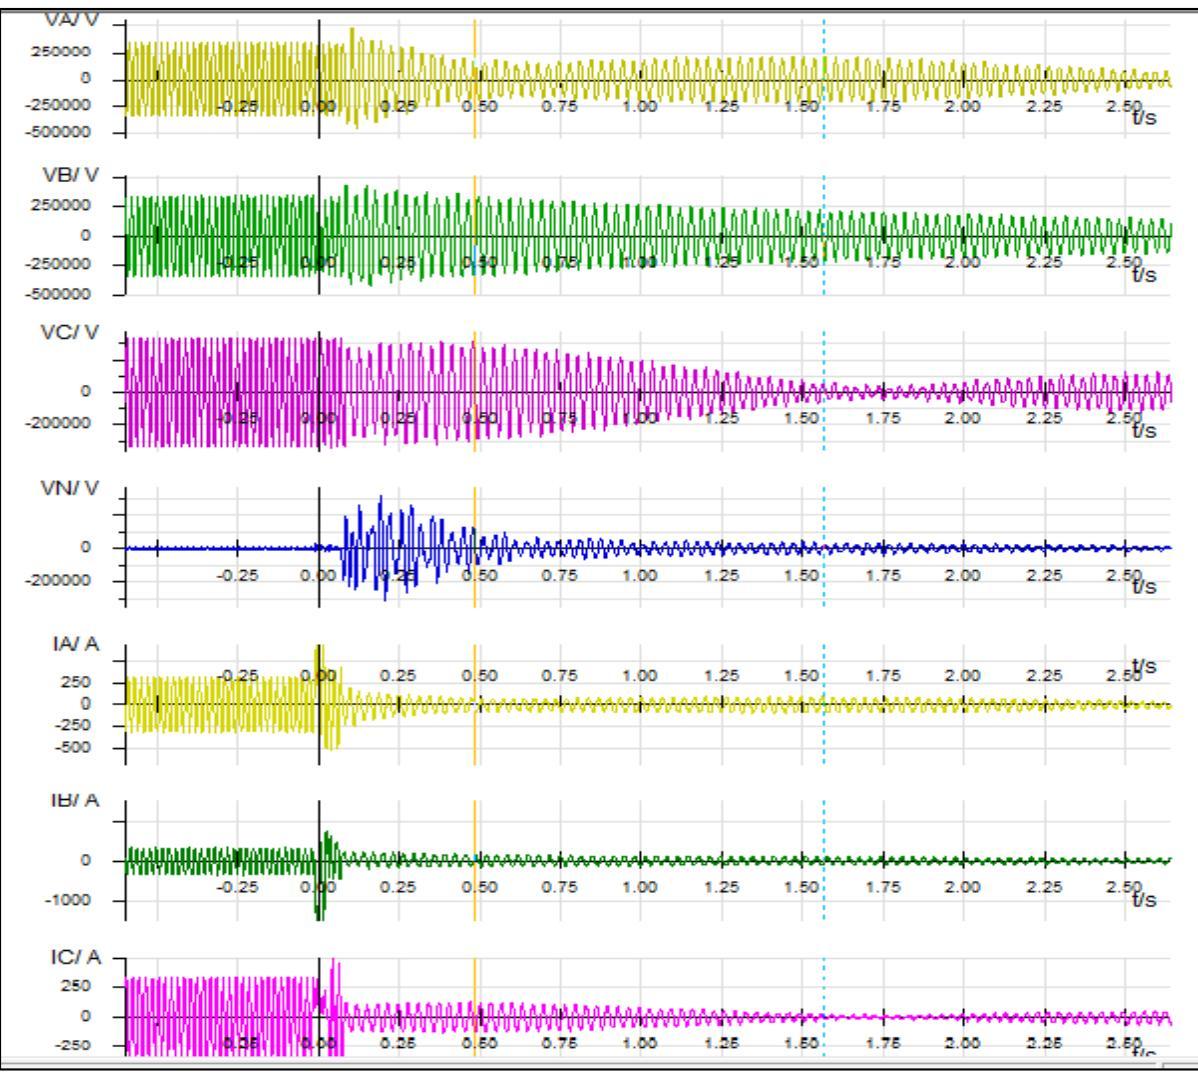
RMS VALUE : Voltage after 3 pole opening momentarily went upto 600 kv.

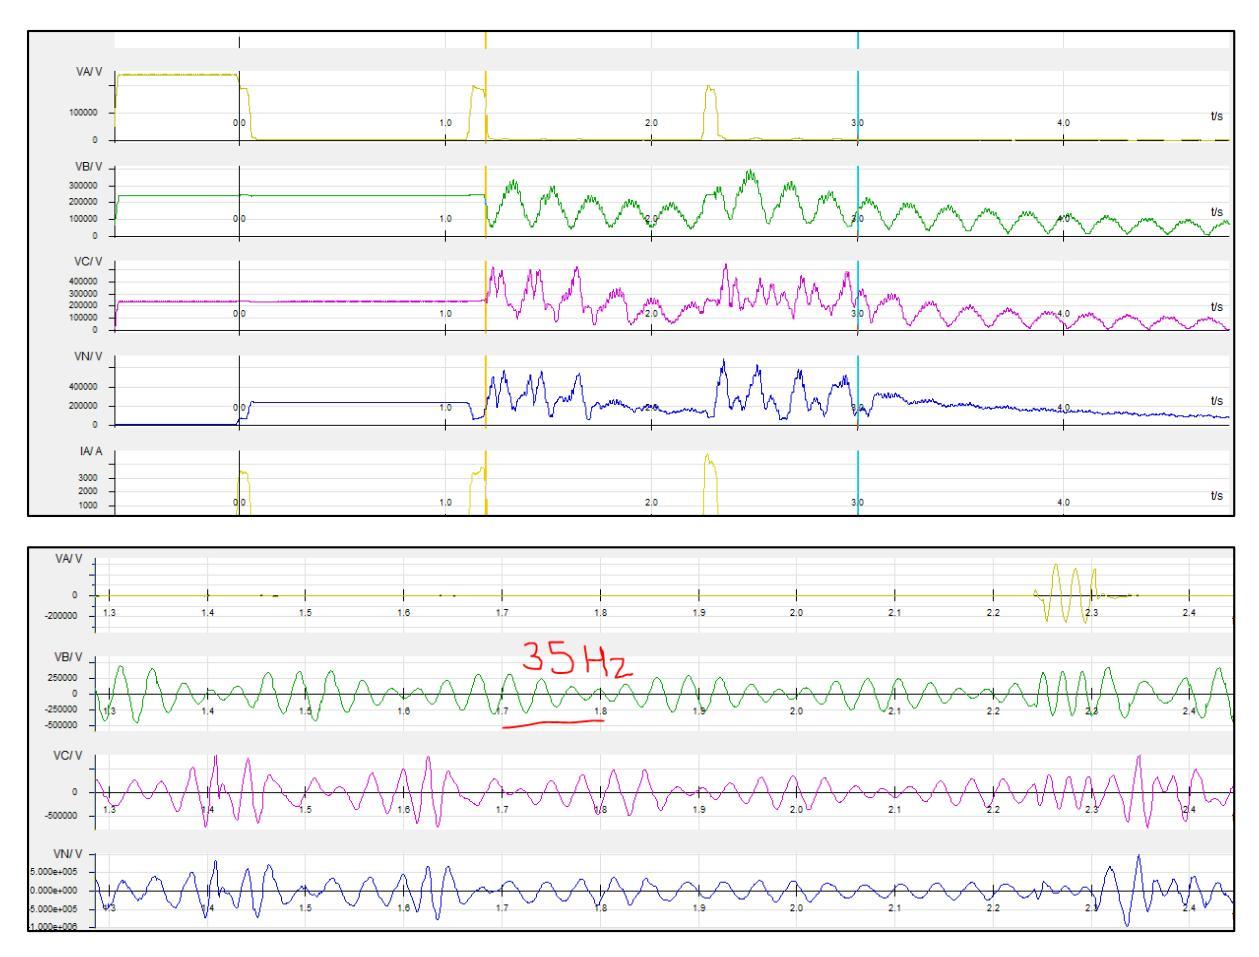
Reactor Ring down phenomenon: Due to Energy exchange between reactor and line capacitance, Electrostatic and electromagnetic energy exchange.

SEVERE HIGH VOLTAGE AFTER 3 POLE OPENING UPTO 800 KV.

Reactor ringdown: At maithon end even after breaker opening line voltage was there for few seconds due to LC oscillations due to 50 Mavr line reactor at maithon end .Line is 172 km twin moose line so charging mvar will be 172*0.55 =94 mvar and .Degree of compensation with 50 Mvar reactor at maithon end comes to 50/94=54%.Hence LC oscillation frequency will be **36 Hz**. With Dr at maithon end LC Oscillation frequency is shown below which is around 35 HZ almost same as calculated above so it can be inferred that these Line voltage with are present due to LC oscillations between reactor and line capacitance. **High voltages due to oscillation frequency close to resonance frequency**.

R phase MCB failed even after than R phase TCB reclosed after 1 second .

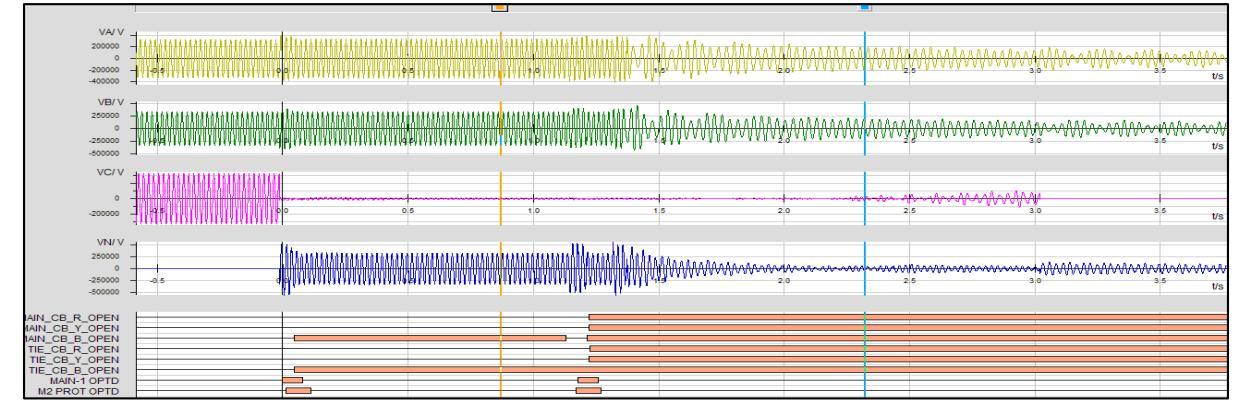
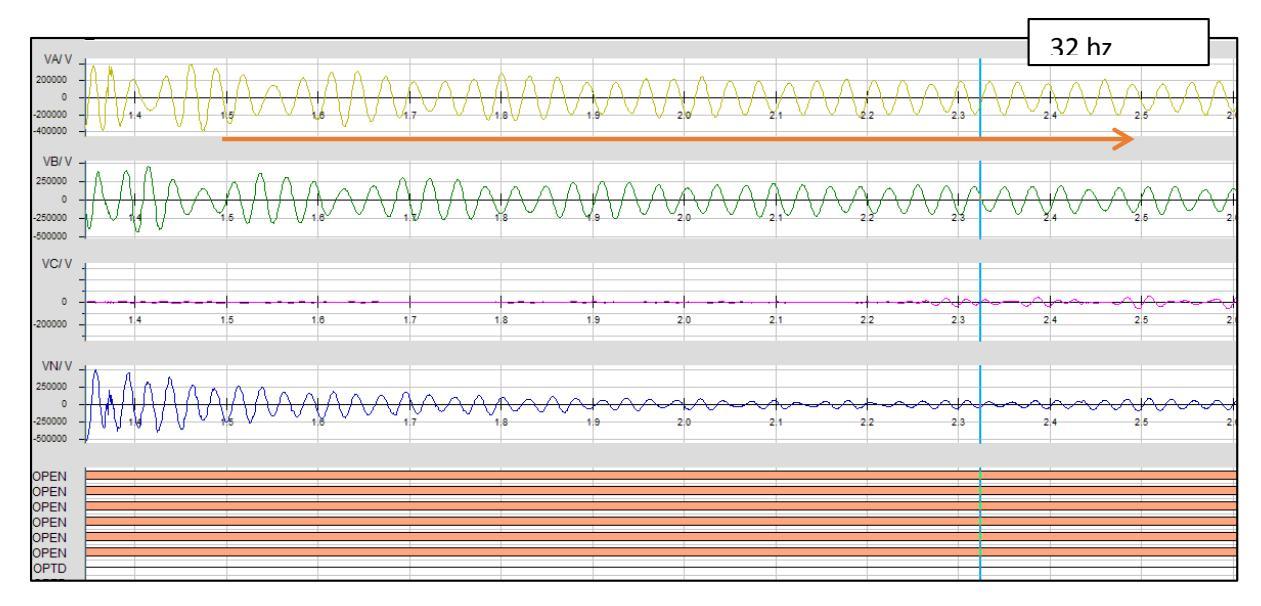
184 Km twin moose line with 50 Mvar Line reactor at Banka end .Degree of compensation k=50%Fosc-**35 Hz**, Reactor ringdown of **32 hz** observed in this case .Max voltage went upto **525 kv**.

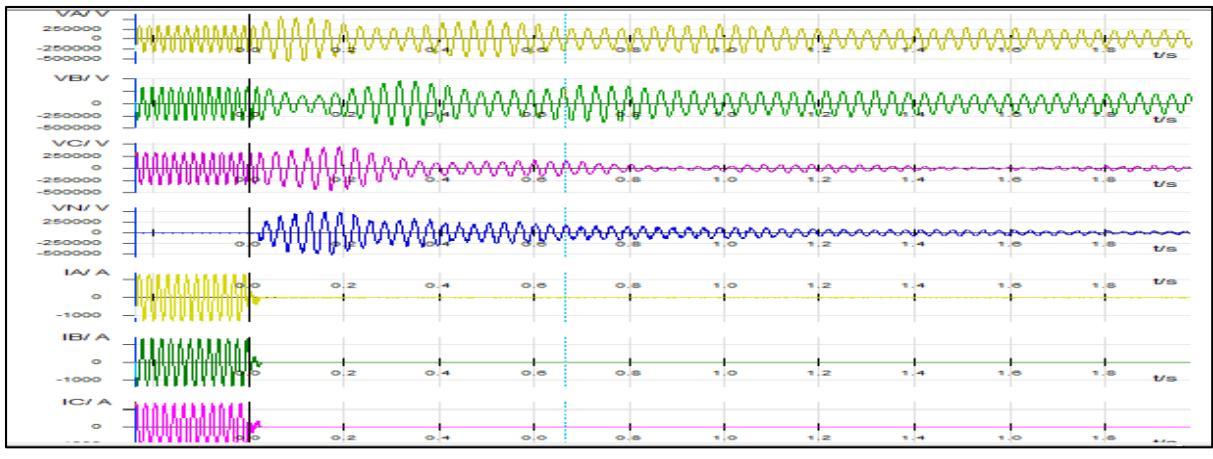
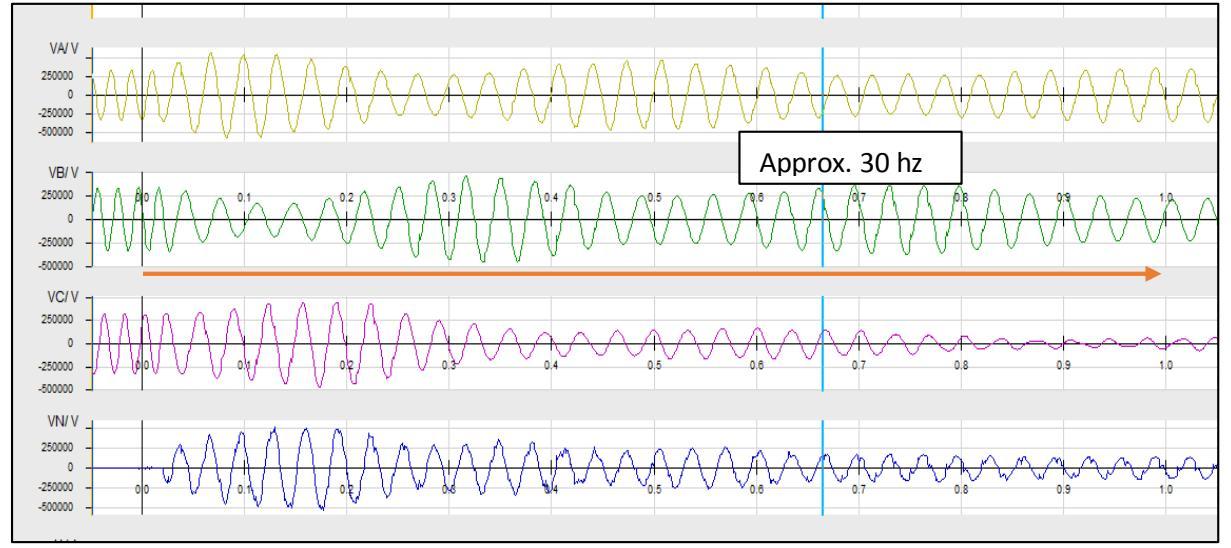
DR for 14th : 215 KM HTLS, line with 63 Mvar L/R at Kishanganj end . K=44% , Fosc=33 hz, Line voltage after 3 phase opening reached upto 550 kv .

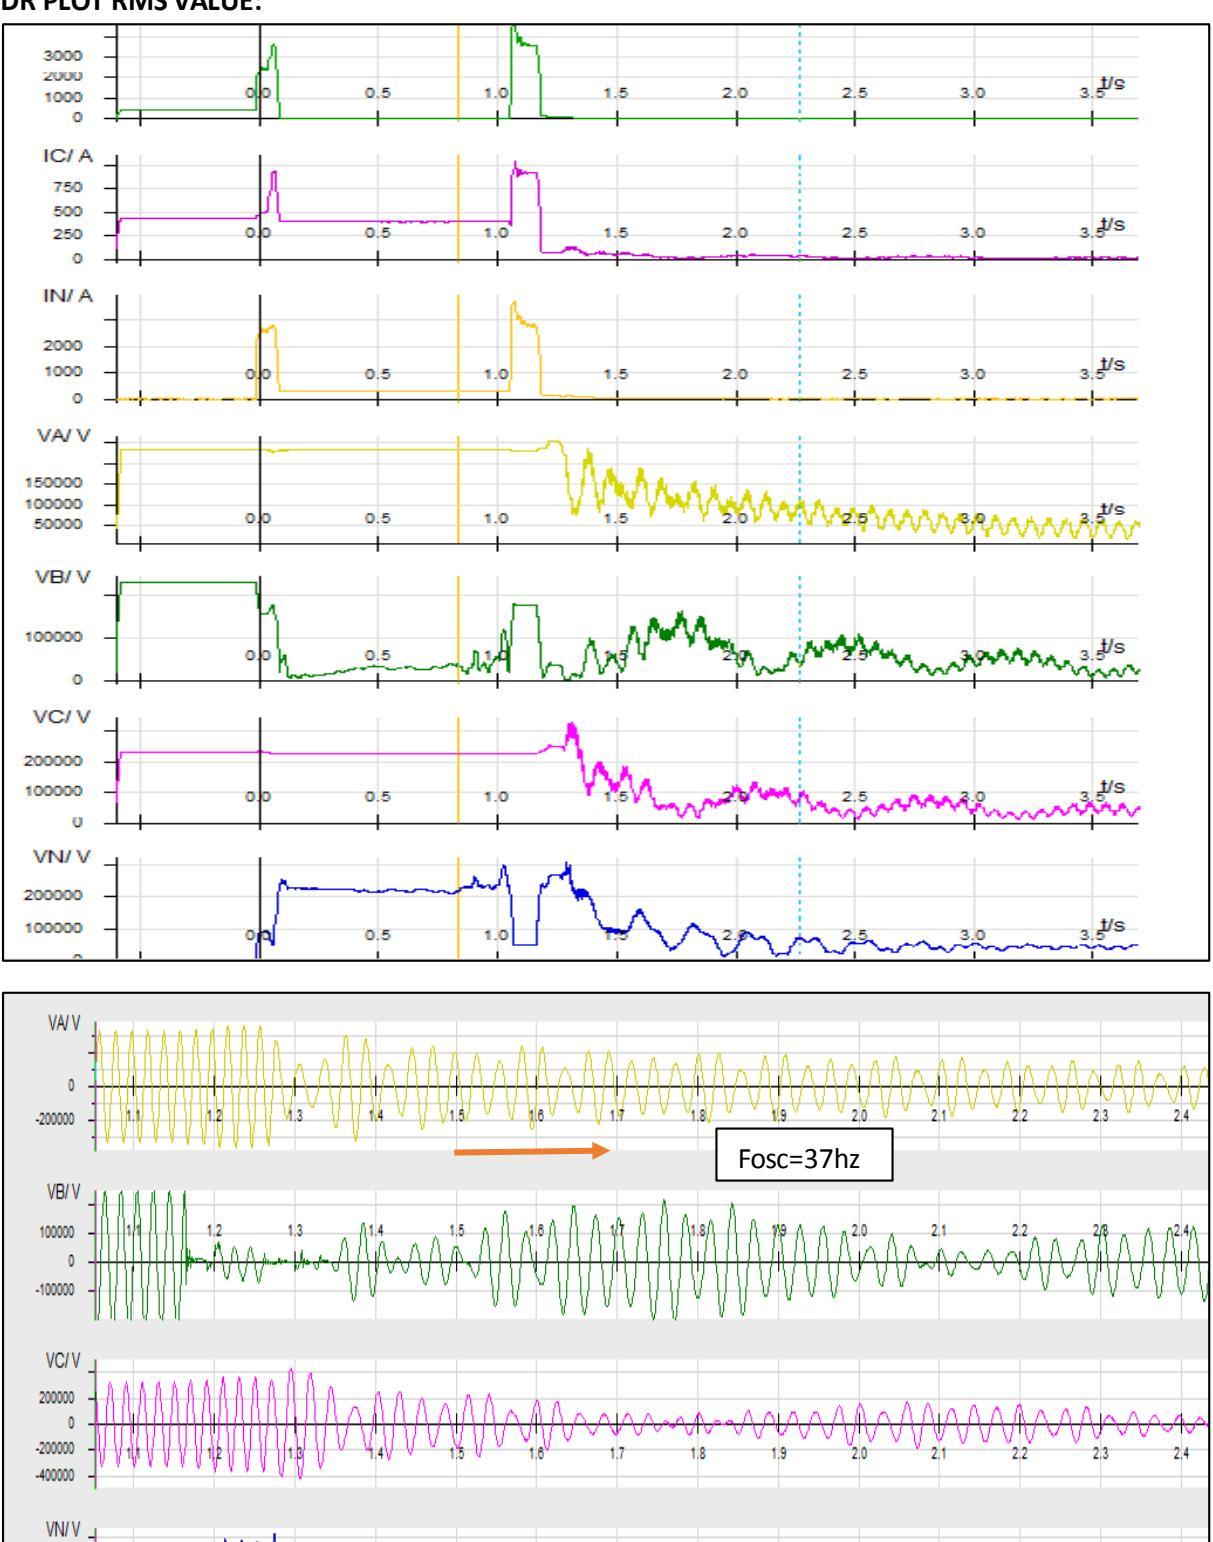
Line is 145 km long twin moose with 50 mvar L/R at lakhisarai end .Line charging mvar=80, K=50/80,SO Fosc =39 Hz. Maximum voltage went upto 500 Kv.

DR PLOT RMS VALUE:

From zoomed plot approx. -37 Hz of oscillating voltage was noticed.

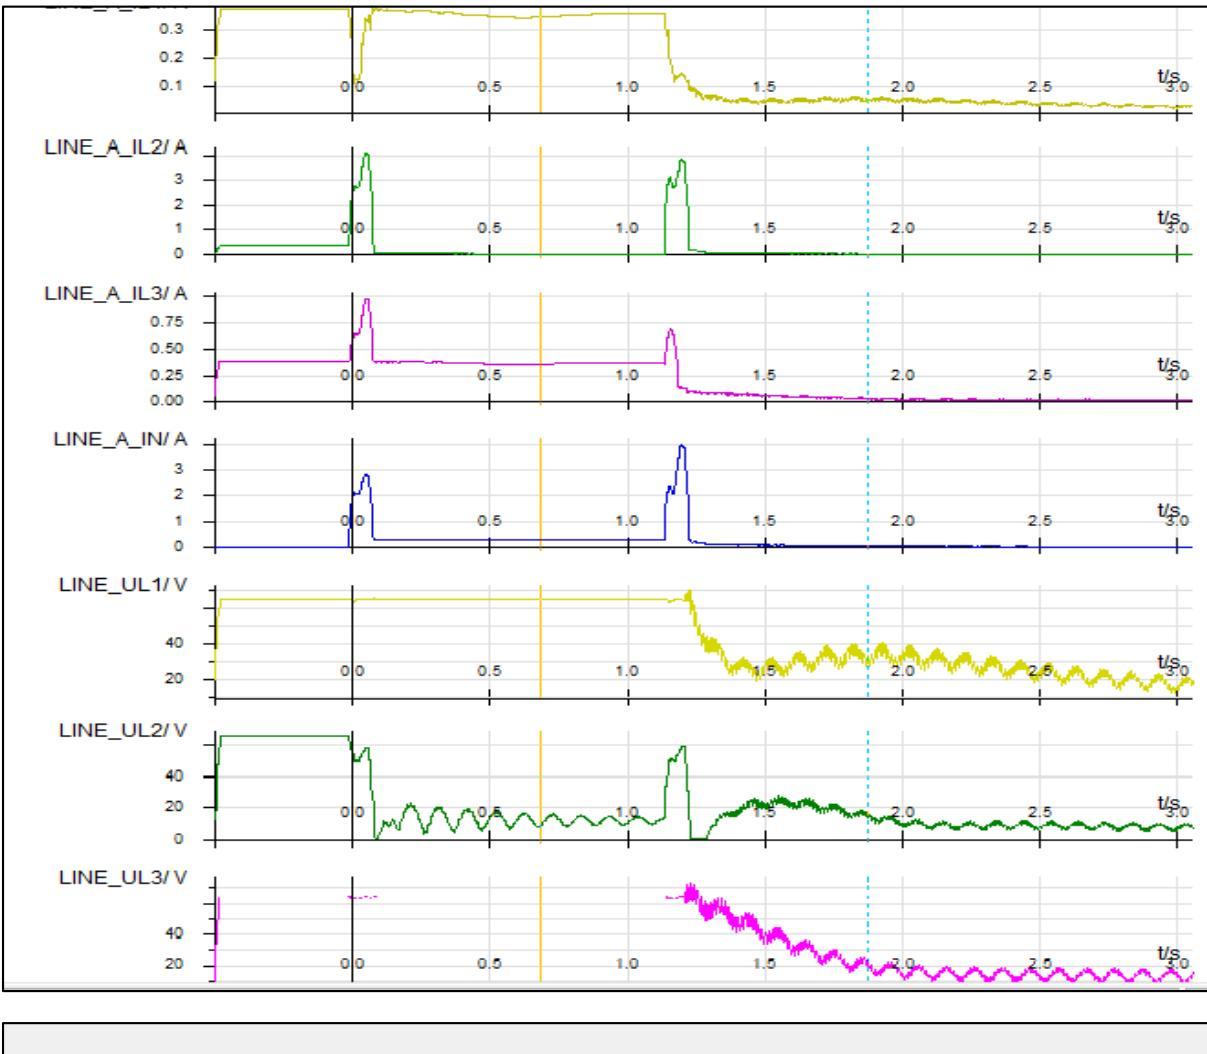
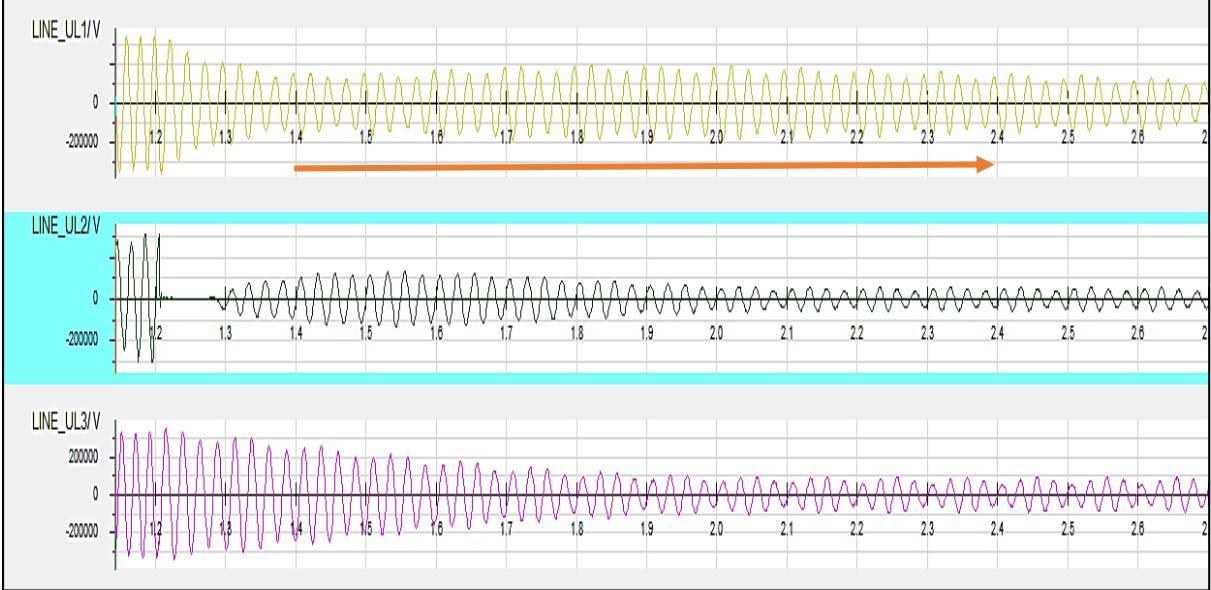
Degre of compensation is 76% so Fosc = 43 Hz. Dr plot voltage after 3 pole opening as shown below observed 40 HZ. Maximum voltage went upto 450 kv.
